Report # MATC-MS&T: 133-1

## Behavior and Repair of Corroded Steel H-Piles Phase I (Axial Behavior)

1. Report No.: 25-1121-0005-133-1		2. Government Accession No.:		3. Recipient's Catalog No.:	
4. Title and Subtitle:  Behavior and Repair of Corroded Steel H-Piles Phase I (Axial Behavior)				5. Report Date: May 2019

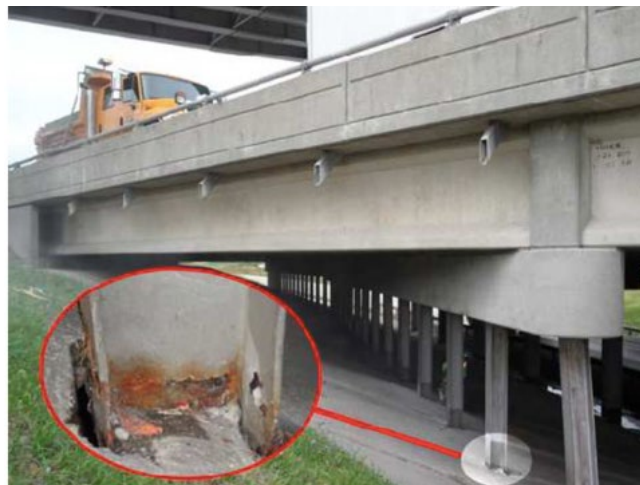
**Figure 1.1** Corrosion of H-piles in I-70/I-270 interchange in St. Louis.

Inspection of many of these bridges revealed severe localized corrosion damage due to aggressive environmental conditions or repetitive dry-wet cycles in a variable level of water table (figs. 1.1 and 1.2). Therefore, there is an urgent need to repair these piles using new techniques that have longer durability and require less maintenance during the extended service lifetime of the bridge.

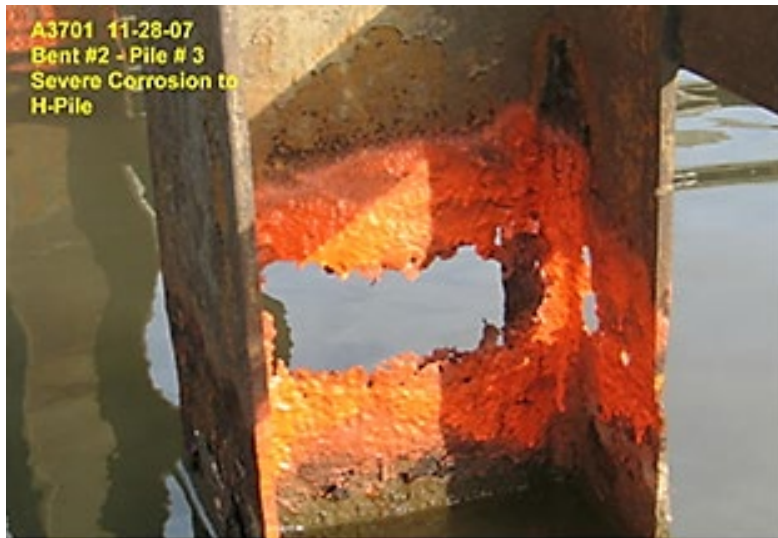
**Figure 1.2** Corroded steel column.

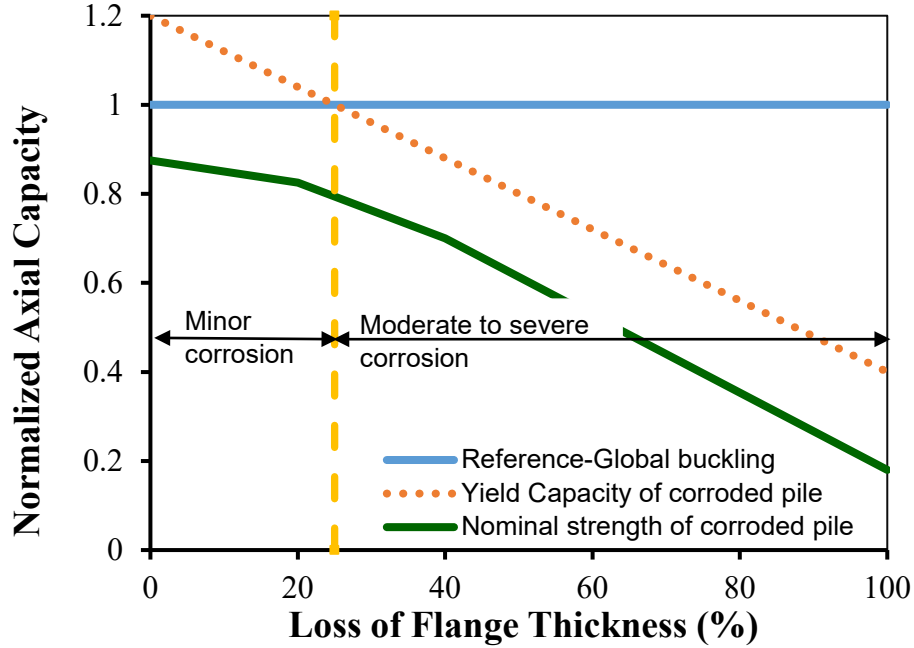
**Figure 1.3** An example of the strength of a pile for a given web thickness reduction (Dawood et al. 2017).

Pile corrosion can be classified into minor, moderate, or major based on the remaining capacity of the pile (Fig. 1.3). Minor damage is defined when the yield strength of the corroded section of the pile is higher than the original design load of the pile. Thus, the pile requires only stiffening sufficient to prevent local and global buckling in order for a remediation measure to be effective. Both moderate and major damages are characterized as the yield strength of the corroded section of a pile being smaller than the original design load of the pile. The pile would require load sharing repair or an alternative load path to reach the design capacity.

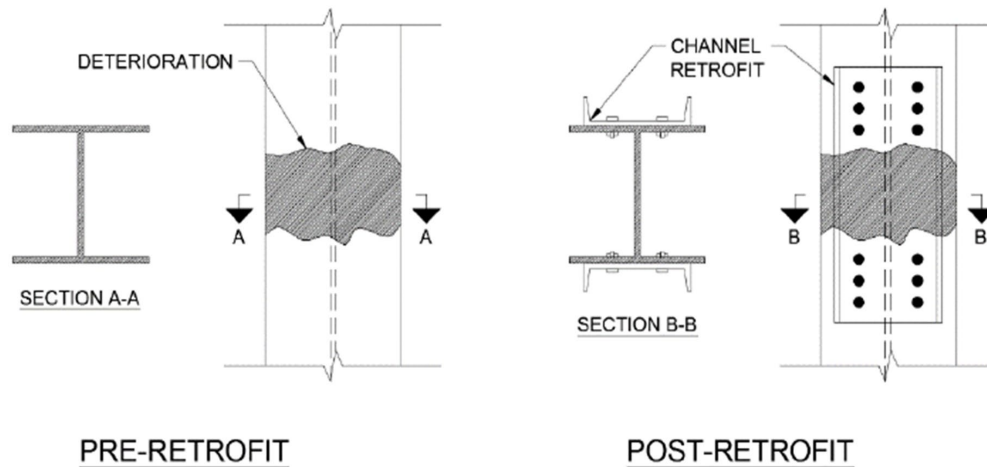
**Figure 1.4** Retrofitting using bolted steel channels (GDOT 2012).

By knowing what capacity still remains, an appropriate retrofit can be applied to a pile. Many repair techniques have been implemented by DOTs for strengthening and ensuring the integrity of corroded steel H-pile columns. Retrofitting involves steel channels bolted or welded (fig. 1.4) to the exterior of the flange across the damaged area of the pile were used by IADOT (Wipf et al. 2003), GDOT (Georgia Department of Transportation 2012), WisDOT (Wan et al. 2013), and Department of the Army (1991). This type of repairing would only serve as a temporary repair because of its susceptibility to continued corrosion (Stauffer 2016).

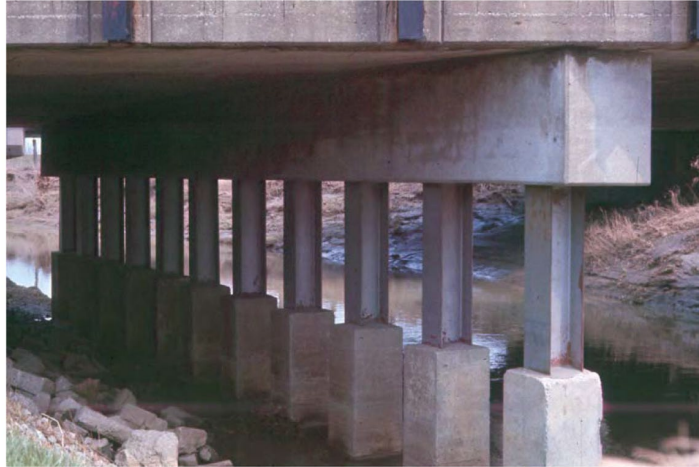
**Figure 1.5** Concrete encasement retrofitting method (ODOT 2008).

Another repair technique included the application of a concrete jacket (fig. 1.5) to corroded steel members to avert the corrosion and increase the strength. It was considered one of the most cost effective and easy to implement retrofit techniques (Soliman et al. 2013). The form can remain in place as part of the jacket or be removed, leaving the concrete on the retrofitted piling (Army and Air Force 1994; Georgia Department of Transportation 2012; Wipf et al. 2003). In some cases, reinforcement can be embedded into the concrete to add sufficient strength and to compensate for the loss of the weak axis bending stiffness (Dawood et al. 2017). This method of retrofitting provides continuous bracing along the deteriorated section, but also inhibits monitoring the condition of the steel after the retrofit is made (Florida Department of Transportation 2011).

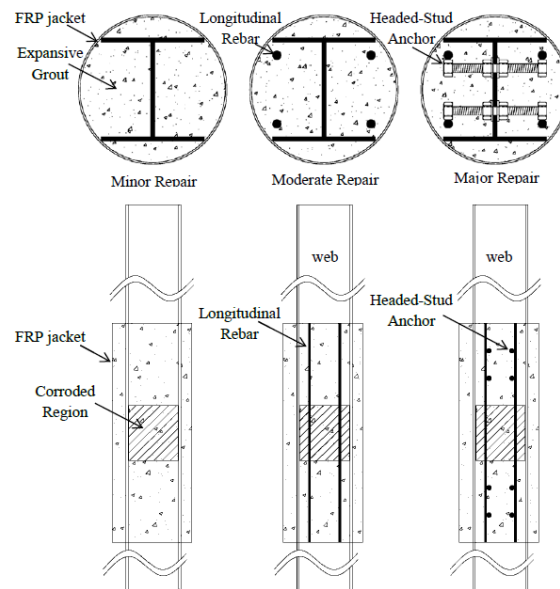
**Figure 1.6** FRP jacket retrofitting types (Dawood et al. 2017).

the most efficient and reliable methods available to remedy structural element deterioration. In the case of column repair, the procedure including wrapping the built-up section with an FRP jacket and filling the jacket with grout or expansive concrete. Using the expansive lightweight concrete allows the FRP jacket to provide active confinement to the steel columns, and hence increases the bond strength and the load capacity of the retrofitted columns (Liu et al. 2005; Vijay et al. 2016). While FRP jacketing of concrete columns is a well-established technique, there has been substantially less research conducted to investigate the effectiveness of this method to retrofit steel piles (fig. 1.6). Moreover, the concrete and FRP tube restrain the steel section, so their susceptibility to buckling is greatly reduced (Karimi et al. 2011; Teng and Yu 2015).

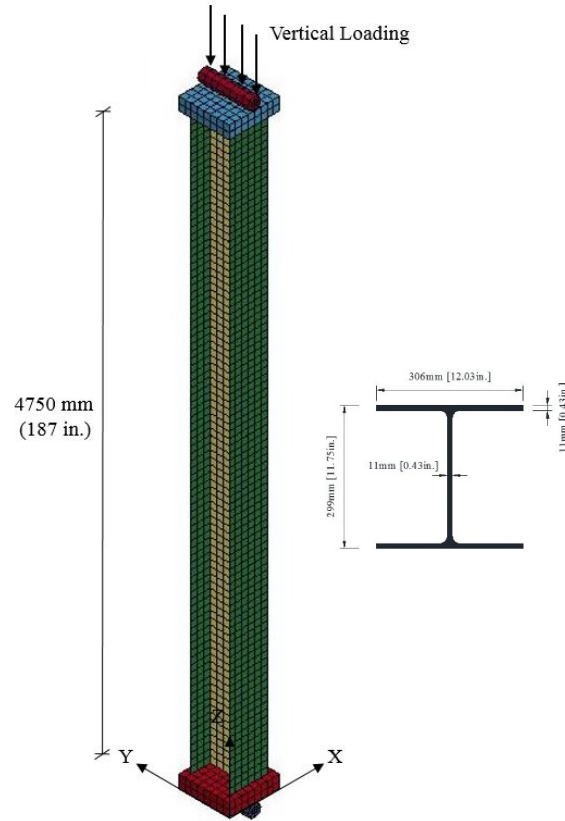
**Figure 2.1** Three-dimensional (3D) view of the simulated H-pile.

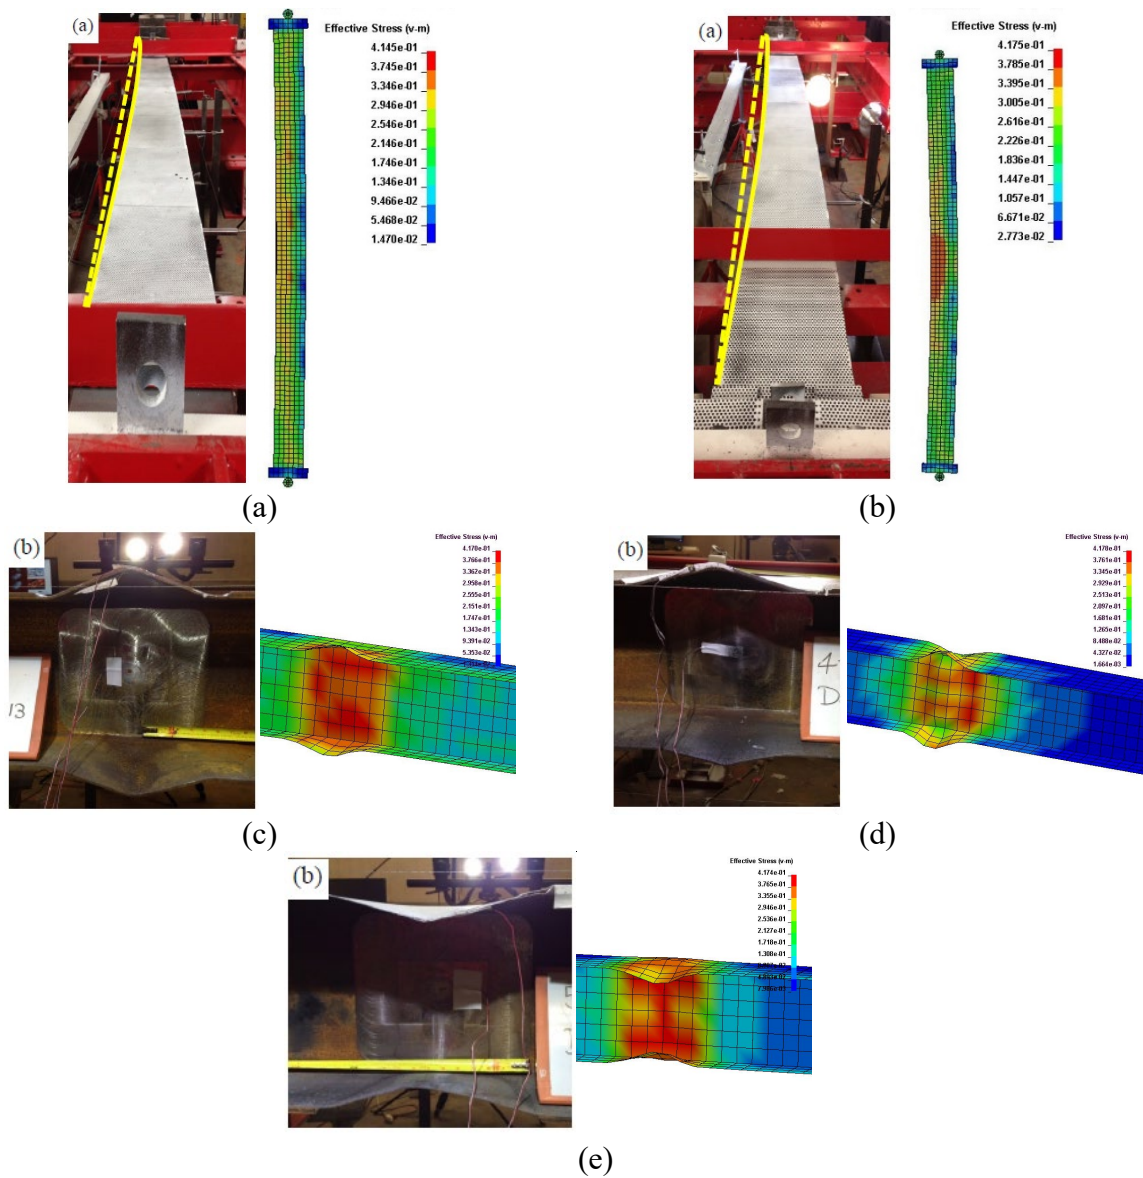
**Figure 2.5** Comparison between the modes of failure of the experimental and finite element models: (a) 0/0, (b) 0/20, (c) 20/40, (d) 40/60 and (e) 80/60.

The FE models were able to capture the test specimens' behavior in terms of initial stiffness and peak load with an error ranging from 0.4% to 10%. The FEMs were not biased in terms of peak loads, as it overestimated the strengths of two specimens and under estimated the strength of three specimens. The FEMs predicted quite well the modes of failure (fig. 2.4). The FEMs and experimental testing showed that all piles reached their yielding loads, which was followed by either global buckling in the case of piles 0/0 and 0/20 (fig. 2.5 (a, b)), or local buckling in the flange or web, depending on the thickness of the corroded section (fig. 2.5 (c, d, e)).

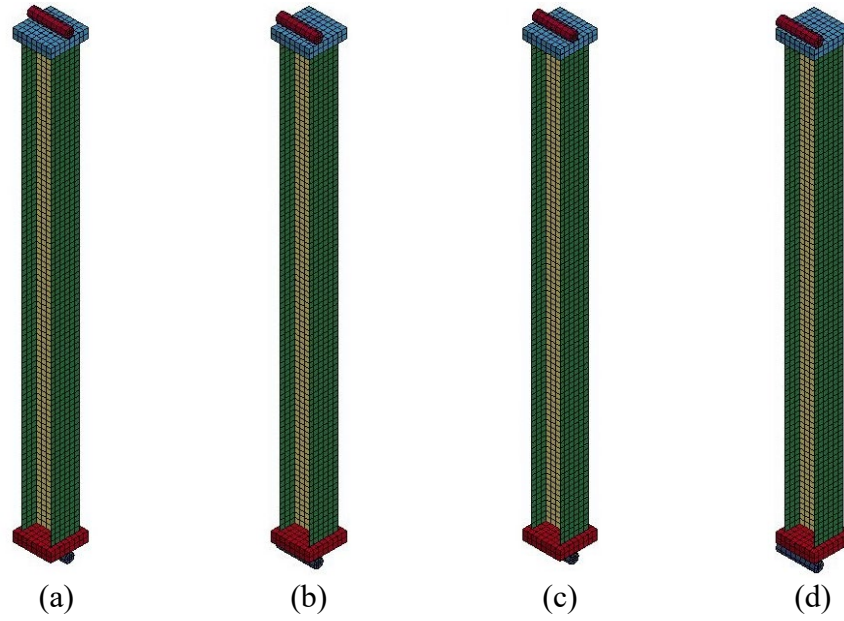
**Figure 2.6** Three-dimensional (3D) view of simulated H-piles with different eccentricity: (a)  $e=0$  mm; (b)  $e=50$  mm; (c)  $e=100$  mm; (d)  $e=150$  mm.

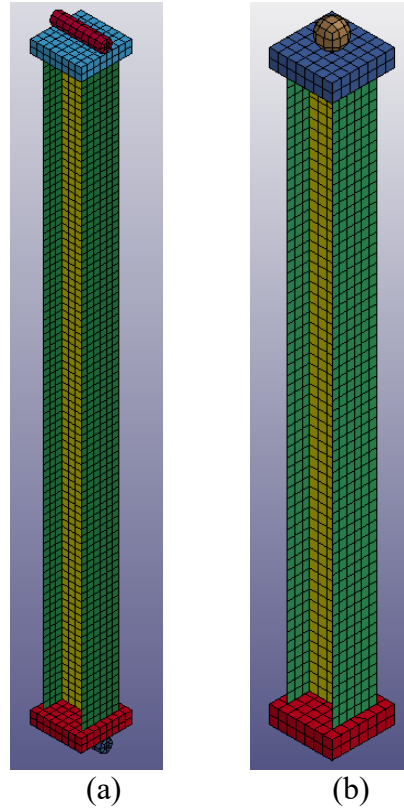
**Figure 2.9** Boundary conditions for the H-piles.

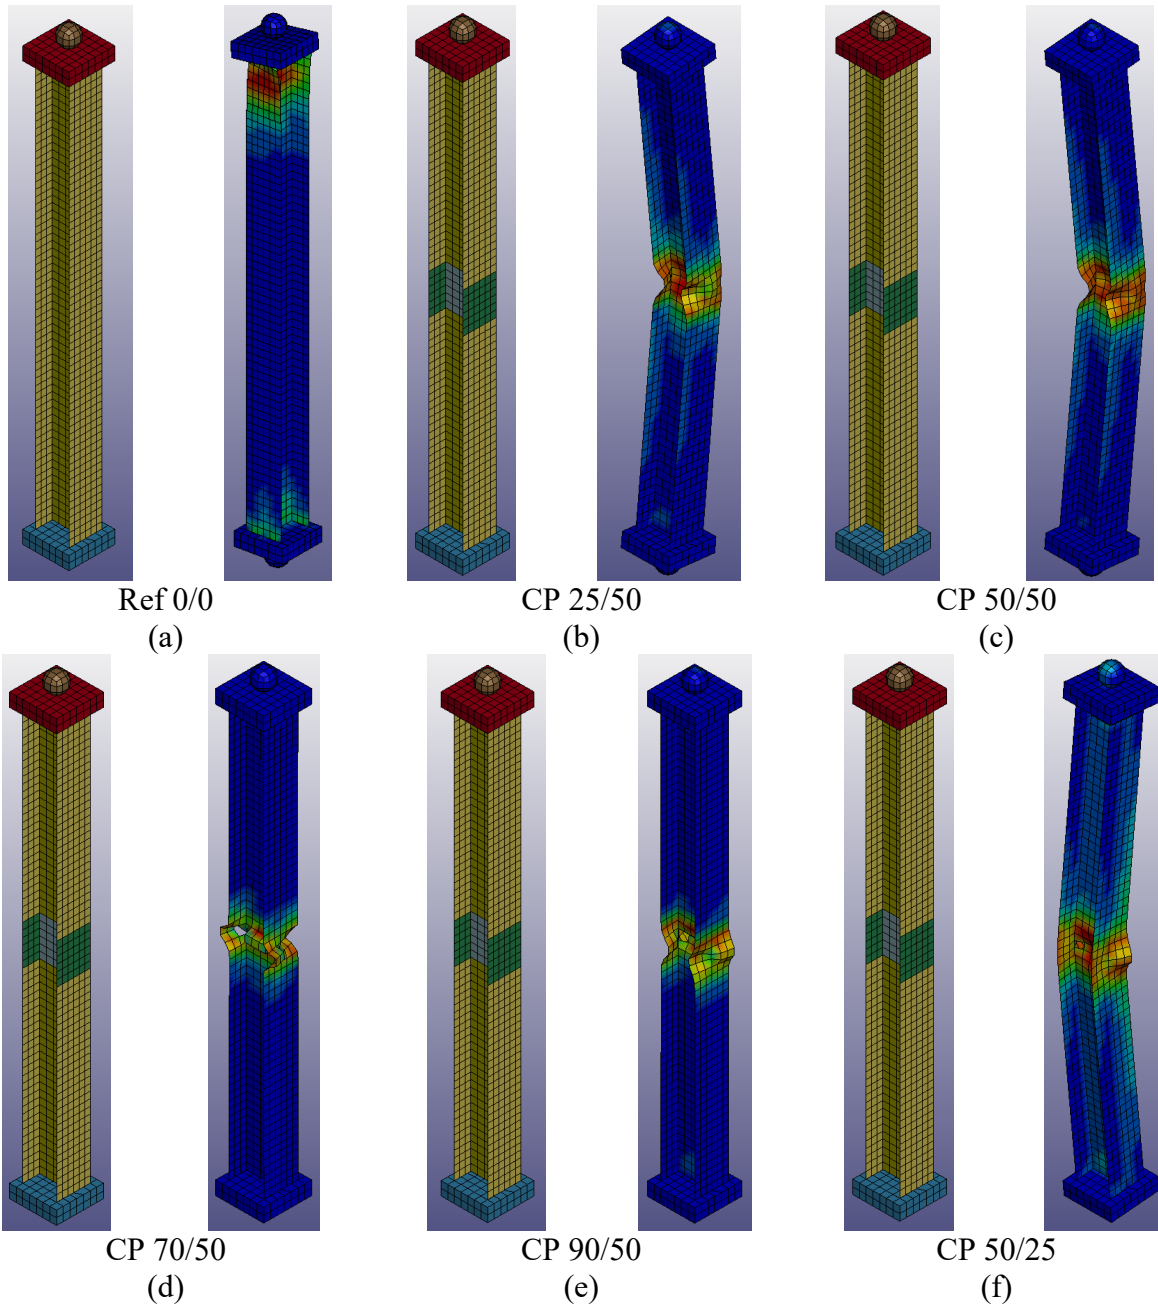
**Figure 2.10** Deformed shape of corroded piles (a)-(f)

The reference model failed due to yielding at the end of the pile (Fig. 2.10 (a)), while all the models in groups A and B failed at the corroded region due to local buckling (Fig. 2.10). The results of the FEMs of groups A and B were examined to determine the loss in the axial capacity compared to that of the reference specimen (Ref 0/0) (Fig. 2.11). Increasing the corrosion depth decreased the axial load carrying capacity due to the change in the failure mode from yielding to local buckling. The response of the pile is very sensitive to the corrosion in the flanges. Reductions by 90% and 50% in the thicknesses of the flanges and web, respectively, resulted in 70% loss in the axial load capacity of the pile, while only a 54% loss in the axial capacity occurred when reductions by 50% and 90% occurred in the thicknesses of the flanges and web, respectively, (table 2.4 and fig. 2.12).

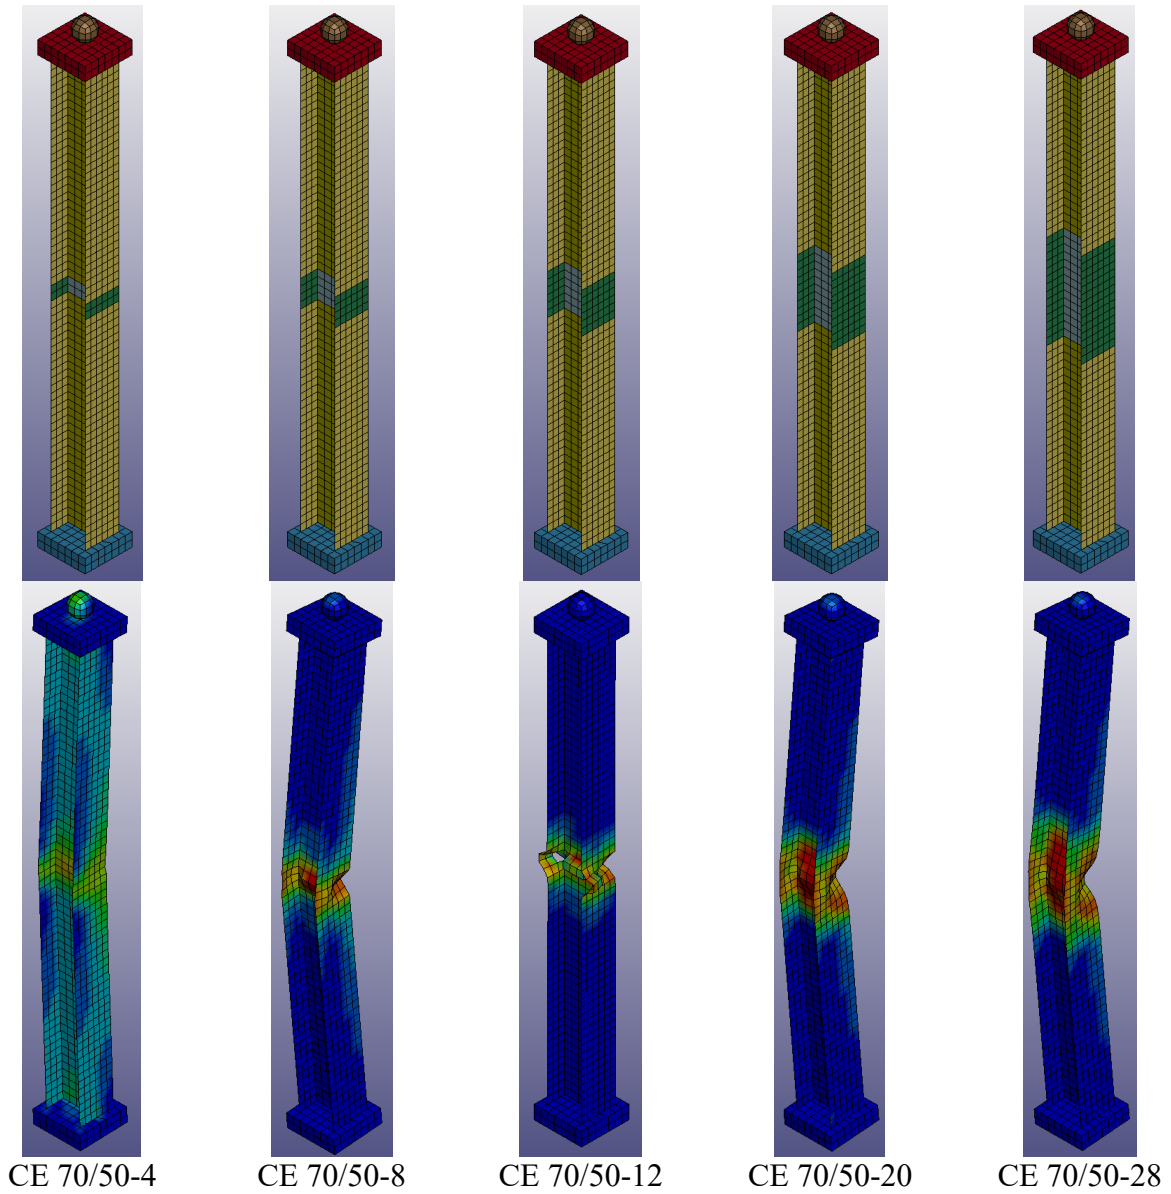
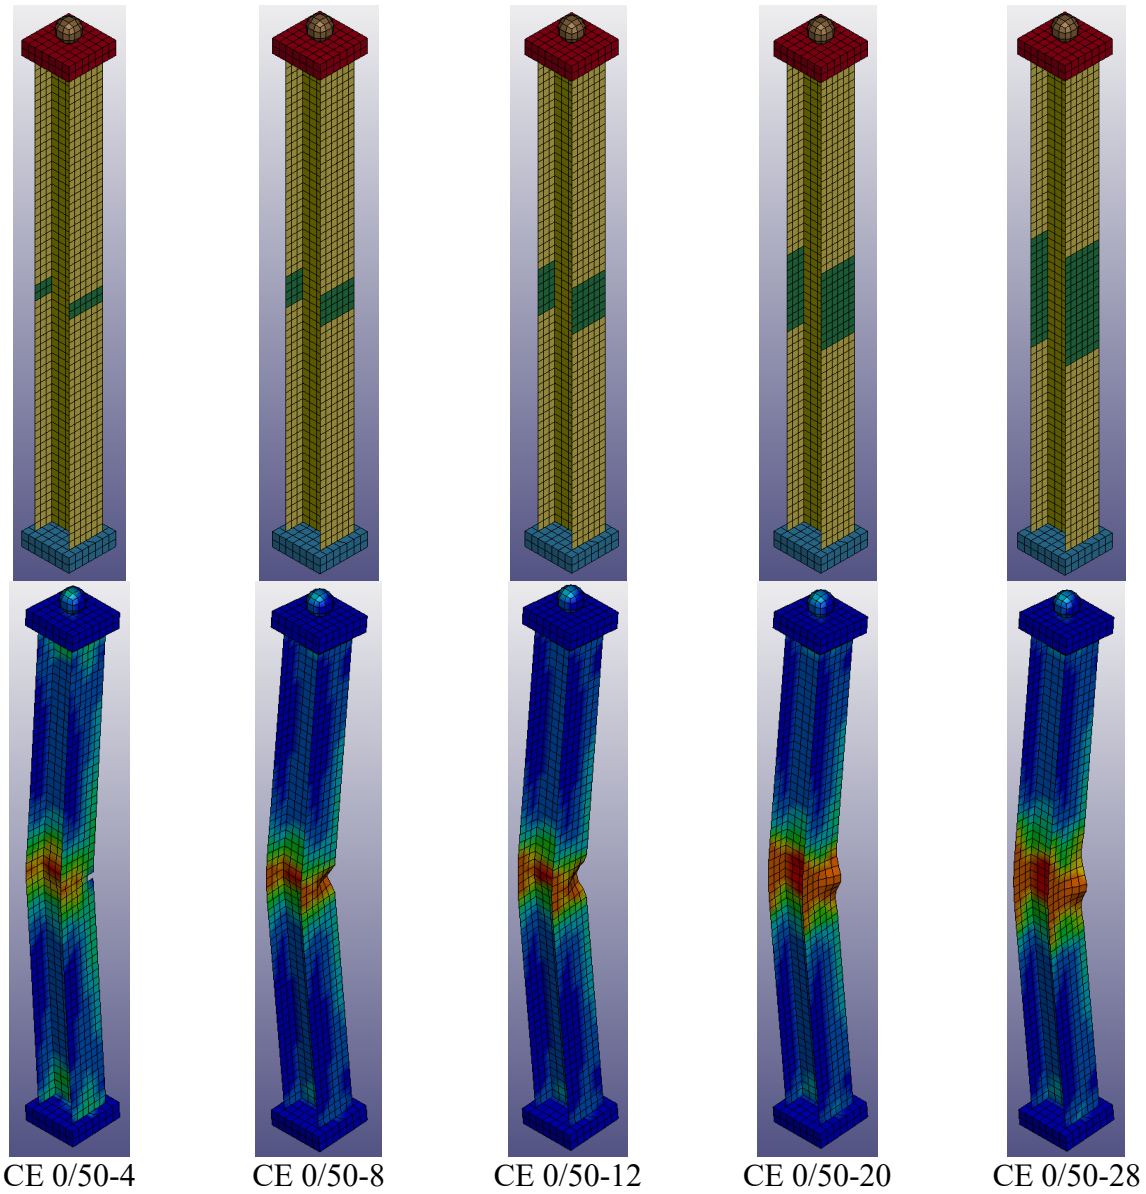
**Figure 2.13** Undeformed and deformed shapes of the corroded piles in groups C and D.

**Figure 2.13 cont.** Undeformed and deformed shapes of the corroded piles in groups C and D.

The corroded length of an H-pile affects the axial capacity of the pile and can change the failure mode from local to global buckling failure. Fig 2.13 shows both the undeformed and deformed shapes of group C models. Increasing the corroded length while having a high corrosion percentage in the web and flanges resulted in increased loss in the axial load capacity of the pile (Fig. 2.14). However, for group D, increasing the corroded section length while having minor corrosion did not reduce the axial capacity of the piles (Fig. 2.15). Furthermore, the losses in the axial capacities of the piles remained constant for piles having corroded lengths exceeding 500 mm and 300 mm (20 in. and 12 in.) for groups C and D, respectively (Fig 2.15).

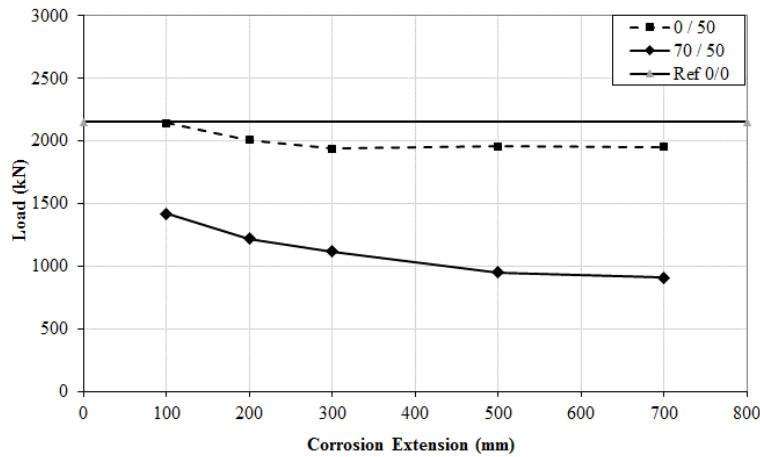
**Figure 2.15** Reductions in the axial load capacity due to different reductions in the corroded section lengths.

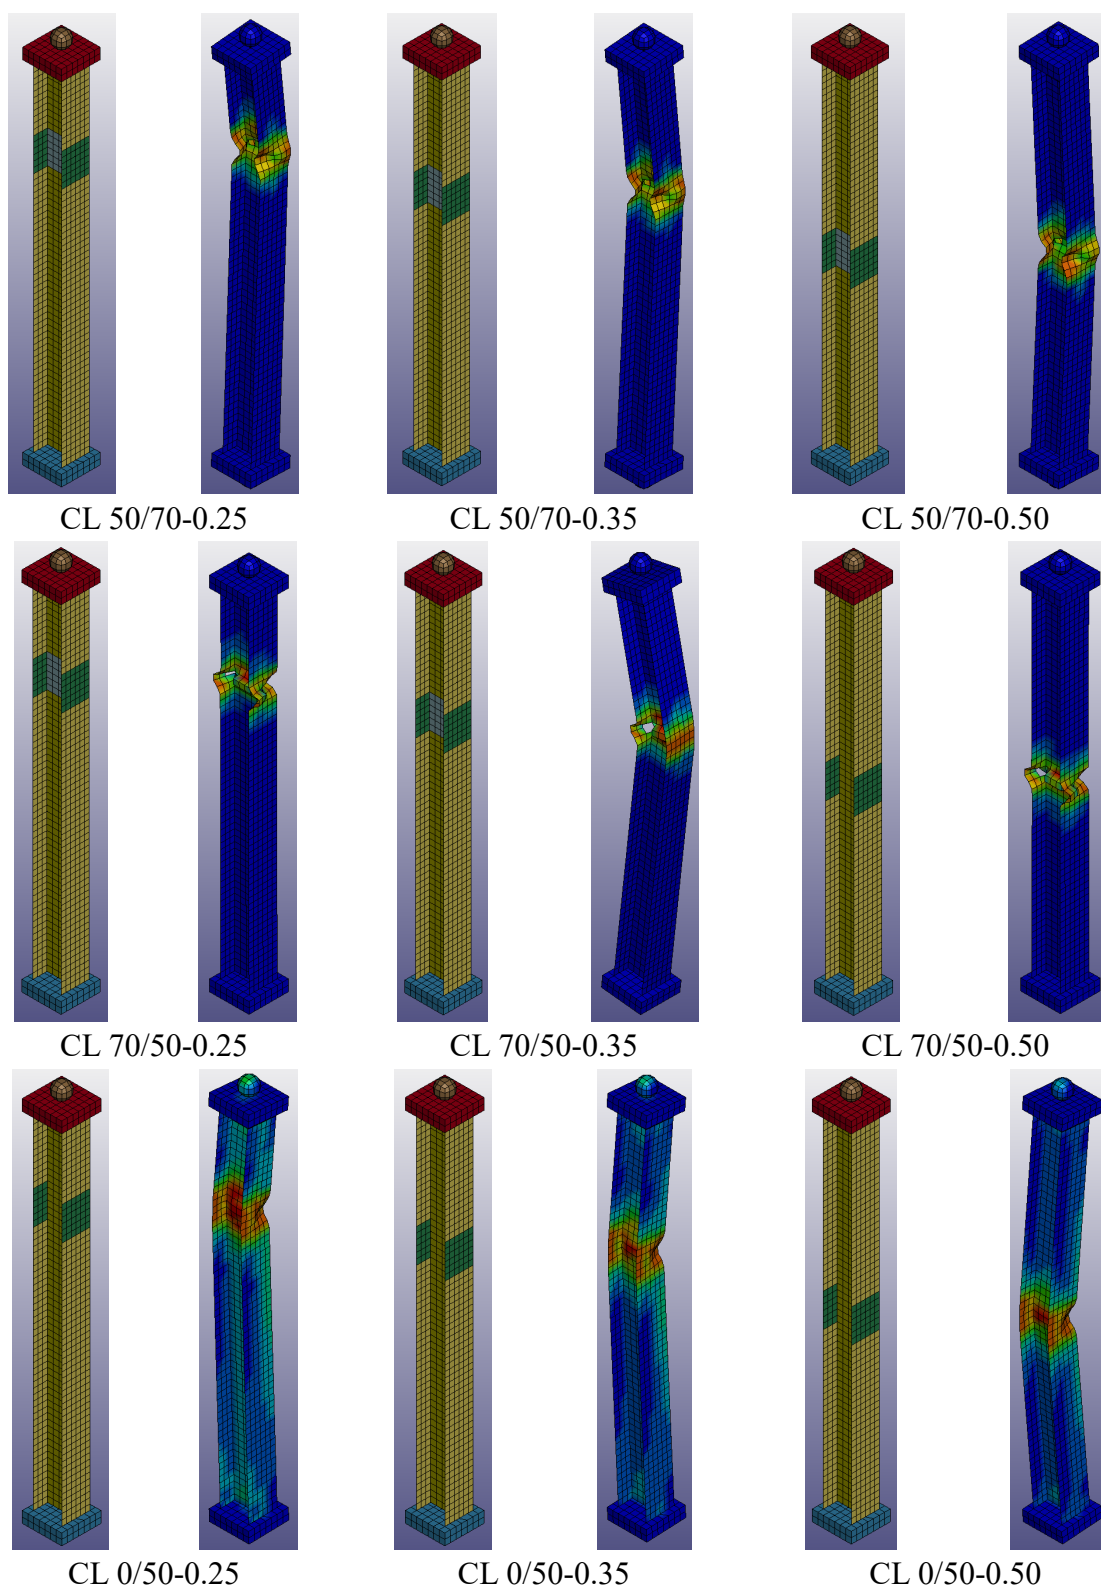
**Figure 2.17** Undeformed and deformed shapes of the corroded piles in groups E, F, and G.

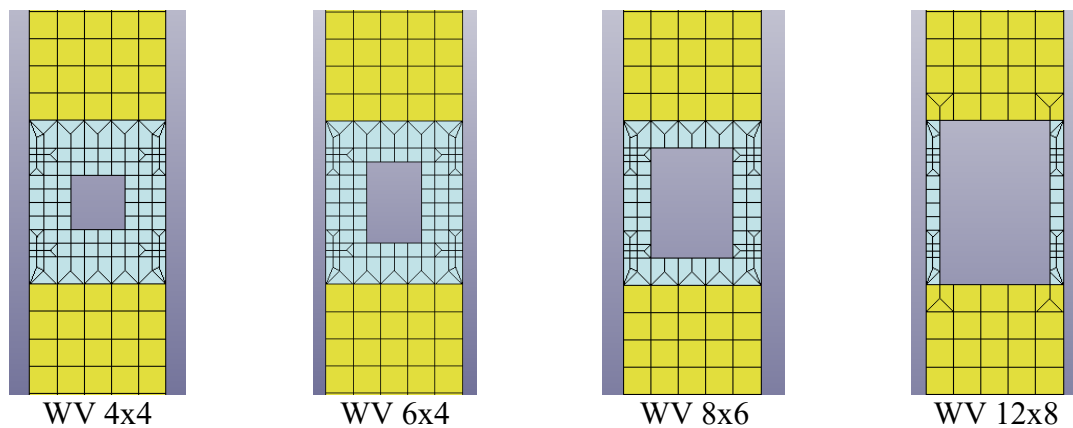
**Figure 2.18** Mesh generation and sizes of the voids in the webs.

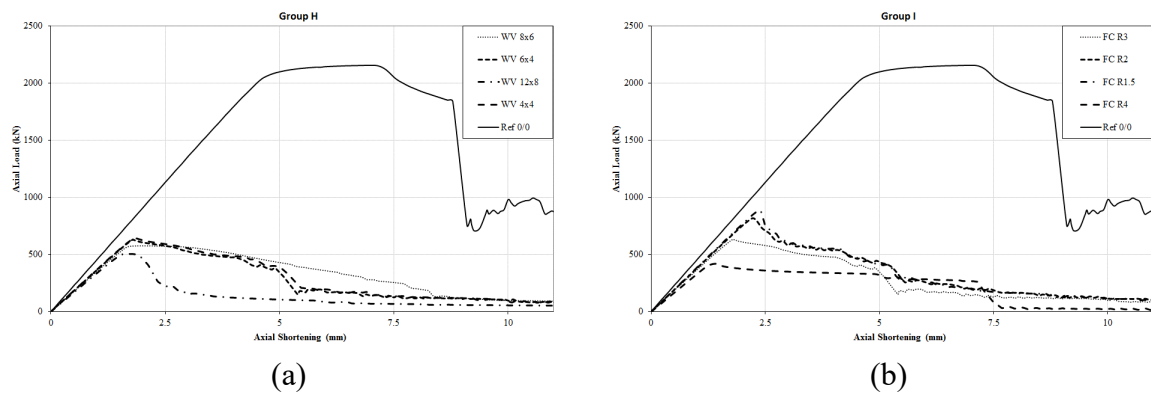
**Figure 2.20** Axial load vs axial shortening of corroded piles having different sizes for the cut in the: (a) Web with fixed cut size in the flanges, and (b) Flanges with fixed void size in the web.

the axial load capacity by 42% to 54% compared to the corroded piles without voids. The size of the voids in the web had a relatively small effect on reducing the axial capacity as all four models lost approximately 70% in their axial load capacity compared to the reference model. Furthermore, increasing the cut size in the flanges significantly reduced the maximum axial capacity of the pile (Fig 2.22 and Table 2.8). Increasing the radius of the cut from 37.5 mm to 100 mm (1.5 in. to 4 in.) increased the loss in axial load capacity from 59% to 80% with respect to the reference pile.

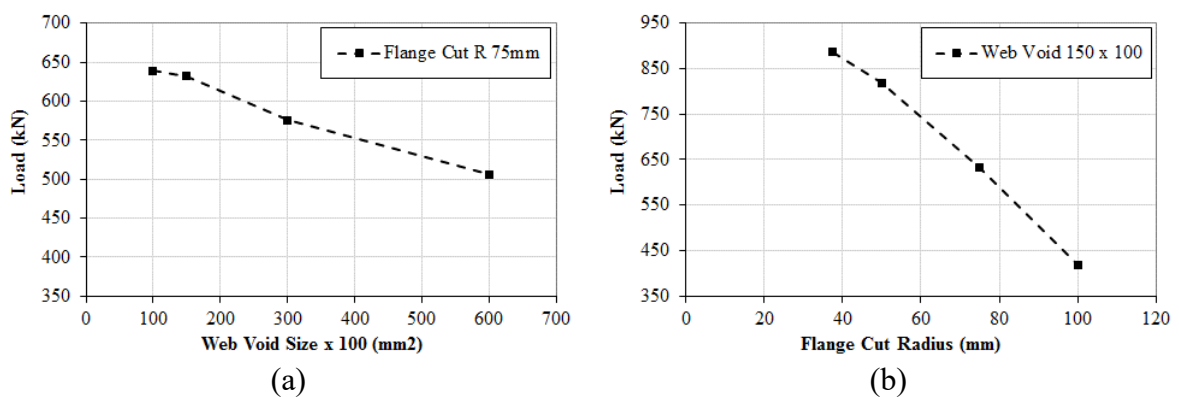
**Figure 2.21** Reductions in the axial load capacity due to different void and cut sizes in the pile.

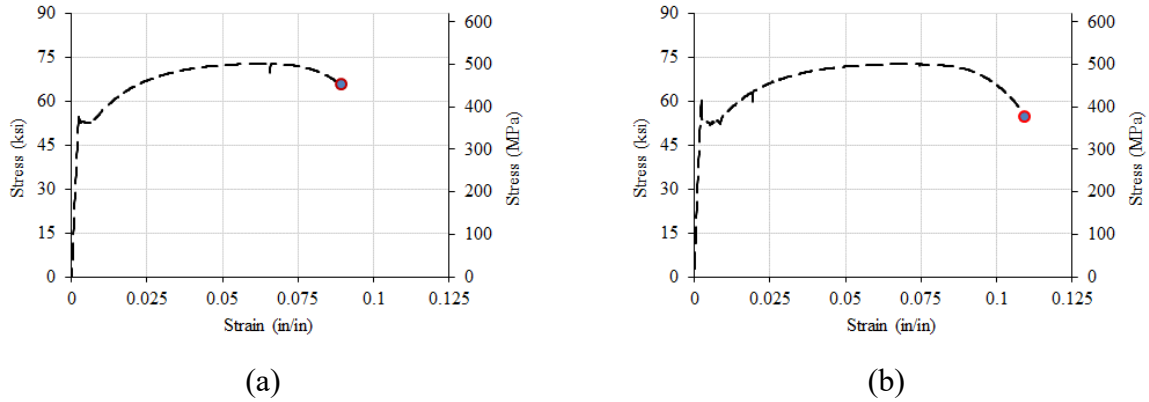
**Figure 4.2** Steel tubes average stress-strain curve (a) flange, and (b) web.

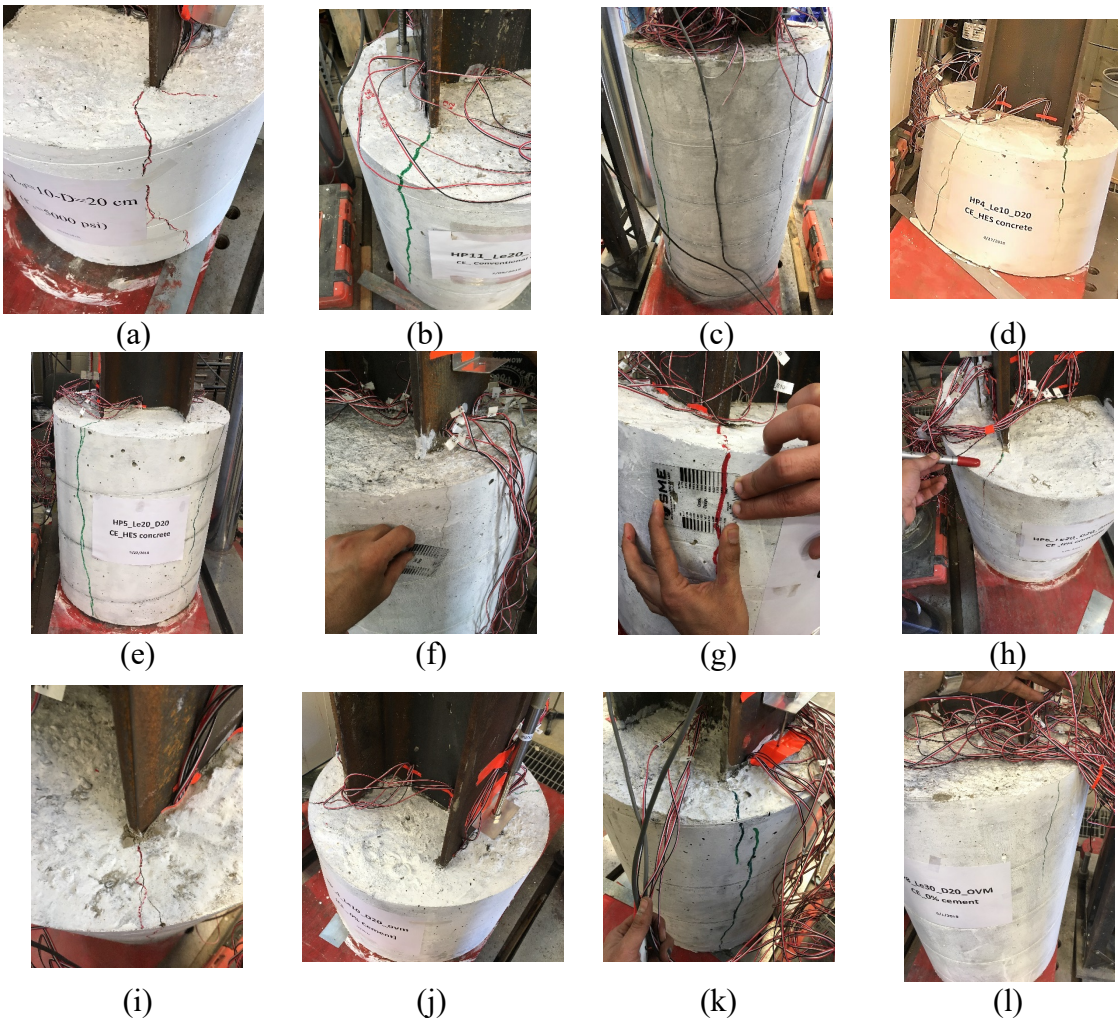
**Figure 4.9** Concrete encasement crack patterns with different embedment length ( $L_{CE}$ ) of 254, 508, 762 mm (10, 20, and 30 in.) (a-c) CC, (d-f) HES, (g-i) GA, and (j-l) GT.

Figure 4.9 shows the failure modes of the 14 tested specimens in this study. Generally after performing the push-out loads, the surface of the steel H-pile was intact (fig. 4.10), which indicated a shear failure occurred on the interface between the concrete jacket and the steel section.

The characteristic feature of this failure mechanism is the downward slip of the steel H-pile followed by a sudden failure at the ultimate load without any concrete crushing. This sudden failure was accompanied by splitting the concrete followed by decreasing in the axial load. Stress concentration occurred at the tips of the steel flanges combined with high hoop strains, which led to vertical cracking. Most of the specimens experienced the same crack pattern (fig. 4.9).

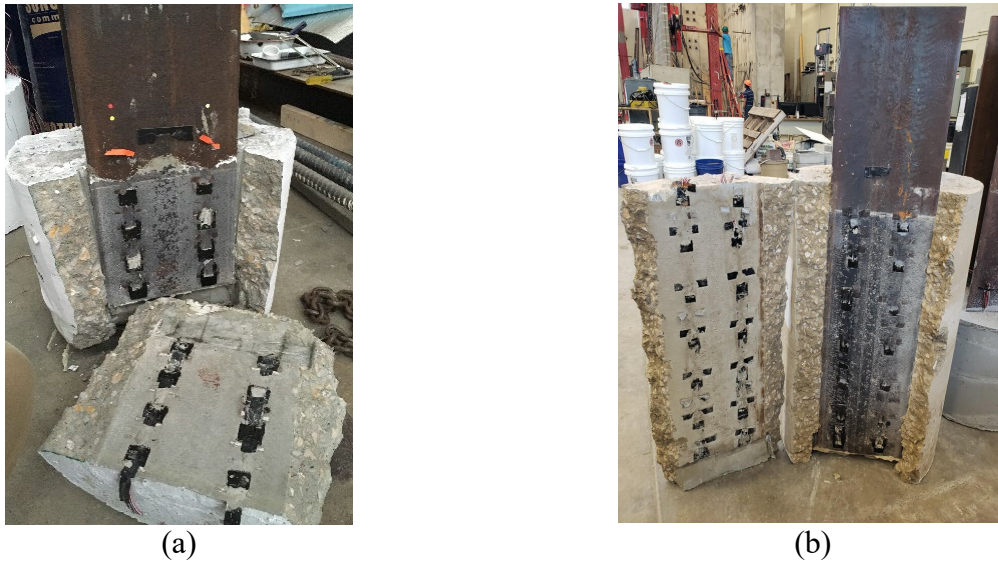
**Figure 4.10** Concrete encasement – steel H-pile contact area condition (a)  $L_{CE} = 254$  mm (10 in.), (b)  $L_{CE} = 508$  mm (20 in.).

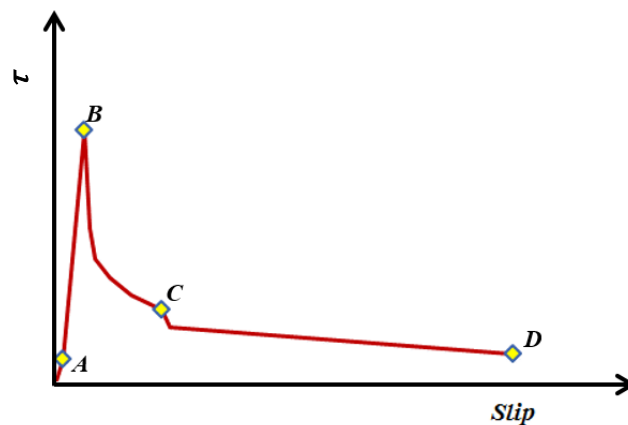
**Figure 4.11** Typical bond stress ( $\tau$ ) versus slip curve

Figure 4.11 shows a schematic of a typical bond stress-slip model curve for the tested piles in this study. In the initial loading stage, the response consists of a stiff linearly ascending part A-B in which the bond resistance is composed mainly of chemical adhesion and/or static friction, with practically very little increase in the slip. After that, as the slip increases, micro cracks appear at the smallest concrete encasement thickness near the flanges' edges; then, the cracks propagate gradually toward the concrete jacket surface. Finally, the radial component of the bond force increases and the widths of the cracks increase significantly, leading to splitting failure at point B. The presented model is similar to bond-slip models between an internal reinforcing bar and concrete where a residual constant friction force (residual bond stress at region C-D) remains at large slip (Cao et al. 2007).

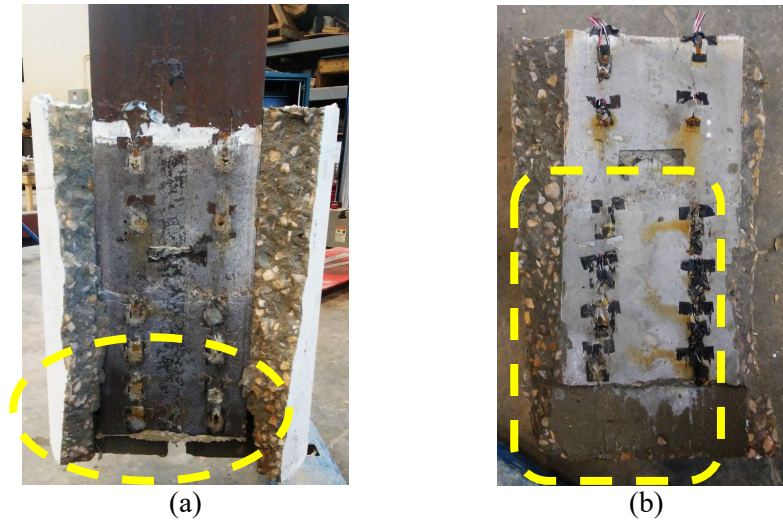
**Figure 4.14** Passive film formation (a) GA specimen ( $L_{CE}=508$  mm (20 in.)), (b) closer view.

(c)). The reason may be attributed to the formation of a passive film (protective iron oxide film) on the steel surface due to the alkaline solution's presence in the GA mix (fig. 4.14), which is more damaged and degraded when subjected to loads (Angst et al. 2017).

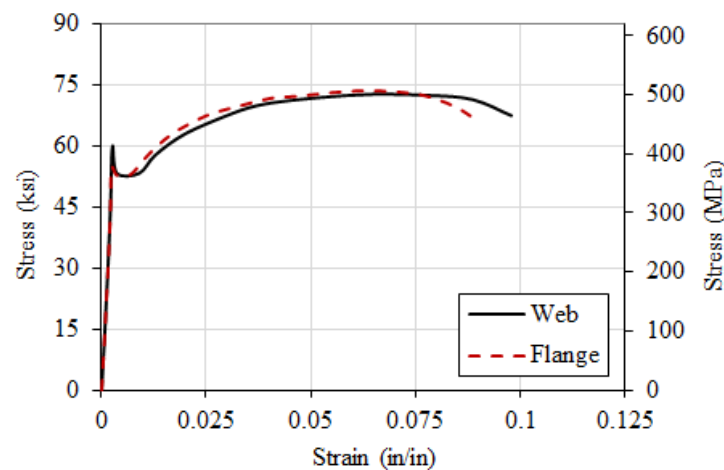
**Figure 5.2** Average steel pile stress-strain curves.

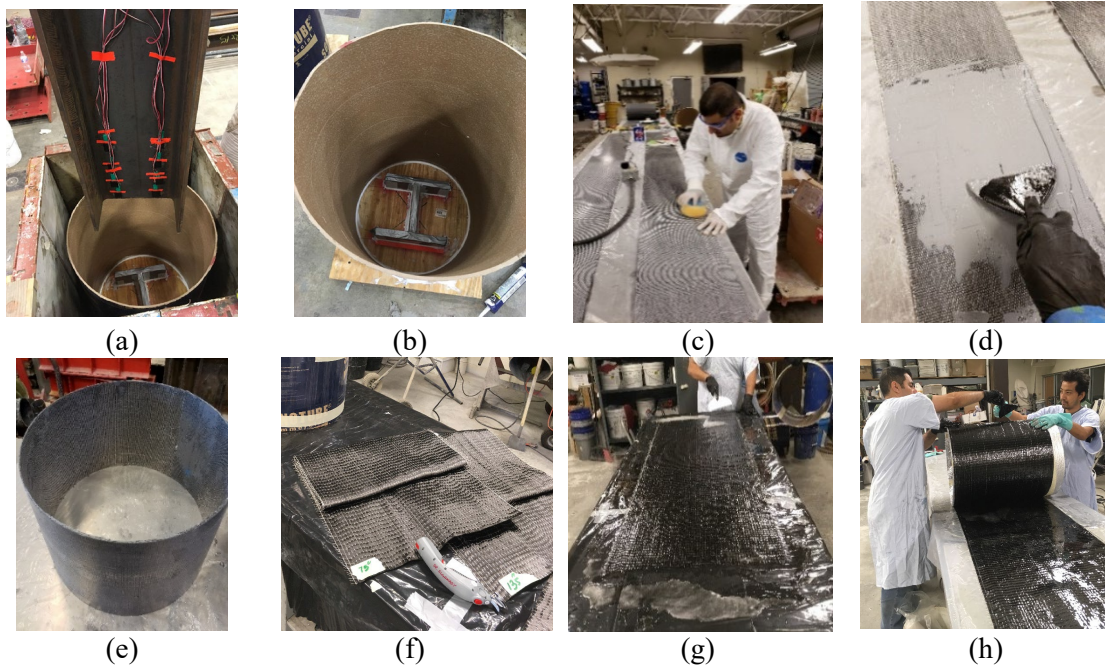
**Figure 5.5** CFRP wrapping process.

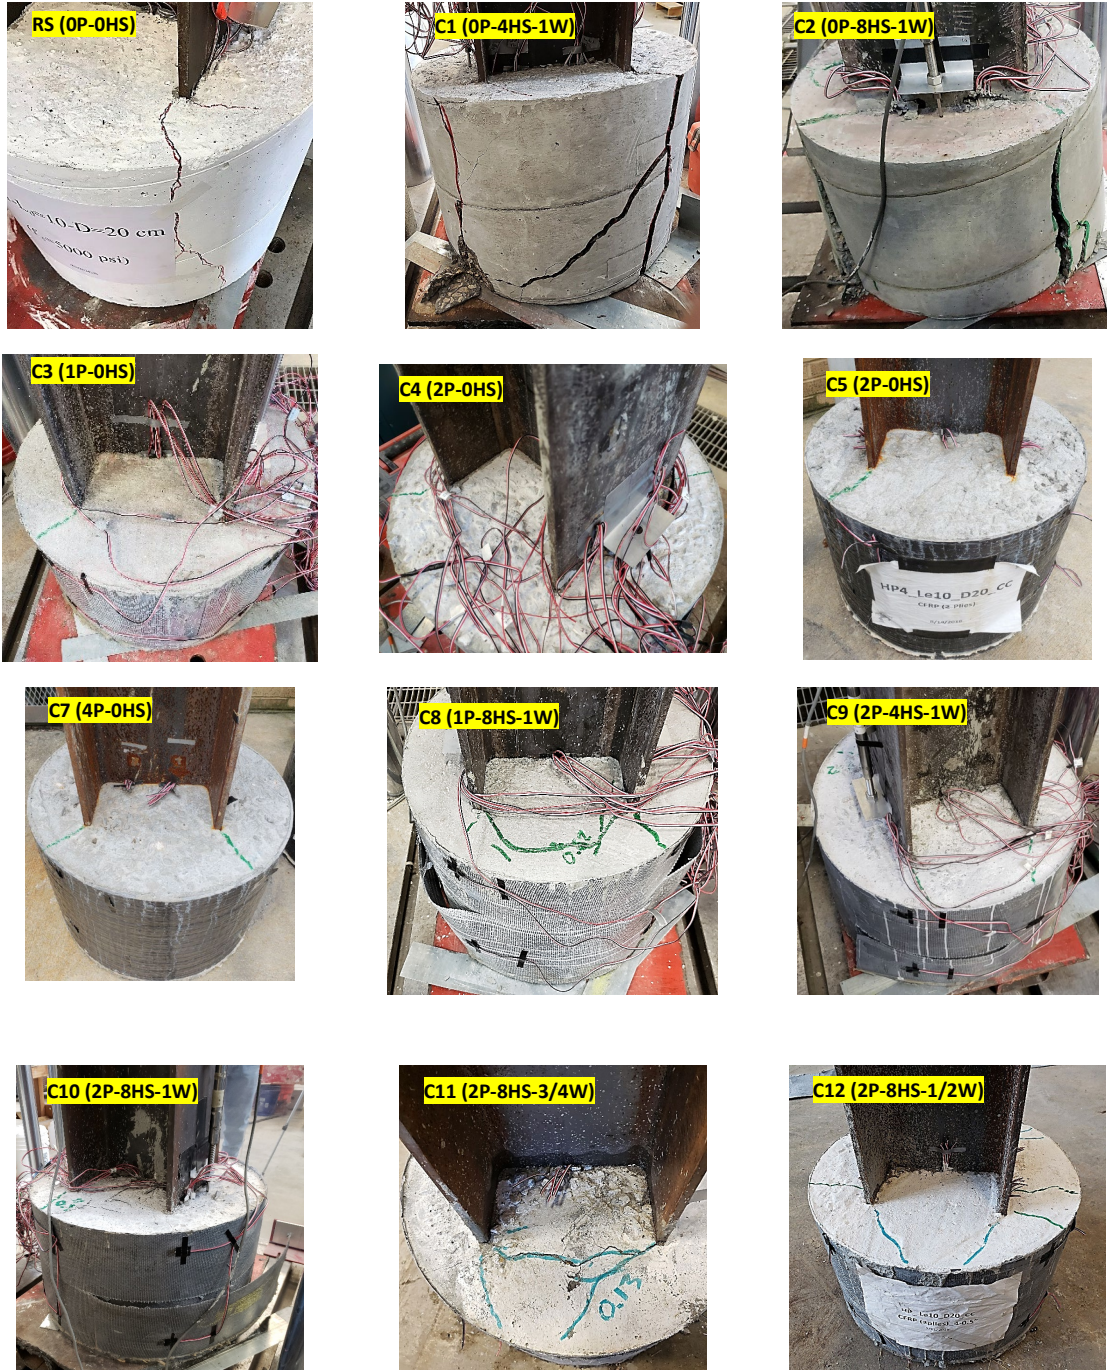
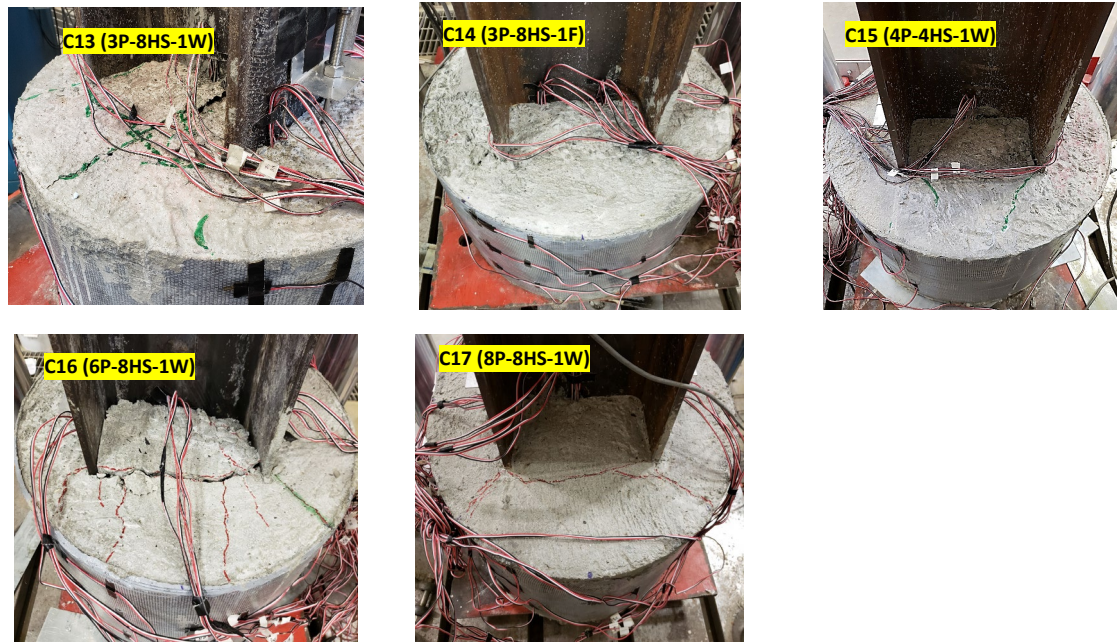
**Figure 5.9** Failure modes of the test specimens.

**Figure 5.9 cont.** Failure modes of the test specimens.

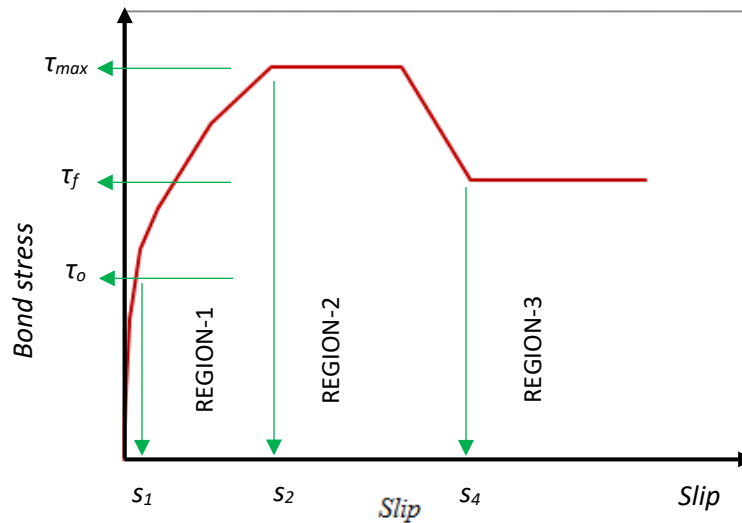
**Figure 5.10** Bond stress-slip model.

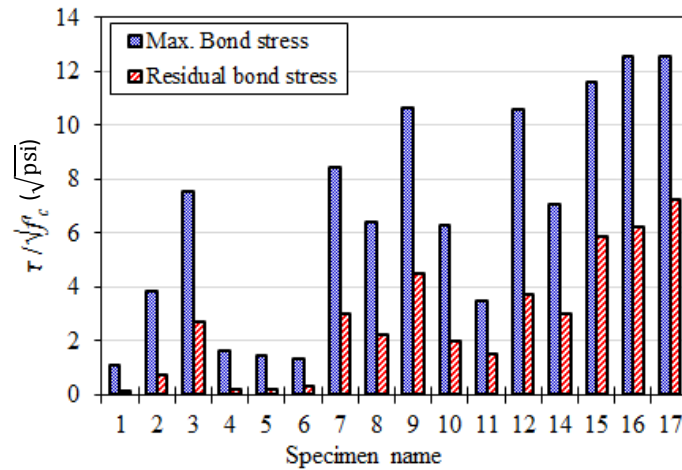
**Figure 5.12** Residual strength of the tested specimens.
