Report # MATC-MS&T: 133-1

## Behavior and Repair of Corroded Steel H-Piles Phase I (Axial Behavior)

1. Report No.: 25-1121-0005-133-1		2. Government Accession No.:		3. Recipient's Catalog No.:	
4. Title and Subtitle:  Behavior and Repair of Corroded Steel H-Piles Phase I (Axial Behavior)				5. Report Date: May 2019

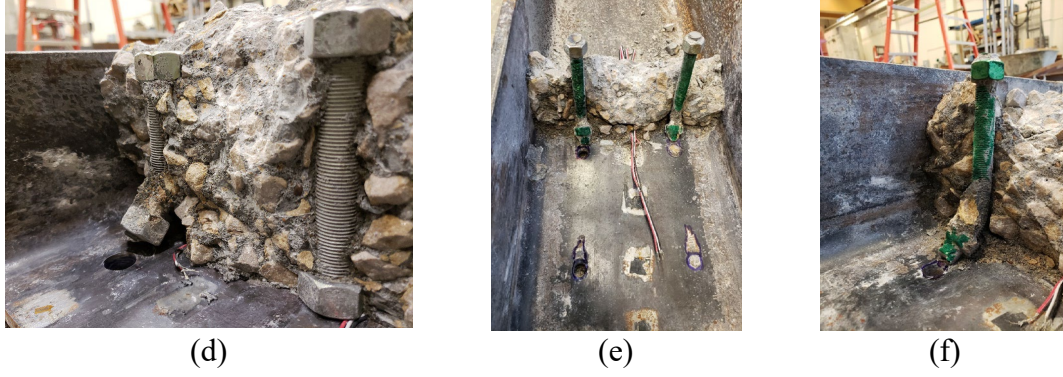
**Figure 5.13** Headed stud conditions (a and b)  $d_a=25.4$  mm (1 in.), (c and d)  $d_a=19$  mm (0.75 in.), (e and f)  $d_a=12.5$  mm (0.5 in.).

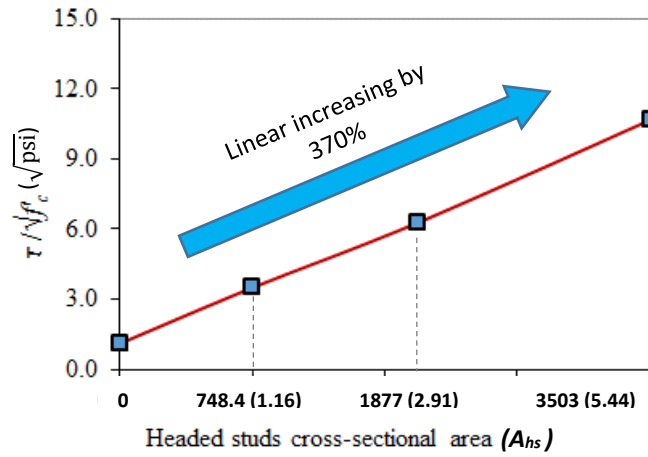
**Figure 5.14** Bond strength ratio vs.  $A_{hs}$ .

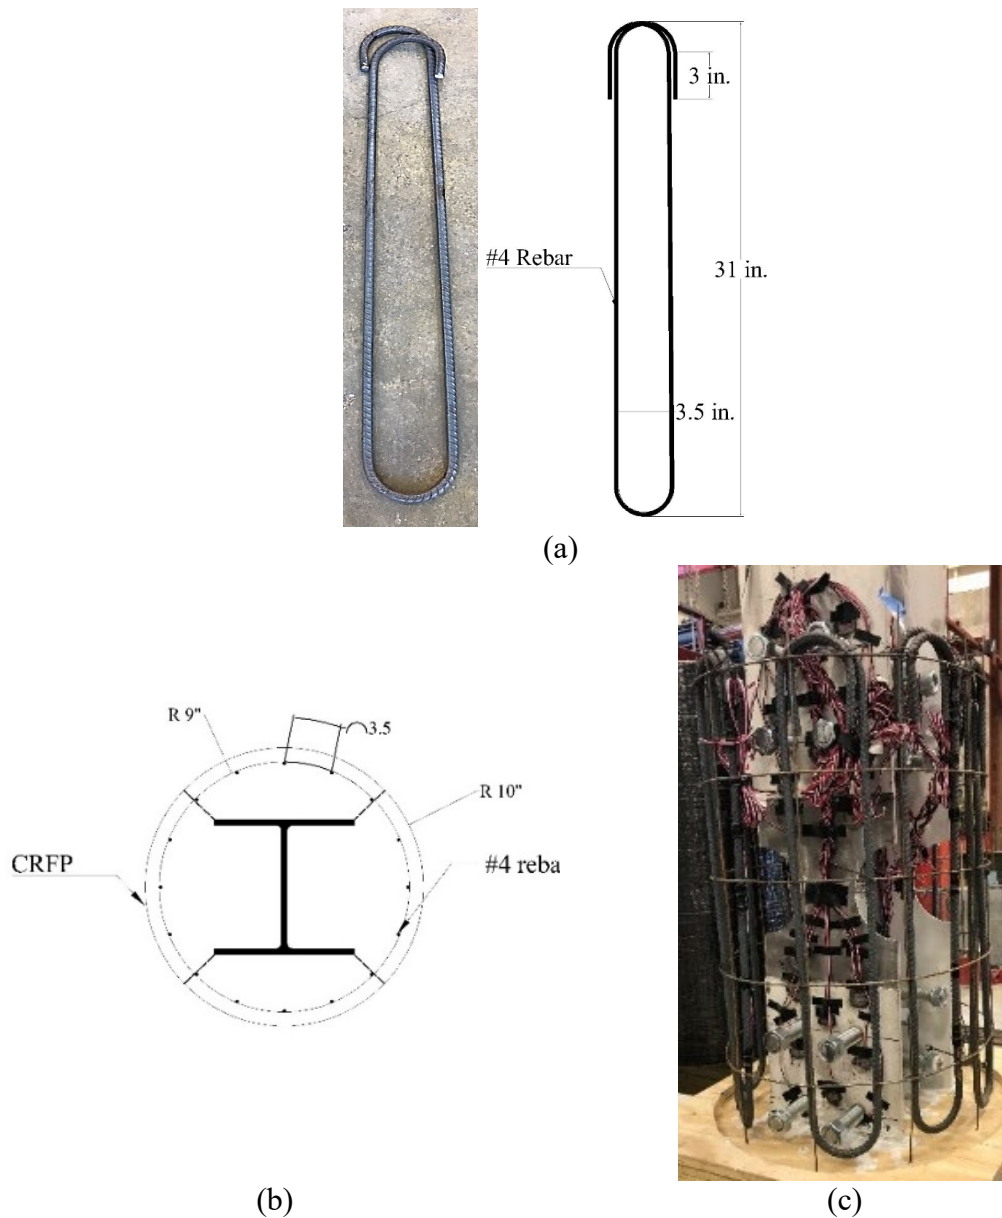
**Figure 6.3** Longitudinal reinforcement in the repair region: (a) closed bar profile, (b) distributions of rebars, and (c) reinforcement cage.

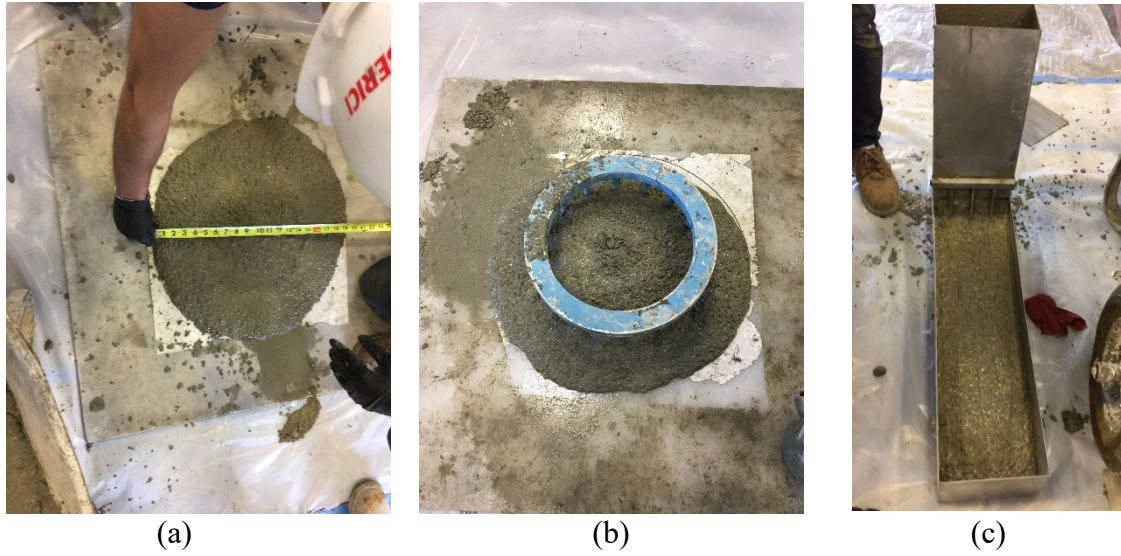
**Figure 6.4** ASTM tests: (a) Slump flow, (b) Passing ability using J-ring, and (c) L-box.

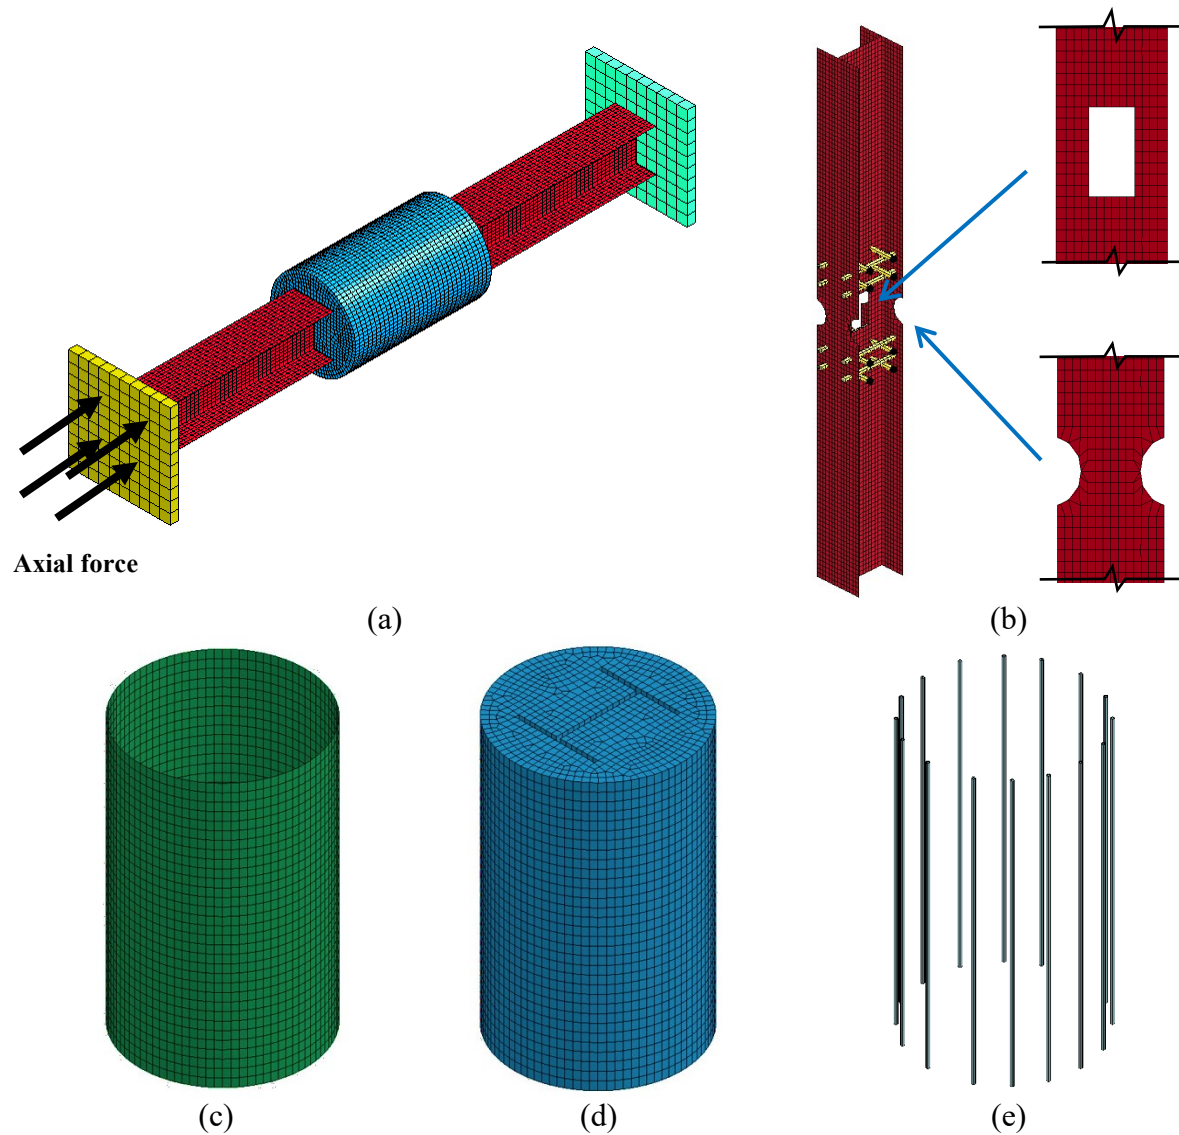
**Figure 6.12** FE modeling: (a) 3D view of the repaired steel pile, (b) steel H-pile, (c) CFRP tube, (d) concrete filling, and (e) steel rebar.

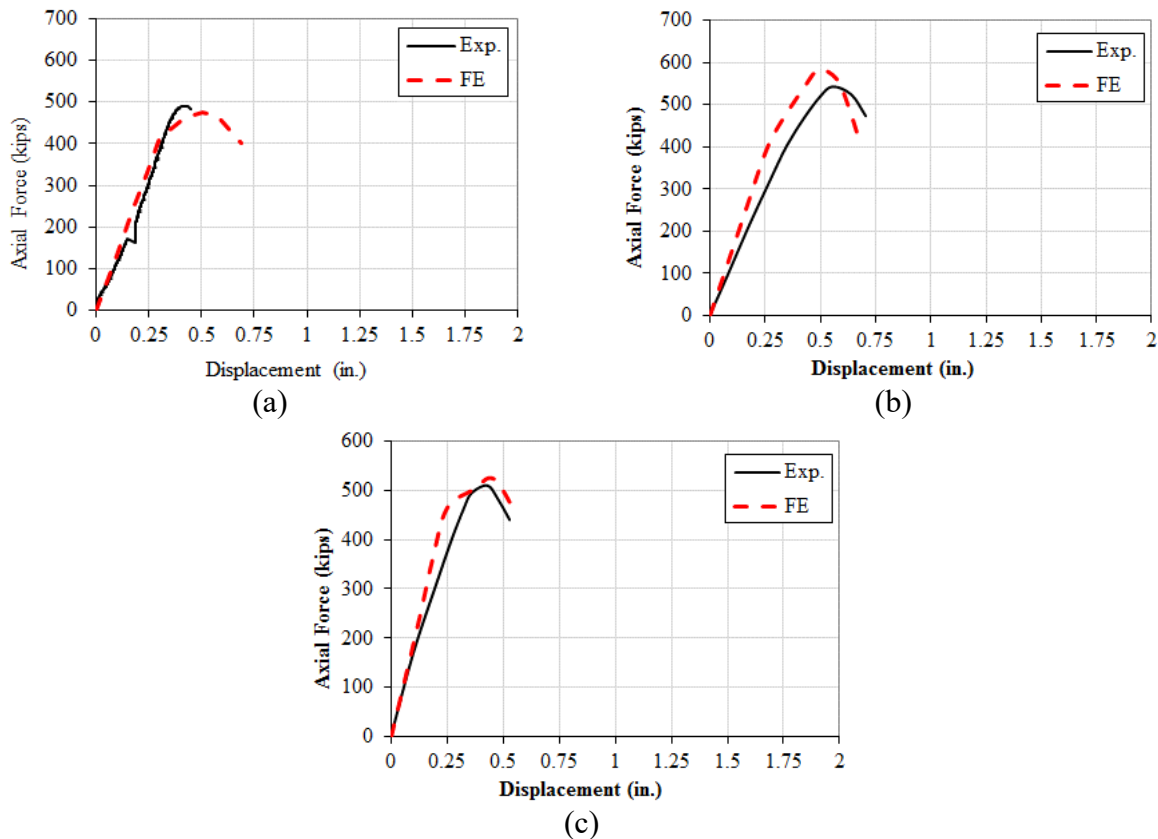
**Figure 6.13** Axial load vs. displacement curves (a) R1, (b) R2, and (c) R3.

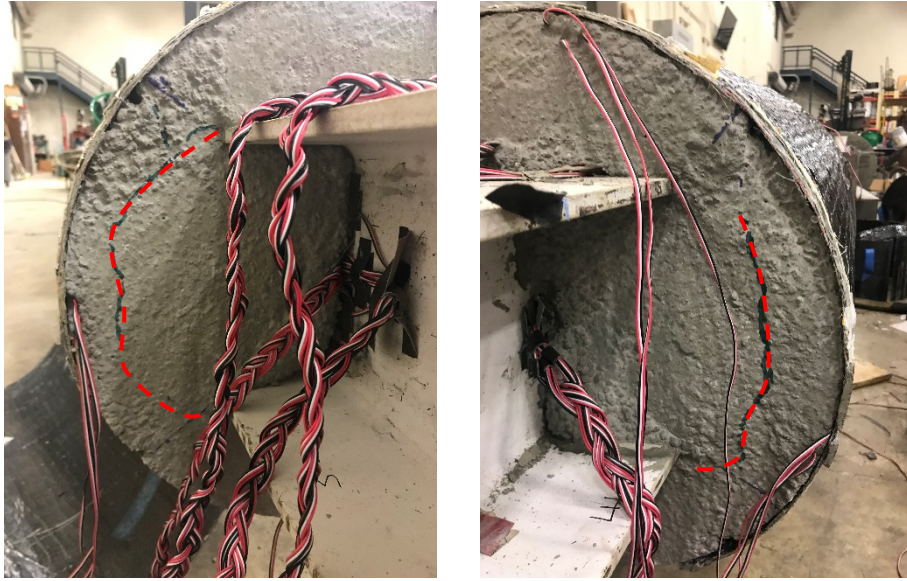
**Figure 6.15** Stress concentration at the tips of flanges on the concrete encasement.

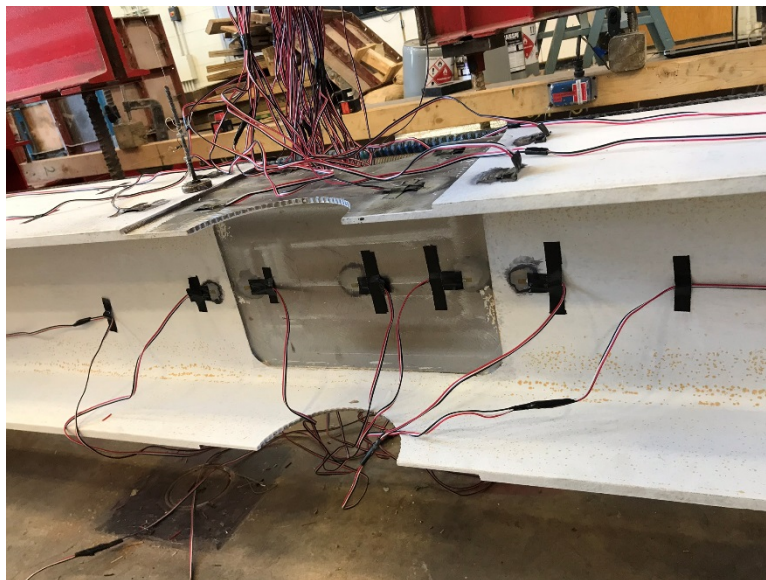
**Figure B.14** Attaching strain gauges to the expected points of failure

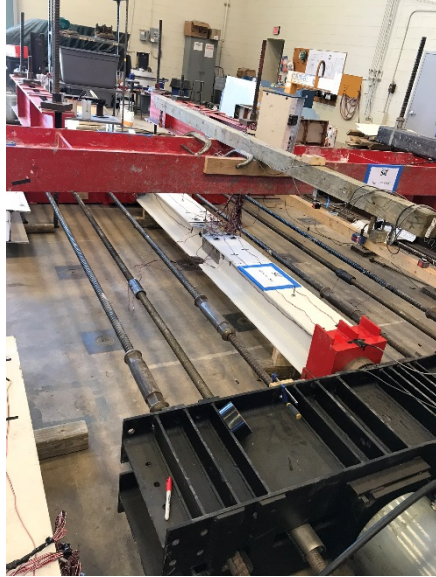
**Figure B.15** Installing the specimen in the testing setup
