# MID-AMERICA TRANSPORTATION CENTER

Report # MATC-MS&T: 131-1

## Sensor-Assisted Condition Evaluation of Steel and Prestressed Concrete Girder Bridges Subjected to Fire - Phase I

December 2020

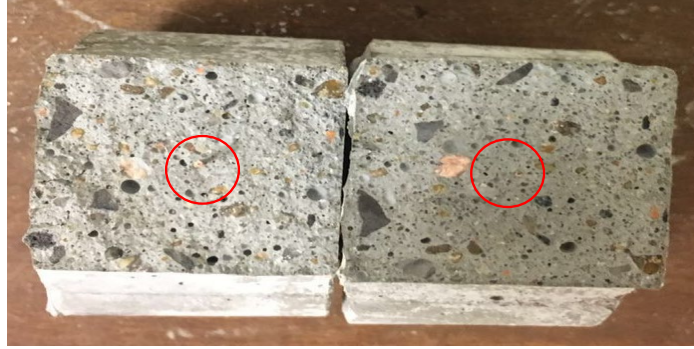
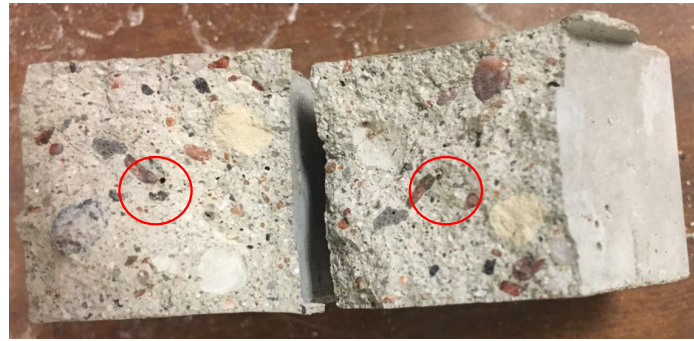
**Figure 3.3** Typical failure mode of cross section (a) 22 specimen (b) 350 specimen (red circles in images indicate the fiber location approximately)

Figure 3.3(a) and (b) show the typical failure mode of the cross section of two kinds of specimens. The optic fiber cross-section can be seen on the overall specimen cross-section. The fiber in the '22' specimen shows no damage in Figure 3.3(a) while the fiber in the '350' specimen showed a black channel in Figure 3.3(b). However, the burning residuals still provide friction between the cement matrix and fiber, which is evidenced from the measured strains by PPP-BOTDA. Figure 3.4 shows load-extension curves. The high temperature affects the tensile strength and does not have much influence on the extension. The maximum extension is about 1.0 mm for all tested specimens. All the specimens reach the maximum load, suddenly followed by brittle failure. Also, the specimen exposure to 250°C has the highest strength among all tested specimens. This is because a certain degree of temperature could increase the hydration degree of cement matrix and thus enhance the strength. After the temperature increases to higher than 250°C, the strength gradually decreases.

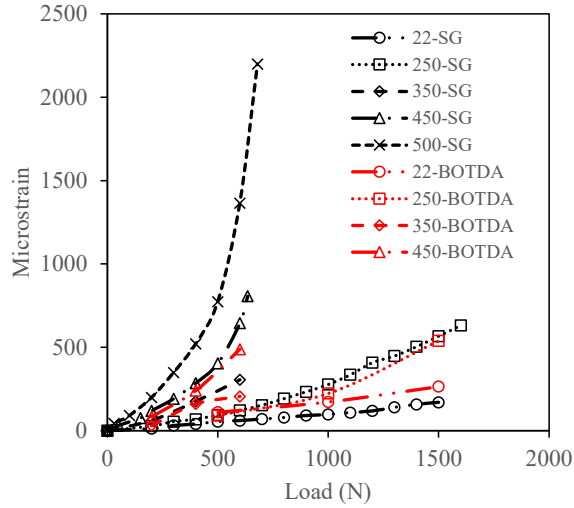
**Figure 3.6** Strain comparisons between BOTDA sensors and strain gages after different temperatures

the same load due to the reduction of stiffness. Figure 3.6 shows strain comparisons between PPP-BOTDA sensors and strain gauges. It should be noted PPP-BOTDA sensors do not have readings at the temperature of 500°C because of the broken fiber. The comparison between the PPP-BOTDA sensors and strain gauges at the temperature of 500°C is not available. Their strain results are comparable after exposure to 250°C, 350°C, and 450°C for three hours. This means that strain transfer from concrete to the optical fiber can be achieved after high temperatures.

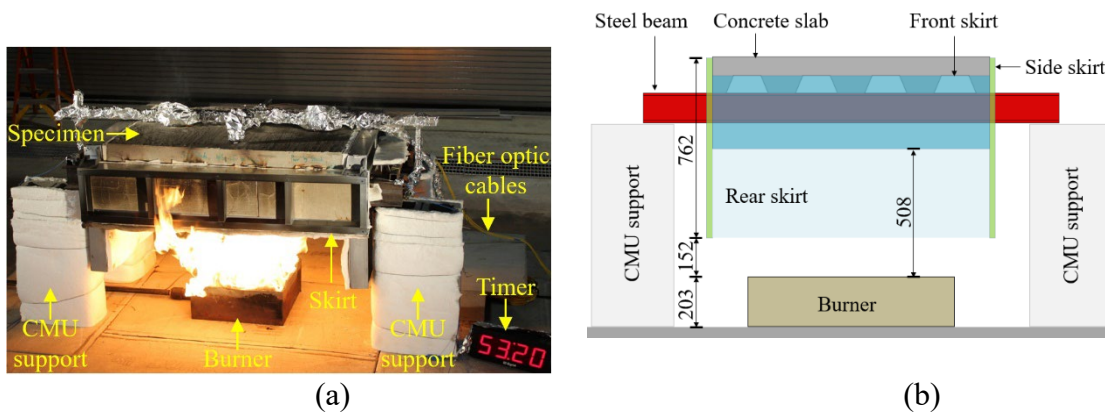
**Figure 4.3** Test setup: (a) photograph, and (b) illustration (units in mm)

Fire tests were conducted in the National Fire Research Laboratory at the National Institute of Standards and Technology (NIST). The test setup was not intended to represent a particular structure, but rather to investigate the performance of distributed sensors in a typical steel–concrete composite structure. Figure 4.3 depicts the test setup located under a 6 m × 6 m (plan) exhaust hood. The flame source was a natural gas diffusion burner measuring 530 mm × 530 mm × 200 mm (length × width × height). Natural gas entered the burner near the bottom, filled the burner cavity, and percolated through a gravel layer to distribute the gas. The burners were manually regulated using a needle valve on the gas supply line. A skirt constructed of cold-formed steel framing and cement board lined with thermal ceramic fiber blankets partially enclosed the space above the burner to trap hot gases beneath the specimen. The skirt was open at the bottom, creating the compartment fire depicted in Figure 4.3(a). The heated compartment created by the skirt was approximately 1220 mm × 920 mm × 300 mm (length × width × height). Each beam was simply-supported at a clear-span of 1530 mm on four supports made of stacked concrete masonry units (CMU). The supports were wrapped with 25-mm thick thermal ceramic blankets for thermal protection.

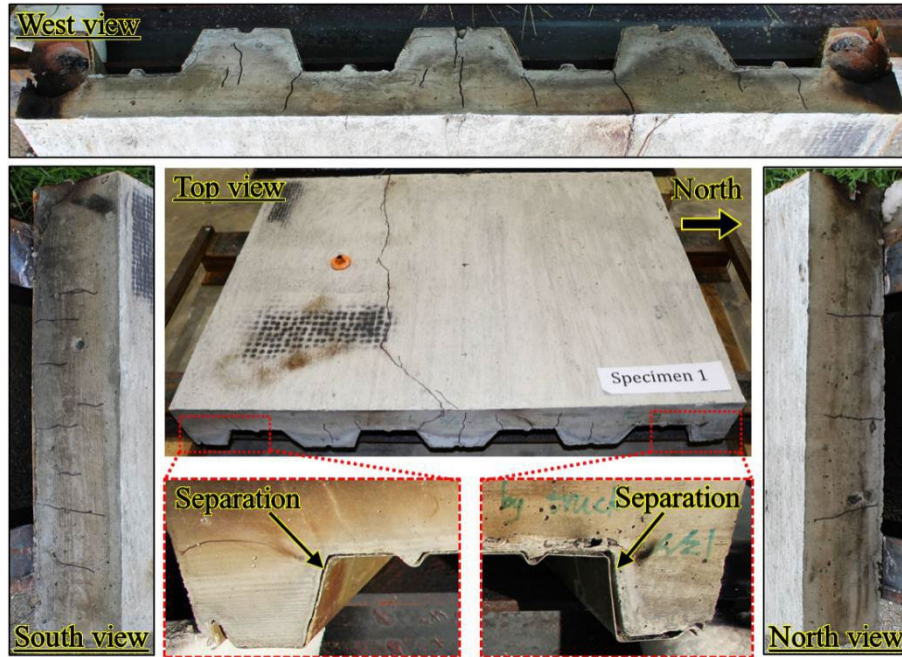
**Figure 4.5** Photograph of CS-1 after fire test: (a) before removal of the steel deck, and (b) after removal of the metal decking at the bottom of the reinforced concrete slab.

After the fire test, several cylinders measuring 76 mm in diameter were cored from the specimens using a diamond core drill, as depicted in Figure 4.5(b). Cylinders were taken in both the thick (thickness: 159 mm) and thin (thickness: 83 mm) sections of the trapezoidal concrete slab. Channels in the concrete created by the removed welded wire mesh and burnt optical fiber sheathing can be observed. While some polypropylene microfibers could still be observed on the top surface of the concrete, no polypropylene fibers could be found near the bottom surface of the tested specimen. This is an indicator of the temperature variation through the depth of the concrete. The melting point of polypropylene fibers is about 165 °C. In spite of the high relative humidity of the concrete (which relates to the moisture content), no widespread spalling occurred, likely due to the use of polypropylene fibers that melted and provided mechanisms for alleviating internal vapor pressure in the concrete slab (Li et al. 2018).

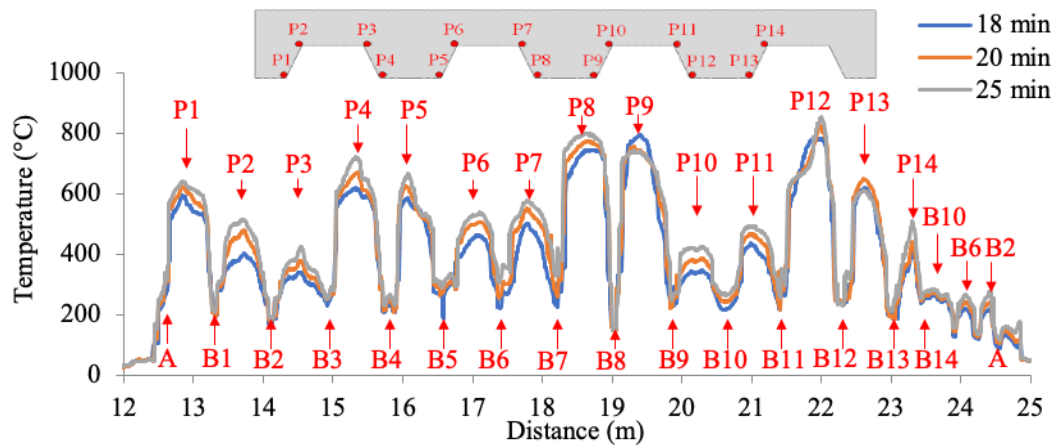
**Figure 4.6** Temperature distributions measured from the distributed sensors in specimen CS-1: (a) DFOS-1, (b) DFOS-2, and (c) DFOS-3. The peaks in slab illustration and test results are marked as “Pn”, where “n” indicates the location of a peak (see Figure 4.2)

After a constant heat release rate had been achieved, temperature distributions along the length of the distributed sensors DFOS-1, DFOS-2, and DFOS-3 in specimen CS-1 at various

time instants are plotted in Figure 4.6. The times are relative to burner ignition. In each figure, the horizontal axis represents the distance along the distributed sensor, measured from the connection to the data acquisition system. The vertical axis represents the measured temperature, which was obtained from the Brillouin frequency shift measured by the distributed sensor. As expected, temperature increases with time in all three sensors during the heating phase of the experiment. However, the spatial patterns of temperature distribution observed from the three sensors are quite different. The different patterns are primarily due to the different locations of the sensors deployed in the concrete, as depicted in Figure 4.2(b)-(d). The locations of the curved portions of the distributed sensors are marked in Figure 4.6 for reference.

The first 10 peaks in Figure 4.6(c) are marked by P1 to P10, which represent the lengths of sensor DFOS-3 in the vicinity of the metal decking, as depicted in Figure 4.2(d). DFOS-3 measured the temperature along the welded wire mesh perpendicular to the direction of the decking flutes. Along the length of DFOS-3, the distance between the fiber optic sensor and the metal decking varied. The temperature is higher in the portions of the sensor closer to the metal decking than in the portions further from the decking. As the fire testing time increases from 160 min to 200 min, the peaks become less prominent. This trend indicates the temperature gradient in the concrete slab decreases over time as the temperature of the entire concrete volume increases.

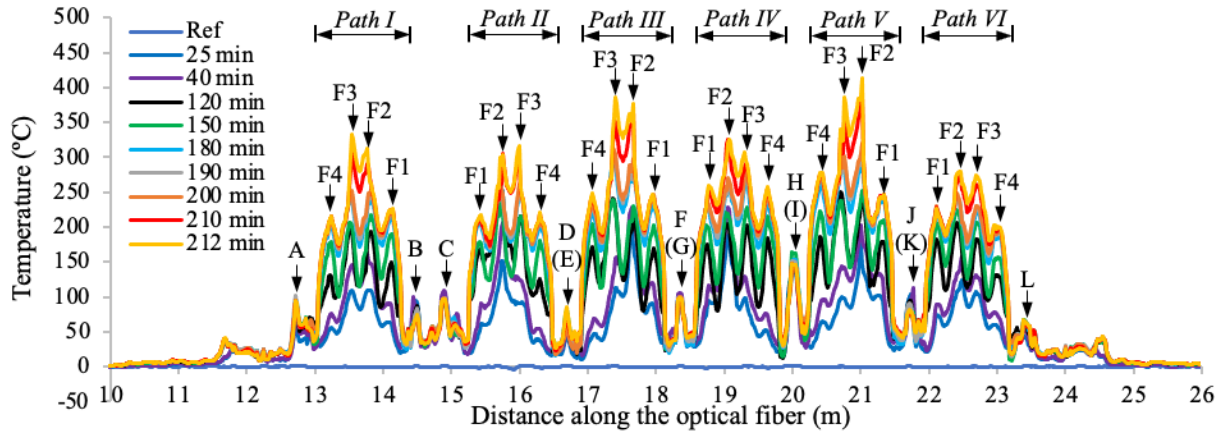
**Figure 4.7** Surface temperature distributions measured from DFOS-4 in: (a) CS-5, and (b) CS-6. “F1” to “F4” stand for Flute 1 to Flute 4 shown in Figure 4.2(e)

Figure 4.7 shows the surface temperature distributions measured from DFOS-4 sensors in specimens CS-5 and CS-6, respectively. In each specimen, the distributed sensor measured the temperature distributions along the six paths on the top surface shown in Figure 4.2(e). Within the range of each path, four peaks are identified corresponding to the four upper flutes of the concrete deck (F1 to F4), indicating a higher surface temperature at the thin concrete sections; by comparing the temperatures corresponding to each flute in the same path, it is seen Flute 2 and Flute 3 have higher temperatures than Flute 1 and Flute 4, because the middle of the slab directly above the burner experienced a higher temperature than the two ends of the slab, consistent with the observations from Figure 4.6.

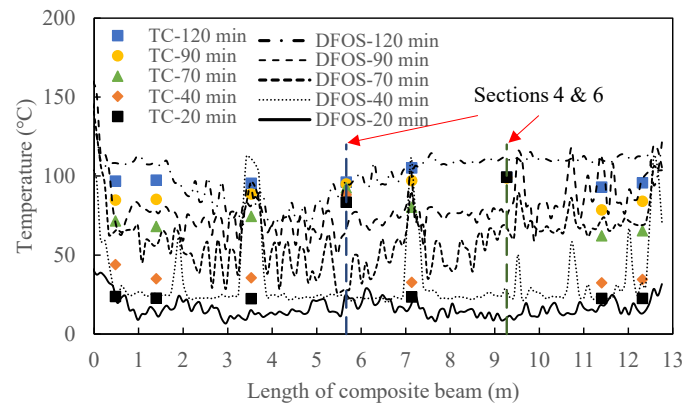
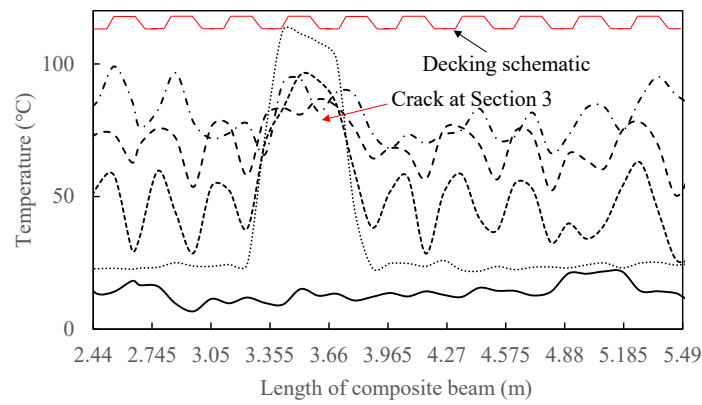
**Figure 5.6** Concrete slab temperatures measured from thermocouple (TC) and distributed fiber optic sensors (DFOS) in CB-DA specimen at various times after fire ignition: (a) 32 mm and (b) 70 mm below the top surface of the slab, and (c) 70 mm below the top surface of the slab (between 2.44 m and 5.49 m) in (b)

Figure 5.6 compares concrete temperatures measured at different times from the longitudinal DFOS and thermocouples deployed along the centerline of the CB-DA specimen that was tested under simultaneous mechanical and fire loads. The fiber optic temperature sensors were located 32 mm (Top) and 70 mm (Bottom) below the top surface of the concrete slab. Their closest thermocouples were positioned at 41 mm and 82 mm from the top surface of the slab. Therefore, the thermocouple temperatures were linearly interpolated or extrapolated to obtain the temperatures at the locations of the fiber optic sensors for comparison.

The thermocouple temperatures in Figure 5.6(a, b) at a given time follow a roughly horizontal line along the length of the specimen; except at Section 4 (Bottom) and Section 6 (Top and Bottom) where temperatures jump suddenly to 100 °C 20 min into the test. While the amplitude of 100 °C at Sections 4 and 6 is likely caused by water vaporization, the rise time is clearly erroneous – possibly caused by multiple unintended junctions in the lead wires, and these data are disregarded in the subsequent analysis.

The DFOS also exhibits an overall horizontal temperature distribution along the specimen, particularly the top temperature sensor; however, the curves show prominent local temperature peaks. The large, non-periodic singular peaks in the DFOS temperature are likely associated with the formation of cracks in the concrete. There are also smaller amplitude periodic variations visible in the DFOS readings. Due to the trapezoidal shape of the metal decking, the concrete cover to the bottom optical fiber from the fire varies from 13 cm to 89 cm over a length of 30.5 cm (refer to Figure 5.1(a)). This results in periodic local temperature fluctuation along the length of the composite beam as can be seen most clearly in the data extracted from Figure 5.6(b) between 2.44 m and 5.49 m and is shown in Figure 5.6(c). The local maxima represent the locations of the thinner concrete cover (13 cm) to the heated surface of the slab; however, this behavior is complicated by the presence of the cracks in the concrete which cause prominent singular temperature variations. This amplitude fluctuation at 30.5 cm spacing is most pronounced at 70 min, i.e., during the controlled cooling phase of a fire, and then gradually disappears.

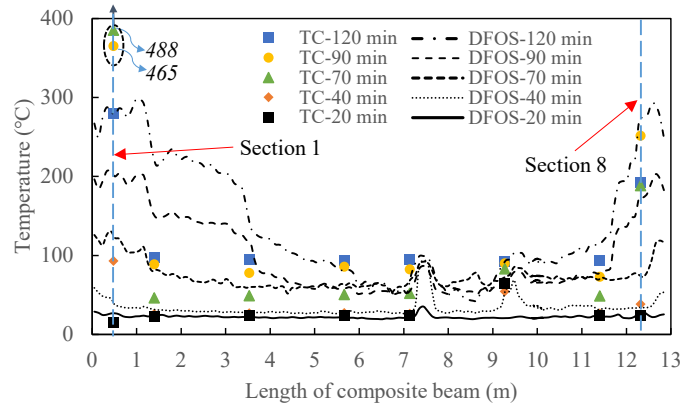
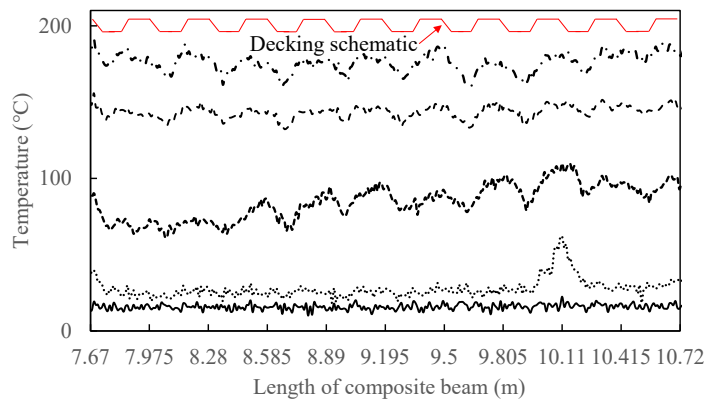
**Figure 5.7** Concrete slab temperatures measured from TC and DFOS in CB-DA-SC specimen at various times after fire ignition: (a) 32 mm, (b) 70 mm below the top surface, and (c) 70 mm below the top surface of the slab (between 7.67 m and 10.72 m) in (b)

Section 6. There are indications of significant cracks formed at the bottom of the concrete slab near Sections 3 and 4, and at the top of the slab near Sections 5 and 6. Once the concrete has been fully desiccated at the sensor location after 70 min of burning, the local temperature variation at the cracks becomes less prominent than those seen in the lower fiber denoted in Figure 5.7(b). Note that minor cracks likely occur between Section 5 and 8 close to the lower fiber. As with specimen CB-DA, low-amplitude periodic temperature variations are visible along the optical fiber between 7.67 m and 10.72 m resulting from the varying concrete cover thickness to the heat source (Figure 5.7(c)).

Unlike the CB-DA specimen, both the thermocouple data and the DFOS data of the CB-DA-SC specimen indicate a temperature rise near the ends of the slab compared to the middle of the slab. This is due to the pronounced cracking in these portions of the slab, which provided additional paths for moisture transport out of the concrete. For the CB-DA specimen, the end temperature rise is not prominent because the heating of the slab was stopped 40 min after burner ignition before the moisture had been driven out of the concrete at the sensor locations. For specimen CB-DA-SC, the end continuity provided by four reinforcing bars and a longer heating time led to a larger bending deformation of the specimen and therefore multiple large cracks were observed at the top side of the concrete slab. During the experiment the concrete slab above the west angle connection cracked at 43 min, released black smoke on top of concrete at 48 min, and flames were visible at 54 min. The concrete slab near the east support cracked at 50 min, released black smoke at 52 min, and flames were visible at 60 min. Thus, the thermocouple readings at the end portion of the concrete slab are indicative of flame/hot air temperature through penetrated cracks, resulting in a temperature difference of over 200 °C between two closely spaced thermocouples (e.g., TCx-7 and TCx-8) at 65 min. As a result, thermocouple data at Sections 1 and 8 are not used for comparison with the DFOS data in the following analysis.

The combined effect of the opening of metal deck seams and multiple penetrated concrete cracks caused the rise in temperature at the end. The heat radiation through the metal decking and heat convection through the seam opening and concrete cracks are combined to create the complicated mechanical and thermal field in the CB-DA-SC specimen. While the thermocouple measurement indicates the end of the slab cooling between 90 min and 120 min due to moisture evaporation, the DFOS indicates a continued increase in temperatures. This inconsistency is likely attributed to the unintended strain induced along the distributed
