MID-AMERICA TRANSPORTATION CENTER

Report # MATC-UNL: 004-24

MASH TL-6 Evaluation of a 62-in. Tall, Single-Slope, Concrete Median Barrier

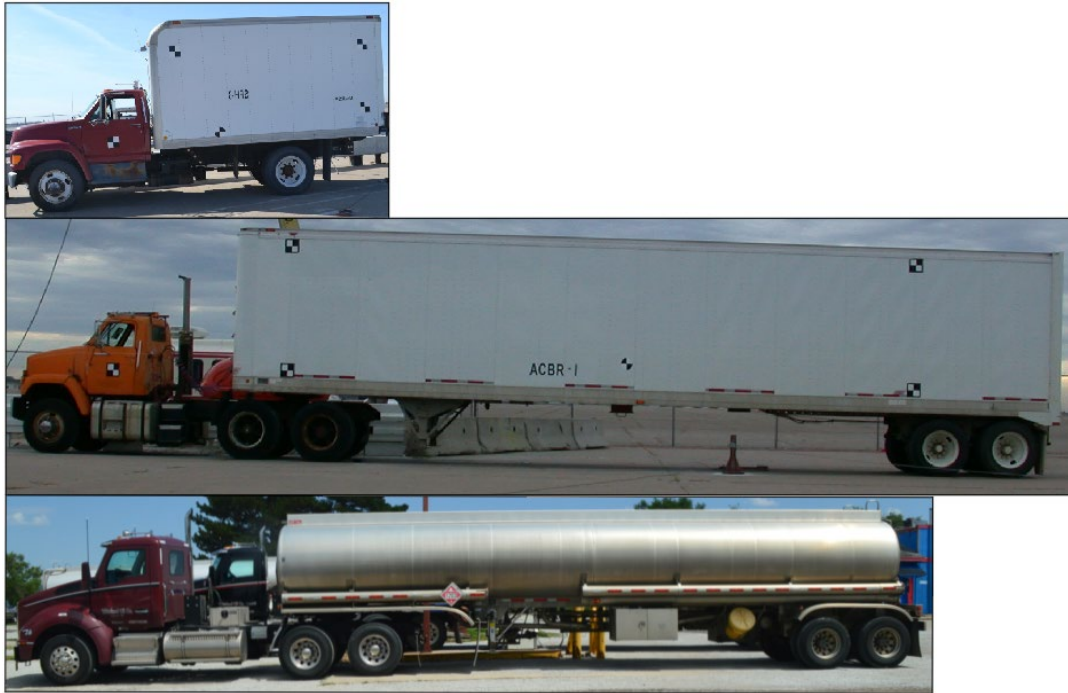
Figure 1.1 TL-4 (22,000-lb), TL-5 (79,300-lb), and TL-6 (79,300-lb) Vehicle Side View [3]

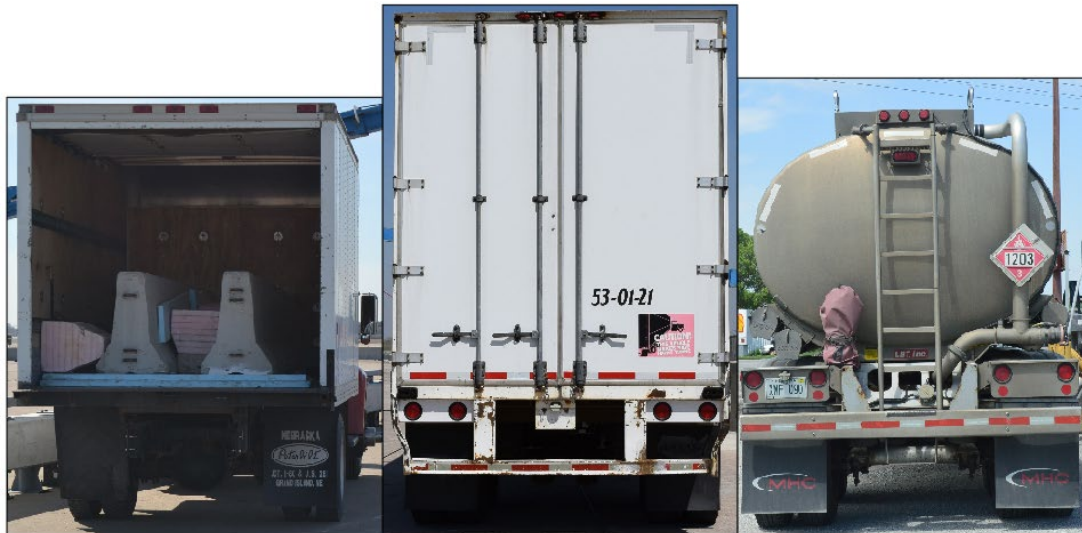
Figure 1.2 TL-4 (20,000-lb), TL-5 (80,000-lb), and TL-6 (80,000-lb) Vehicle Rearview [3]

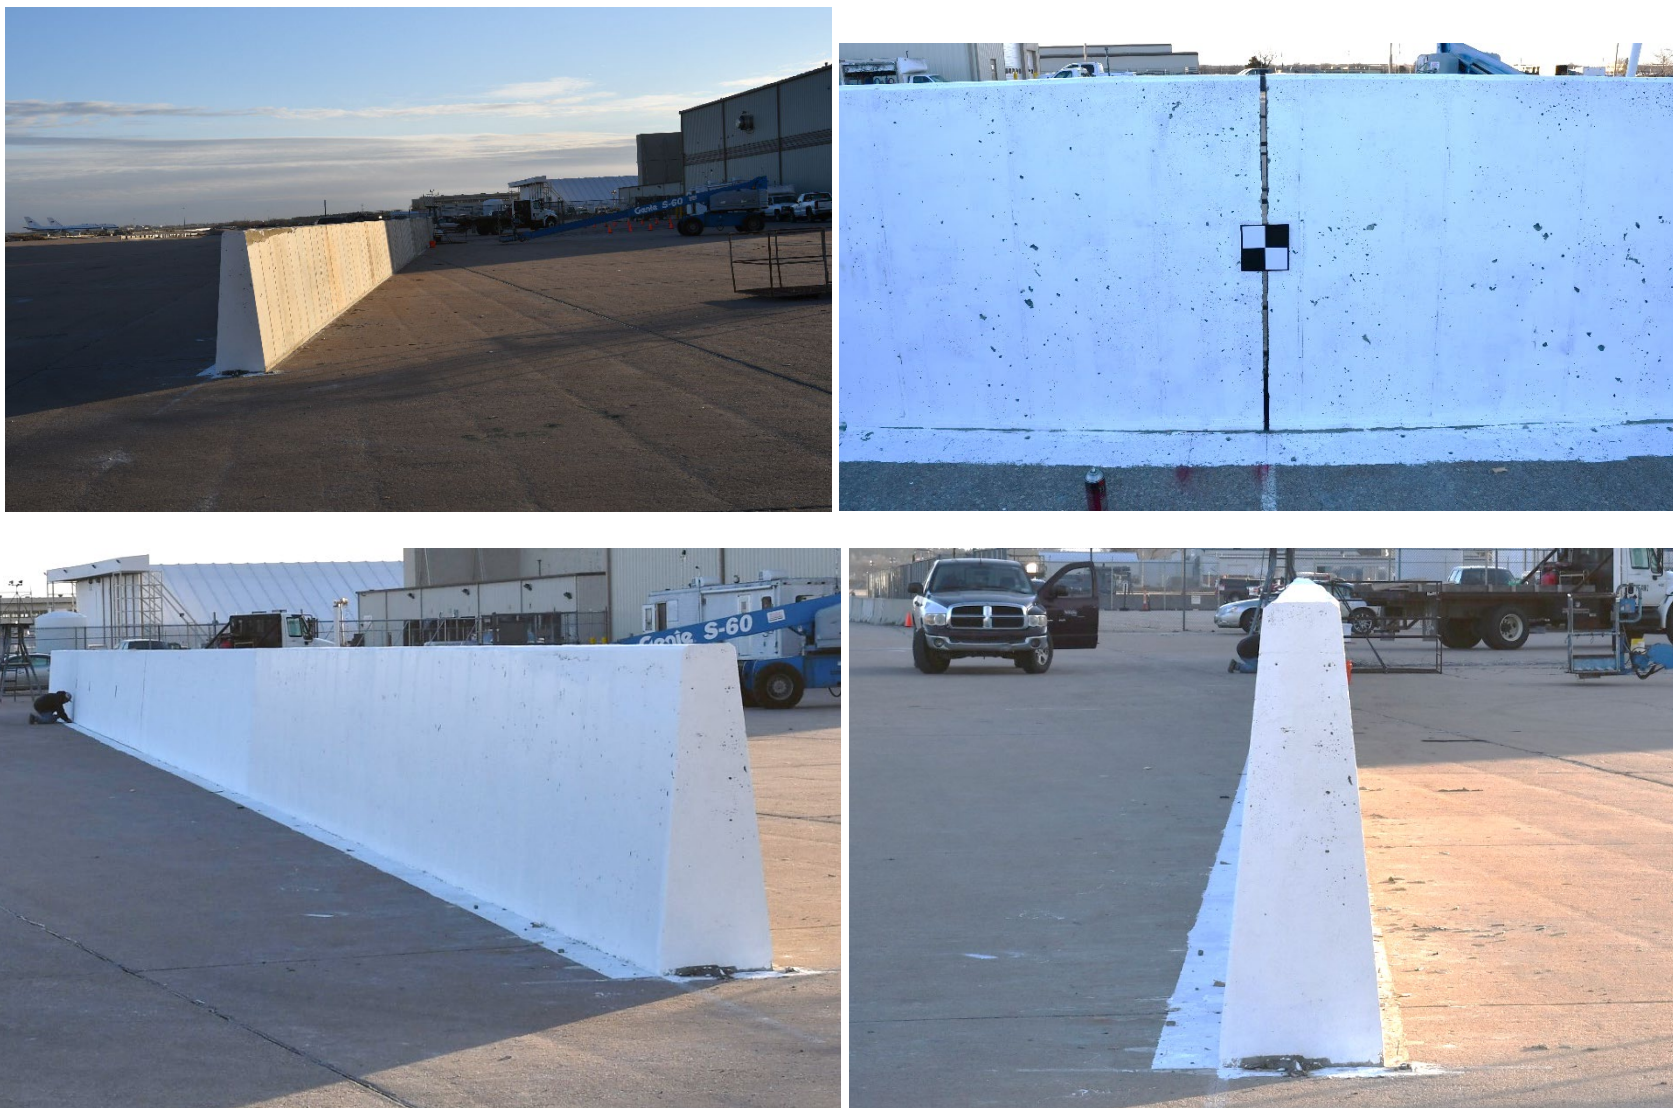
Figure 3.14 MwRSF Optimized TL-6 Single-Slope Barrier Installation, Test No. MTL6-1

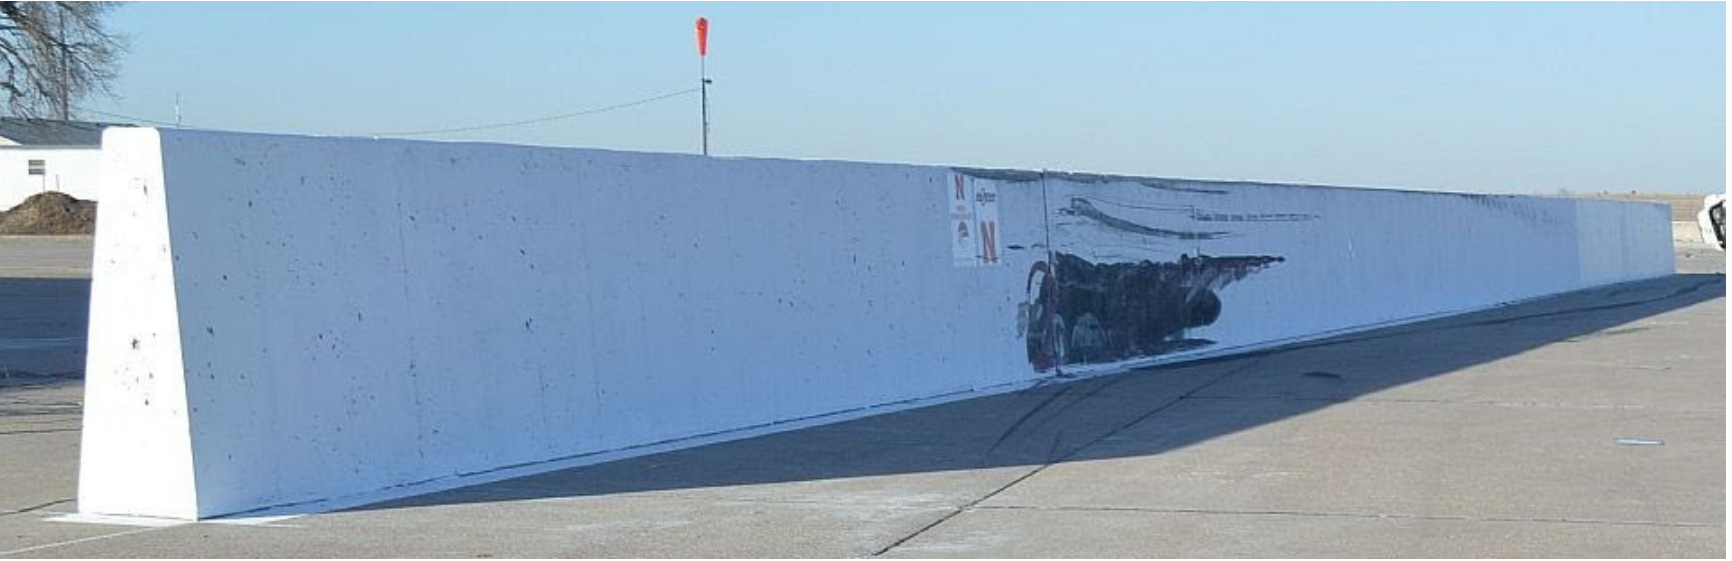
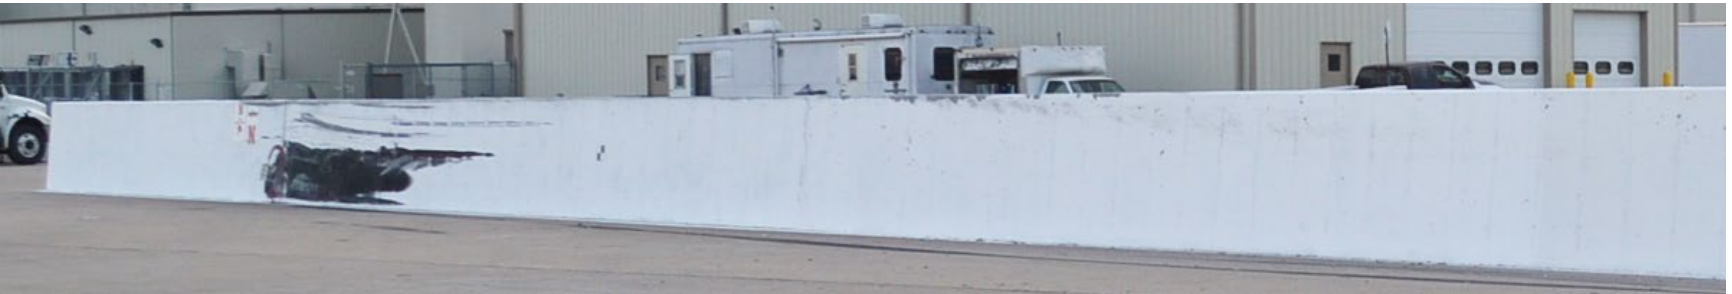
Figure 6.11 System Damage, Test No. MTL6-1

Tire contact marks on the front face of the barrier began 6 ft – 10 in. upstream from the expansion joint and ended approximately 26 ft downstream from the expansion joint. The overall width of the tire contact marks varied, but the highest point was 38.5 in. above the tarmac. Contact marks from other portions of the vehicle were observed up to the top of the barrier and gouging or spalling occurred along the top-front edge of the barrier from 6 ft – 10 in. upstream from the expansion joint to approximately 77 ft – 8 in. downstream from the expansion joint. Additional intermittent gouging and chipping along the top-front edge of the barrier extended through the end of vehicle contact.

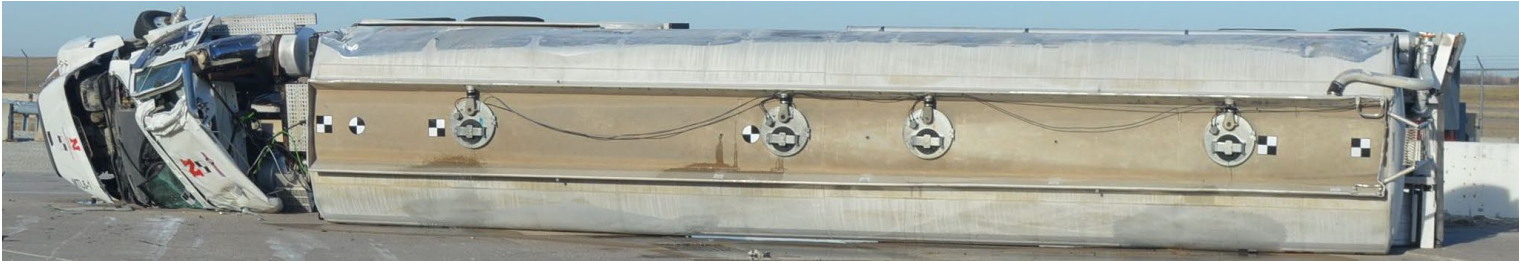
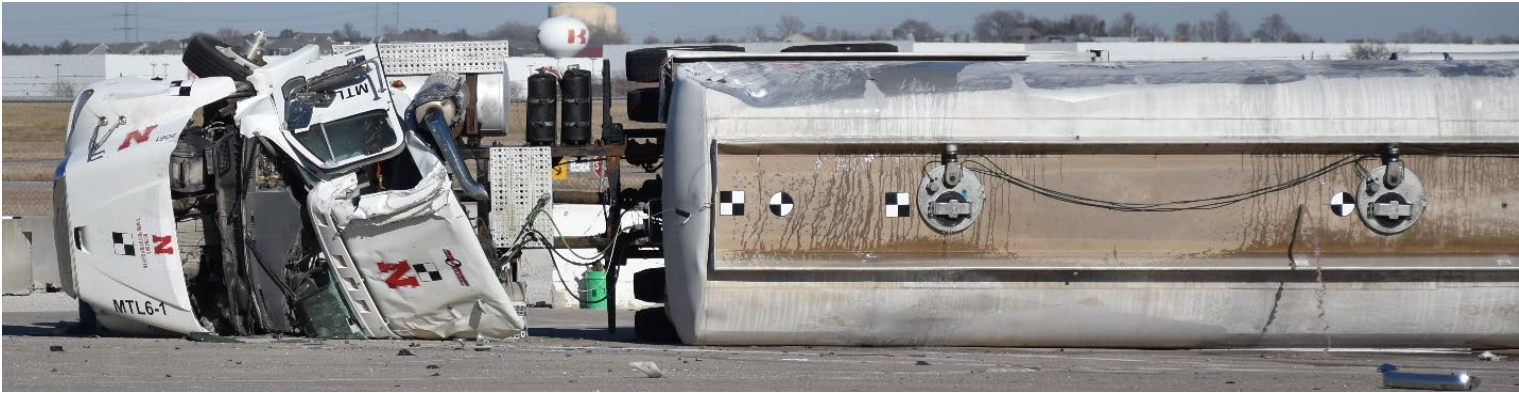
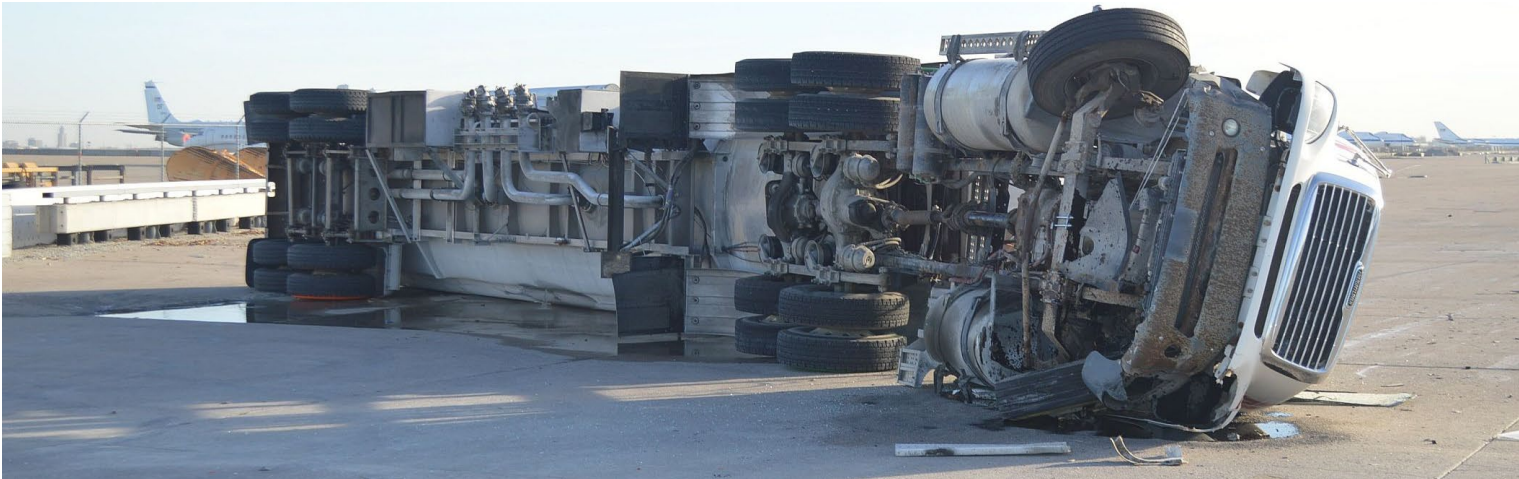
Figure 6.17 Vehicle Damage and Final Rest, Test No. MTL6-1

long. The top of the trailer was scraped, and the longitudinal safety rails were slightly deformed. One tear was observed in the undercarriage of the tank. The suspension, wheels, frame, and undercarriage of the trailer were not damaged.

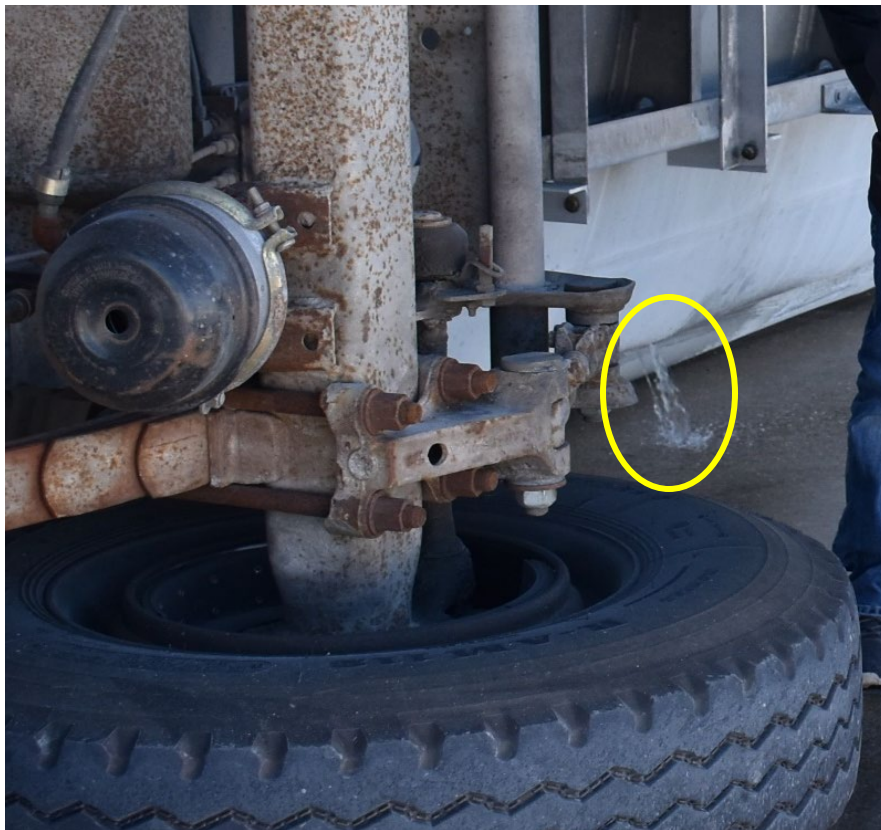
Figure 6.24 Locations of Trailer Leaks, Test No. MTL6-1

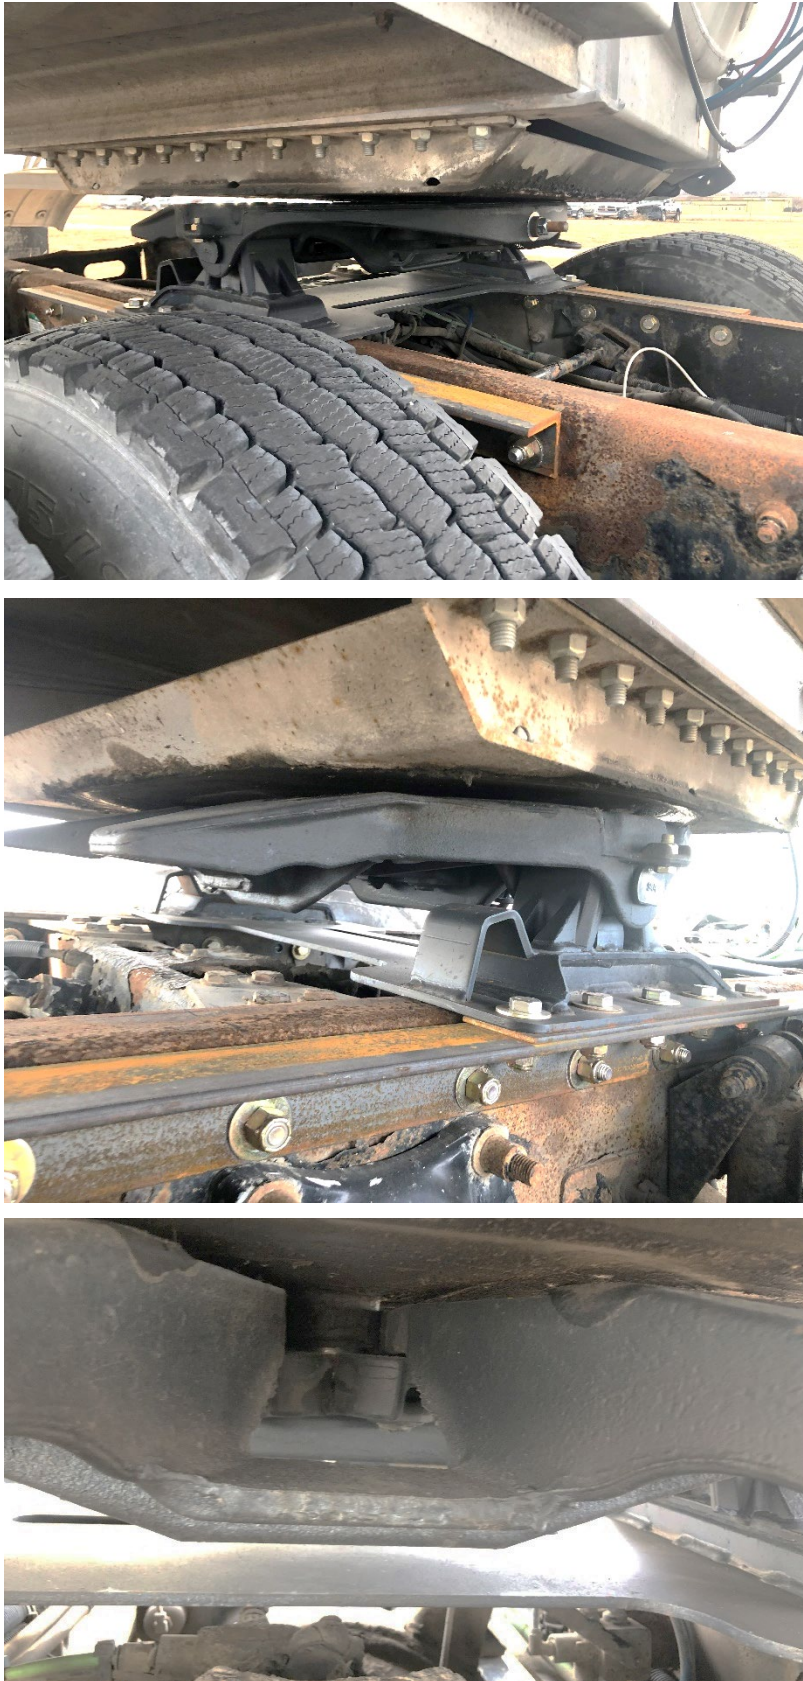
Figure 6.30 Fifth Wheel Damage, Test No. MTL6-1
