# MID-AMERICA TRANSPORTATION CENTER

Report # MATC-MS&T: 133-5

## Over-Height Vehicle Impact with Bridge Girders Having Different Boundary Conditions

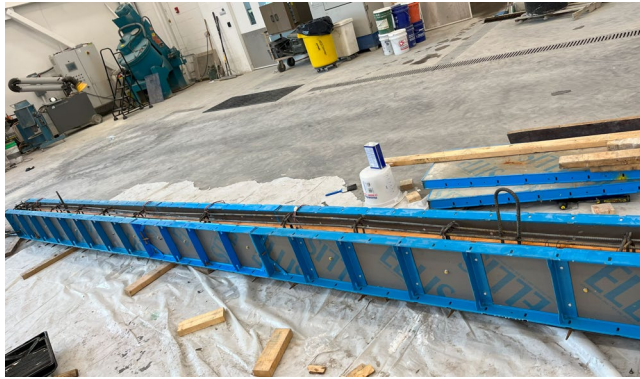
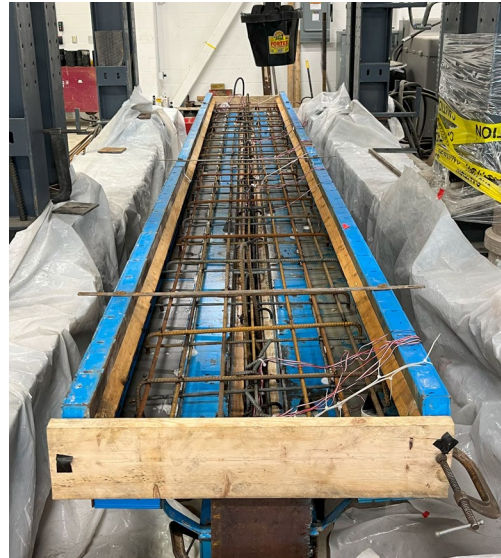
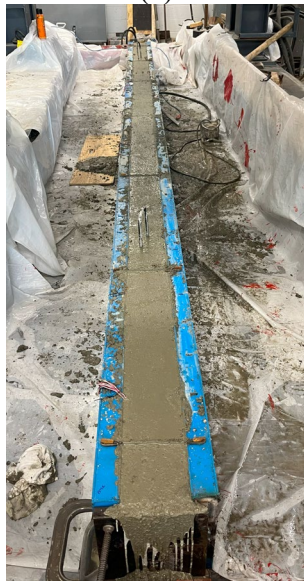
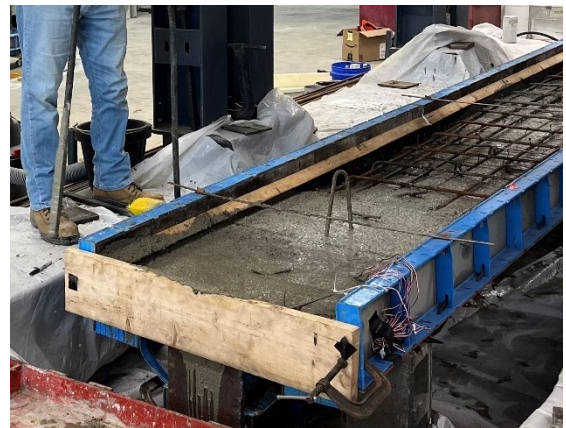
Figure 2.2 Preparation of test specimens (a) Formwork and reinforcement for Isolated beam (b) Formwork and reinforcement for T-beam (c) casting of Isolated beam (d) casting of T-beam (e) Isolated beam after strand torching and demolding, and (f) T-beam demolding

elements were constructed in the university structural lab. Figures 2.2 a & b depict the prepared formwork and reinforcement layout for the girder before concrete casting.

The fresh concrete mixture was placed into the prepared formwork (Figure 2.2 c & d) using mechanical vibrators for proper consolidation. Twenty-four cylindrical specimens measuring 4 x 8 inches were cast to assess the concrete's compressive strength. To prevent moisture loss, both the rafters and cylinders were covered with burlap and plastic sheets after casting. On the seventh day following casting, the prestressing strands were cut after verifying the concrete's compressive strength, and the formwork was removed (Figure 2.3 e & f). To monitor compressive strength development ( $f'_c$ ), three-cylinder specimens were tested 7, 28, and 56 days after casting and on the day of girder testing. ASTM C39/C39 M conducted these testing [9] standards (Table 2.1).

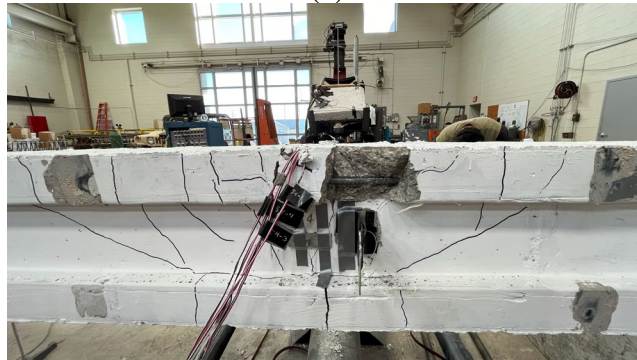
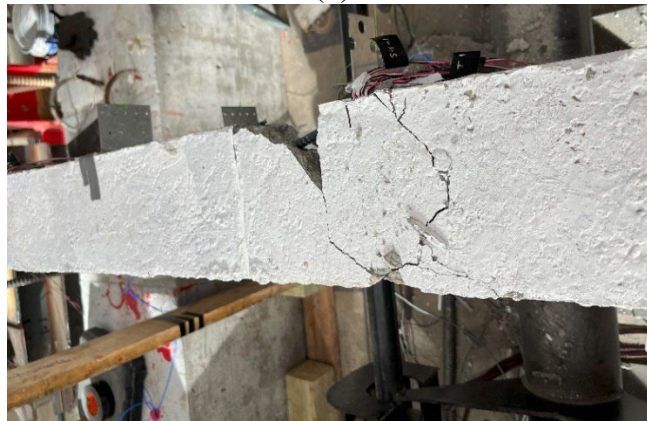
Figure 3.2 Characteristic damage pattern after impact – Isolated beam (a) Crack propagation and spalling of concrete – front view (b) Concrete deterioration and fissure development – rear view (c) Top view of concrete degradation and crack formation

The impact caused localized scabbling and spalling of concrete at the impact point on the girder's bottom flange and web, as well as on the top flange (Figure 3.2 a) due to compressive stress waves, resulting in the loss of approximately 48% of the concrete cross-section. Additional spalling occurred on the opposite side's top flanges due to tensile waves caused by concrete crushing from contact energy. With the continuation of the impact process, the concrete in the web transition, top flange, and bottom flange undergo significant plastic deformation, multiple cracks appear, and the concrete on the impact side begins to spill. Due to the influence of bending and shear, there was also noticeable plastic deformation at the interface of the web and the top flange on the other side of the beam (Figure 3.2 b, c, d & e).

Shear cracks developed along the length of the girder, with crack widths ranging from 0.004-inch diagonal hairline cracks to a 0.1-inch vertical crack at the tensile face of the impact point (Figure 3.2 d). The failure of the specimen is first introduced by punching shear around the impact zone due to the relatively high rigidity of the impactor, as well as the high compressive strength of the PC girder. This phenomenon can also be observed from girder backside diagonal and horizontal cracks between the web and bottom flange. With the penetration of the impactor,

the damaged impact zone behaves as a ‘hinge’ that moves upward and laterally due to the compressive prestressing forces and the severity of the impact event. A visual inspection after testing showed that none of the prestressing strands had become unbundled (Figure 3.2 c) despite the damage.

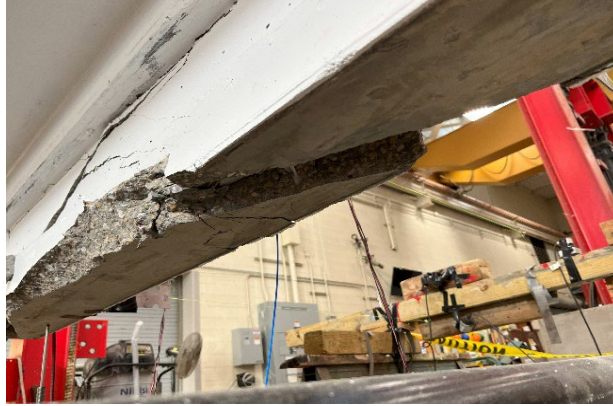
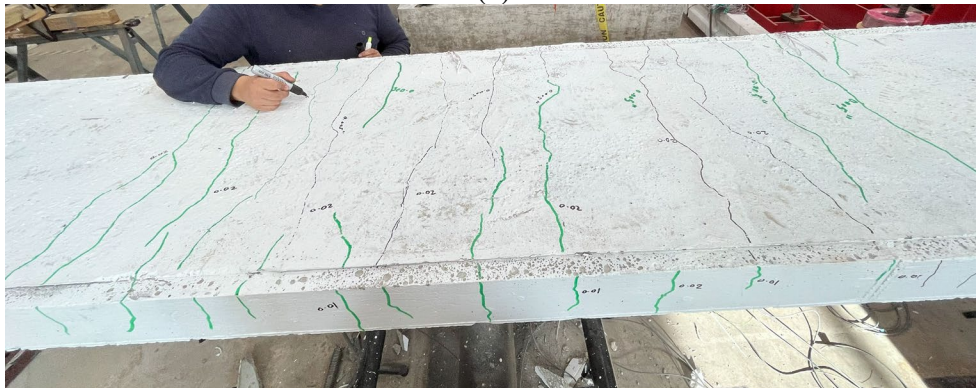
Figure 3.3 Characteristic damage pattern after impact – T-beam (a) Crack propagation and spalling of concrete – front global view (b) Concrete deterioration and fissure development – rear global view (c) Front view of local damage and strand exposure (d) Rear view of local damage (e) Close-up view of a concrete girder showing significant spalling and cracking along its underside, highlighting structural damage, and (f) Top view of crack formation within deck

Figure 3.3 cont. Characteristic damage pattern after impact – T-beam (a) Crack propagation and spalling of concrete – front global view (b) Concrete deterioration and fissure development – rear global view (c) Front view of local damage and strand exposure (d) Rear view of local damage (e) Close-up view of a concrete girder showing significant spalling and cracking along its underside, highlighting structural damage, and (f) Top view of crack formation within deck

The T-beam specimen underwent a lateral impact loading scenario like the isolated beam at the same speed but with partial restraint provided by a cast-in-place reinforced concrete deck acting on the top flange. This deck partially restrained horizontal and vertical translation of the top flange during impact. The cracking pattern that developed along the length of the T-beam was mainly around the impact region, 48 in. away from the supports (Figure 3.3 a and b), with closer crack spacing compared to the Isolated beam test at the same impact energy level. The concrete in the impact area is crushed, and cracks appear, with some steel bars yielding. Furthermore, the concrete on the other side of the beam sustains relatively plastic damage

Shear cracks dominated the girder's span, propagating from the bottom flange to the junction of the web and the top flange. Additionally, vertical cracks propagated in the front face of the deck and up into the concrete deck slab itself. This contrasted with the Isolated beam, which exhibited a more flexible response. Unlike the more flexible Isolated beam, the T-beam exhibited a stiffer response due to the top flange restraint. This increased stiffness led to extensive concrete scabbling and spalling of the bottom flange (Figure 3.3 c), particularly on the girder's tensile face and soffit (Figure 3.3 d & e), resulting in the loss of approximately 56% of the concrete cross-section. Interestingly, the top flange was almost intact due to the presence of the concrete deck restraining in Figure 3.3 c.

Cracks ranged from 0.005 in. up to 0.02 in. within the concrete deck, illustrated in Figure 3.3 f, due to the upward bending of the prestressed T-beam during the impact event, while diagonal crack widths within the girder ranged from 0.005 in. to 0.1 in. A horizontal crack shown in Figure 3.3 d greater than 0.1 in. was induced within the girder at the transition of the bottom flange and the web, attributed to the added stiffness from the flange restraint. At midspan, the maximum

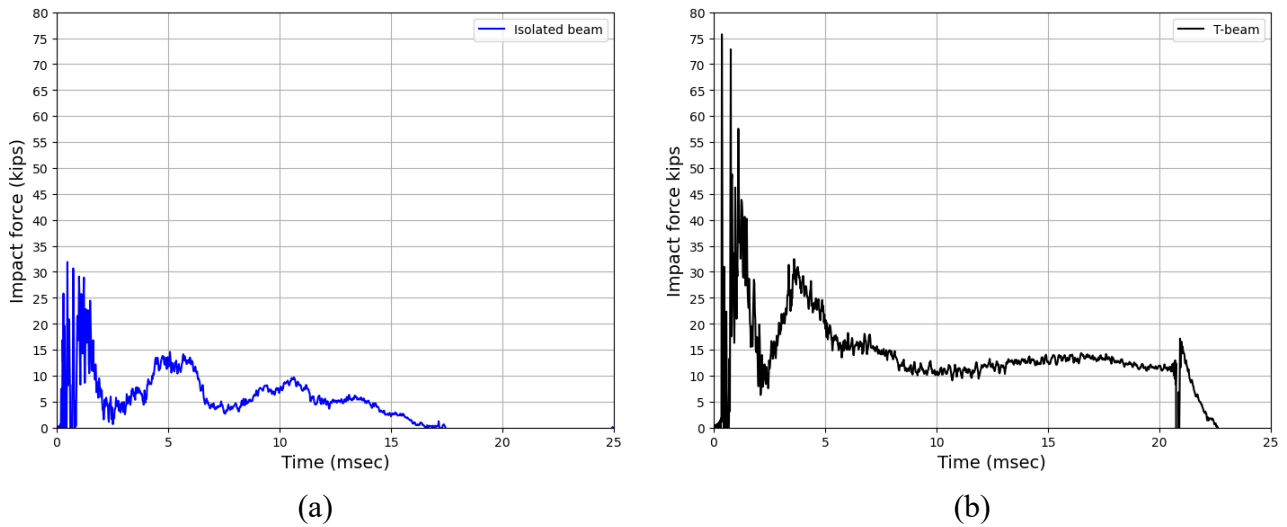
Figure 3.4 Impact forces time histories for (a) Isolated beam, and (b) T-beam

Figure 3.4 displays the time history of impact forces for girders 1 and 2. The data acquisition system captured the time history of the impact force for each test. During the first 2.5 milliseconds of impact, the force pattern showed a sharp triangular peak as contact was made. This was followed by free vibration that decayed over 22.5 milliseconds of the total 25-millisecond impact duration. The peak force depended on several factors: impact speed, mass, local contact stiffness, and overall girder stiffness. The beam system's global stiffness primarily determined the subsequent free vibration phase. For the isolated beam, the peak force was 32 kips (Figure 3.4 a),

whereas it increased to 76 kips (Figure 3.4 b) for the T-beam, which is more than 50% of the force. This higher impact force increased the acceleration of the T-beam specimen, aligning with conservation of momentum principles based on the velocity generated in the beam by the impact cart's collision.

For the impacted isolated beam (Figure 3.4 a), at the instant of contact between the impactor head and the concrete beam, the impact force increased almost linearly with time, which indicates that concrete deformed in its elastic range and severe local punching failure was observed in the isolated beam at the impact area. At  $t = 0.2$  ms, the slope of the impact force-time curve started to reduce since the specimen's stiffness decreased due to local deformation. At  $t = 0.9$  ms, the impact force reached its maximum value of 33 kip. The impact force dropped dramatically after that to almost zero. At  $t = 5$  ms, the impact force increased again to 14 kips because the speed of the girder tended to be smaller than that of the impact cart, and the contact area between the impactor and the girder became larger. After that, a small vibration was introduced to the girder, resulting in a large fluctuation of the curve as the dynamic responses mainly depend on the local stiffness rather than the overall stiffness along the impact direction. At about  $t = 10$  ms, the impact force tended to be stable. The area under the impact force-time curve revealed small impact energy was absorbed as the impacted I-beam was severely damaged. Figure 8A shows that the impacted beam reached 7.4 inches with noticeable residual displacement due to the permanent impact damage.

For the impacted T-beam (Figure 3.4 b), at the instant of contact between the impactor head and the concrete beam, the impact force increased almost linearly with time, which indicates that concrete deformed in its elastic range. At  $t = 0.3$  ms, the slope of the impact force-time curve started to reduce since the specimen's stiffness decreased due to local deformation. At  $t = 0.7$  ms,

the impact force reached its maximum value of 76 kip. The impact force dropped dramatically after that because the speed of the specimen moving forward was larger than that of the impact cart, and the girder was trying to separate from the impact. At  $t = 3.5$  ms, the impact force increased again to 33 kips because the speed of the girder tended to be smaller than that of the impact cart, and the contact area between the impactor and the girder became larger. After that, the impact force decreased due to local deformation and the probability of a smaller contact area when the girder moved upward. At the same time of 7 ms, a small vibration was introduced in the girder, resulting in a small fluctuation of the curve, and at about  $t = 10$  ms, the impact force tended to be more stable due to the presence of the concrete deck restraining. compared to the Isolated, tested beam. The area under the impact force-time curve revealed large impact energy was absorbed as the impacted T-beam sustained the primary energy.

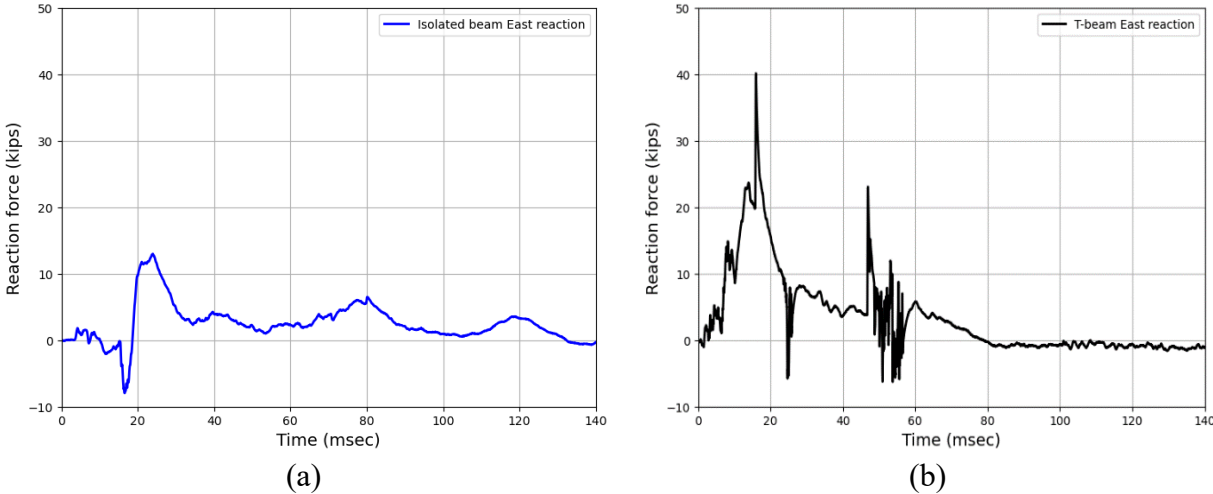
Figure 3.5 Time histories of support reaction forces (a) Isolated beam, and (b) T-beam

Figure 3.5 depicts the time histories of support reaction forces. The peak east support reactions measured 13 and 40 kips for Isolated and T beams, respectively. The relatively low

value of peak support reactions compared to the peak impact forces can be attributed to the inertial forces that immediately responded to the impact event.
