# MID-AMERICA TRANSPORTATION CENTER

Report # MATC-UNL: 004-24

## **MASH TL-6 Evaluation of a 62-in. Tall, Single-Slope, Concrete Median Barrier**

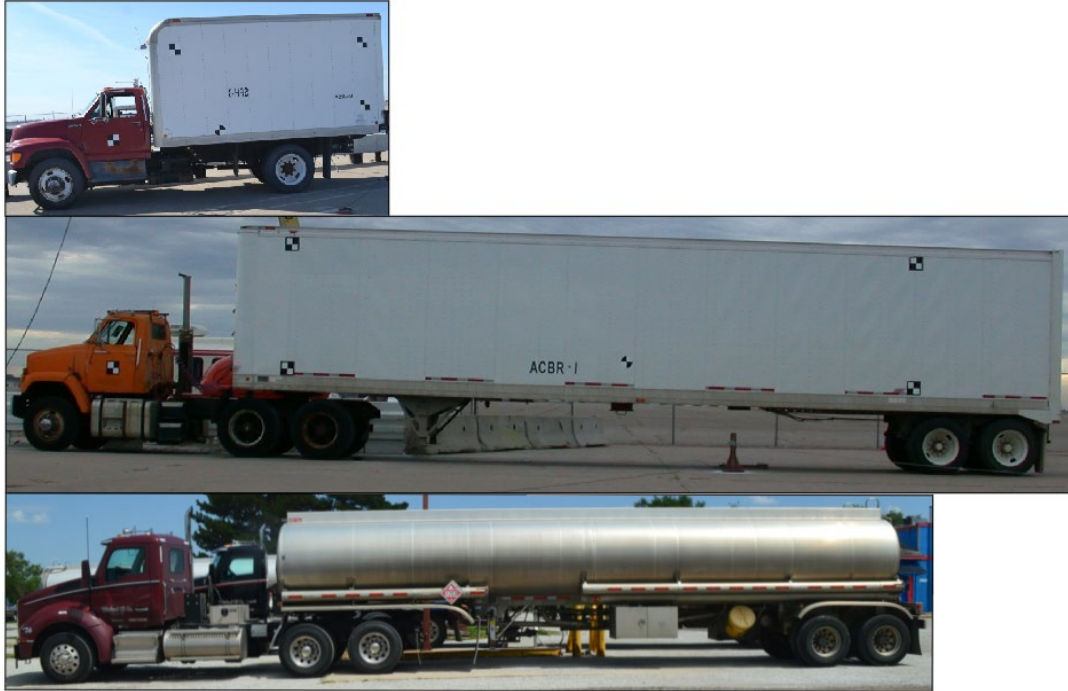
Figure 1.1 TL-4 (22,000-lb), TL-5 (79,300-lb), and TL-6 (79,300-lb) Vehicle Side View [3]

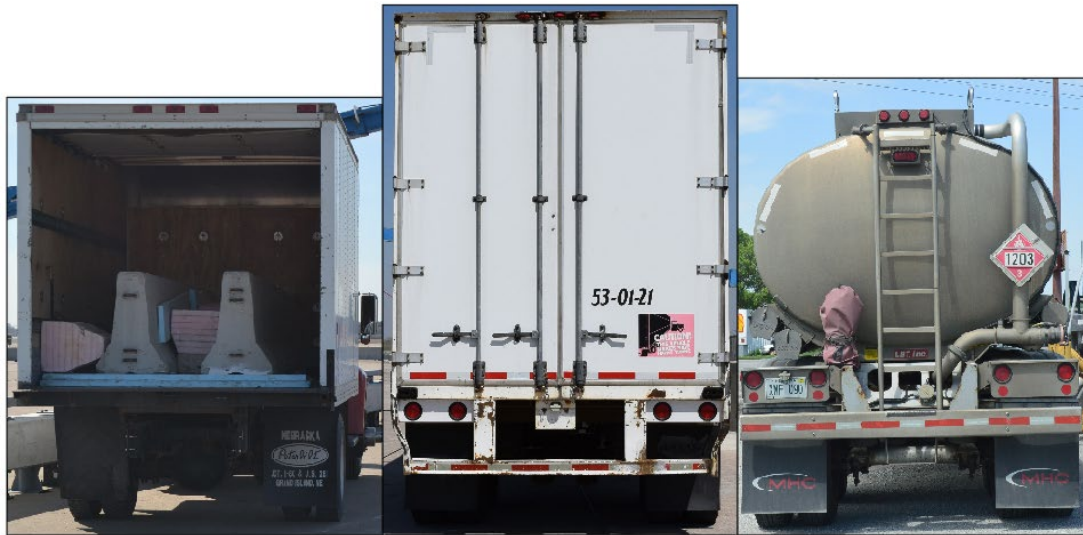
Figure 1.2 TL-4 (20,000-lb), TL-5 (80,000-lb), and TL-6 (80,000-lb) Vehicle Rearview [3]

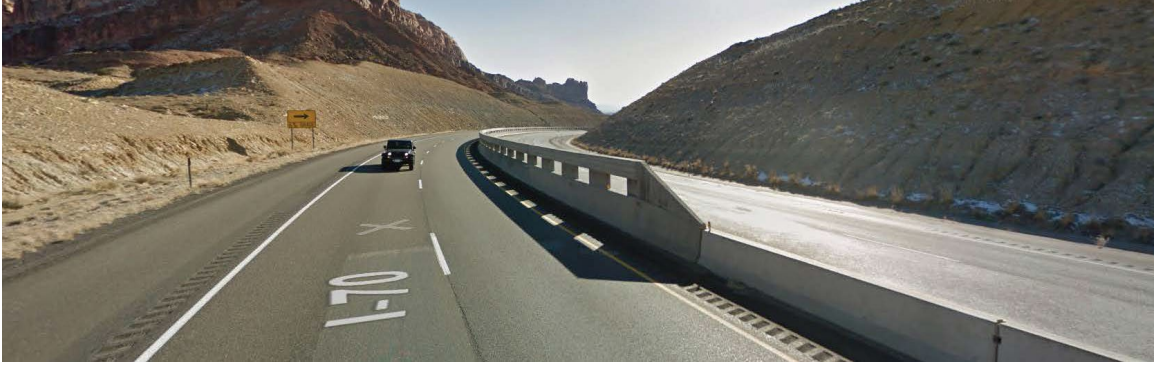
Figure 2.5 Utah DOT 84-in. Tall Roman Wall Installation [3]

The Utah DOT installed an 84-in. tall modification of the TTI Roman Wall in a narrow median on a large curve on Interstate 70, as shown in Figure 2.5. The Utah DOT has also utilized an 84-in. tall solid concrete wall, which was installed on the roadside to shield a railroad line adjacent to a curved highway, as shown in Figure 2.6.

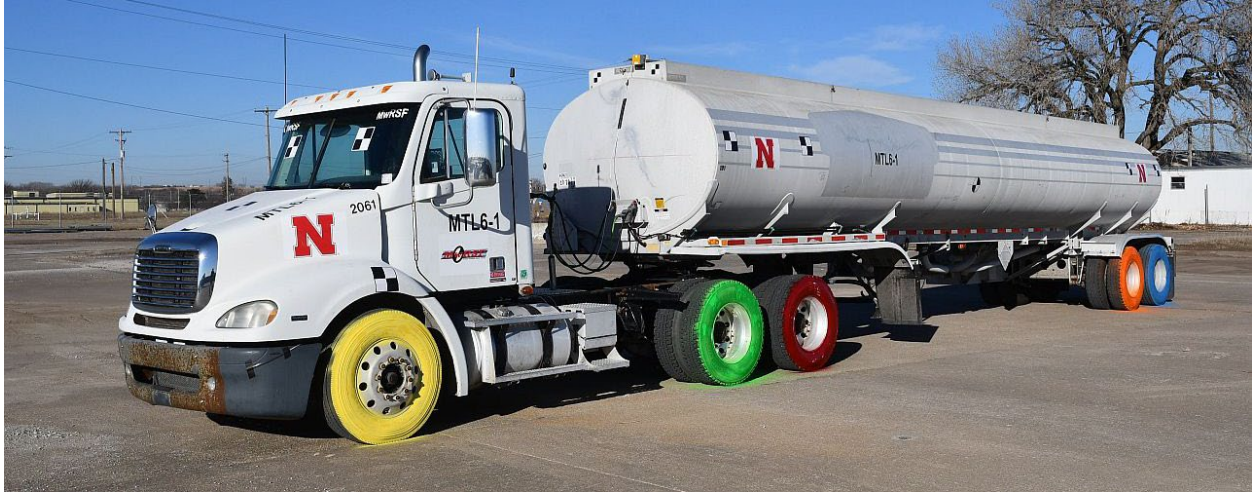
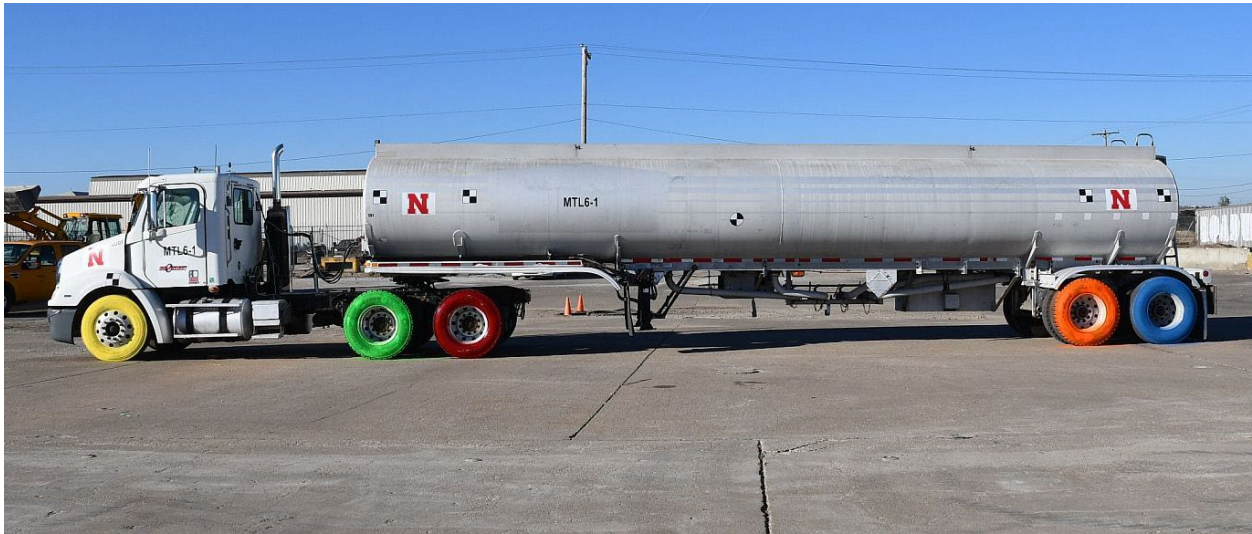
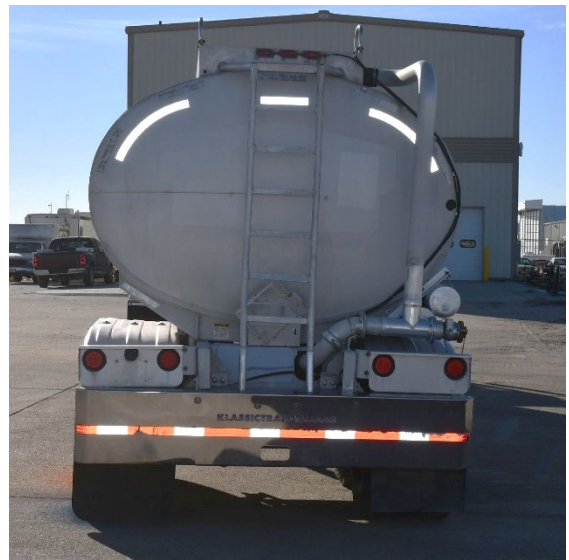
Figure 5.3 Test Vehicle, Test No. MTL6-1

The test vehicle consisted of two separate entities: the truck and trailer, which were connected with a pinned bracket connection known as the “fifth wheel.” The truck was less than 12 years old as specified by MASH requirements for heavy trucks. The trailer consisted of a 1996 Fruehauf (LBT) BKZ 4466 trailer. Note that although MASH provides a recommended 12-year maximum age of the test vehicle, no guidance was provided for recommended age of the trailer. Thus, the research team selected a trailer which was consistent with the dimensions shown in MASH, with construction similar to in-production models of trailers, and which was similar to the model used in computer simulations. The trailer had a payload capacity of 9,500 gallons distributed in four tanks. The four tanks had capacities of 4,000 gal, 1,200 gal, 1,500 gal, and 2,800 gal from front to back, respectively. The rear tandem to the fifth wheel connection was 34 ft – 9 in. long, and 32 ft – 11½ in. measured from the center of the rear tandem axle to the estimated center of the truck tandem rear axle. The overall trailer length was 42 ft – 6 in. The trailer tank jacket, bulkheads, baffles, and pipe connections were constructed from aluminum alloy structural materials consistent with modern liquid petroleum transport tank specifications.

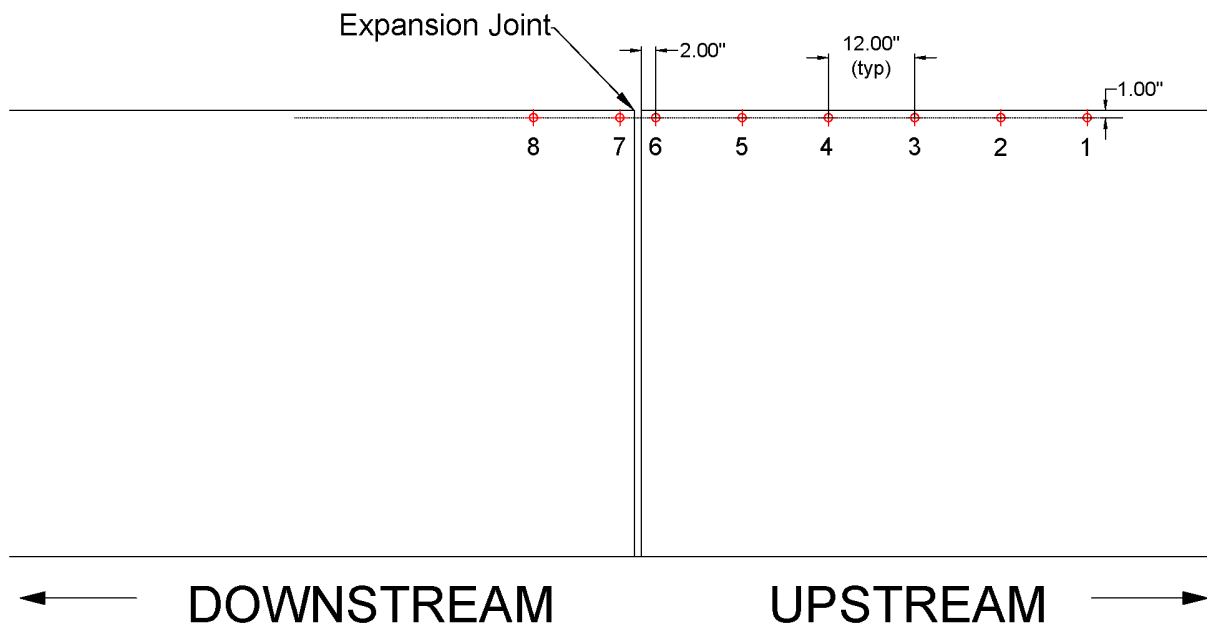
Figure 5.16 Location of Linear Potentiometers, Test No. MTL6-1

Eight linear potentiometers were installed on the back side of the barrier near the top, as seen in Figure 5.16. Two were placed downstream from the expansion joint and six were placed upstream. Strain gauges were placed on reinforcing bars both upstream and downstream from the expansion joint, as illustrated in Figure 5.17. Each linear potentiometer had a 0.90-in. diameter cross-section with an operational temperature range between -40 and 190°F and up to 95 percent humidity, was rated to IP64 (dust and water resistant), and utilized rod end joints for increased mounting flexibility. The strain gauges were single-axis GOBLET F-series foil strain gauges with a 5-mm gauge length and 350 Ohm gauge resistance. During testing, output voltage signals were sent from the transducers to a National Instruments PCI-6071E data acquisition board, acquired with LabView software, and stored on a personal computer at a sample rate of 10,000 Hz. Specifications for the foil strain gauges are shown in Figures 5.18 and 5.19.

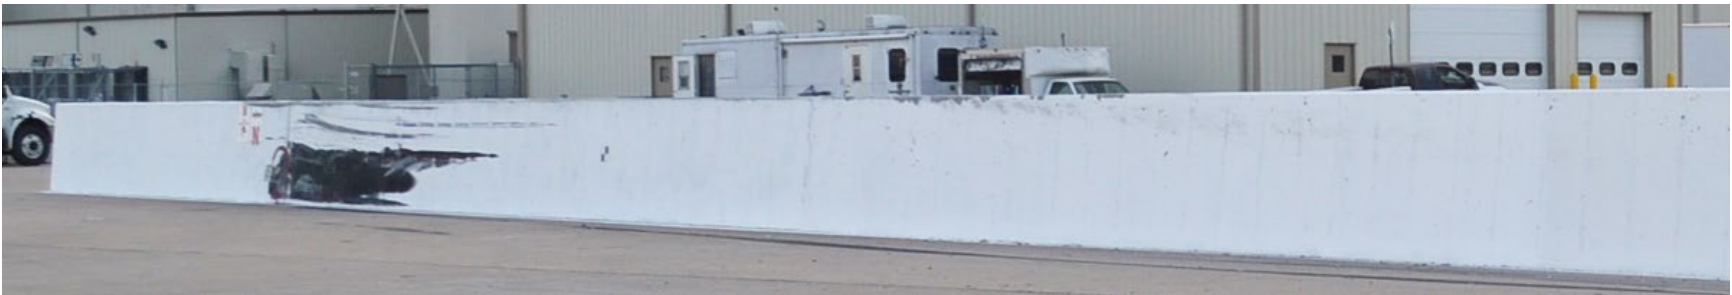
Figure 6.11 System Damage, Test No. MTL6-1

Damage to the barrier was minimal, as shown in Figures 6.11 and 6.14. Barrier damage consisted of contact marks on the front face of the barrier, minor concrete chipping and grinding, and chipping around the top and impact-side surfaces of the expansion joint. The length of vehicle contact along the barrier was approximately 90 ft – 6 in., beginning 6 ft – 10 in. upstream from the centerline of the expansion joint.

Tire contact marks on the front face of the barrier began 6 ft – 10 in. upstream from the expansion joint and ended approximately 26 ft downstream from the expansion joint. The overall width of the tire contact marks varied, but the highest point was 38.5 in. above the tarmac. Contact marks from other portions of the vehicle were observed up to the top of the barrier and gouging or spalling occurred along the top-front edge of the barrier from 6 ft – 10 in. upstream from the expansion joint to approximately 77 ft – 8 in. downstream from the expansion joint. Additional intermittent gouging and chipping along the top-front edge of the barrier extended through the end of vehicle contact.

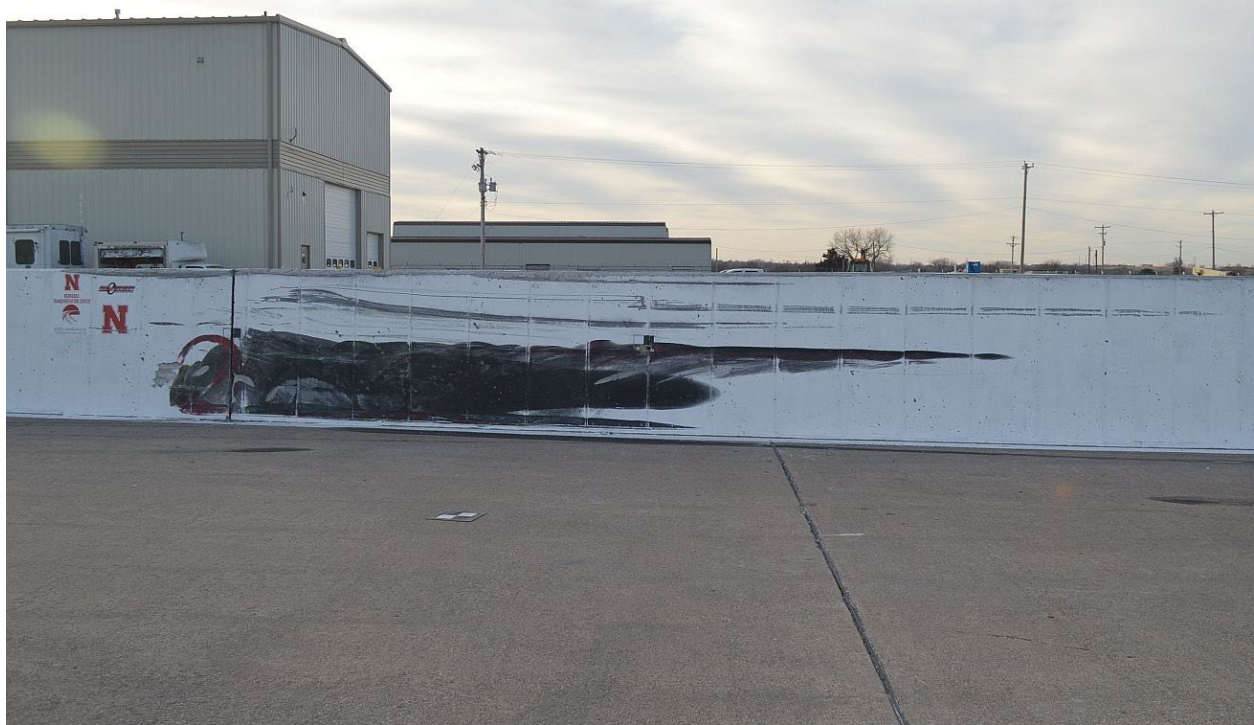
Figure 6.12 System Damage, Test No. MTL6-1

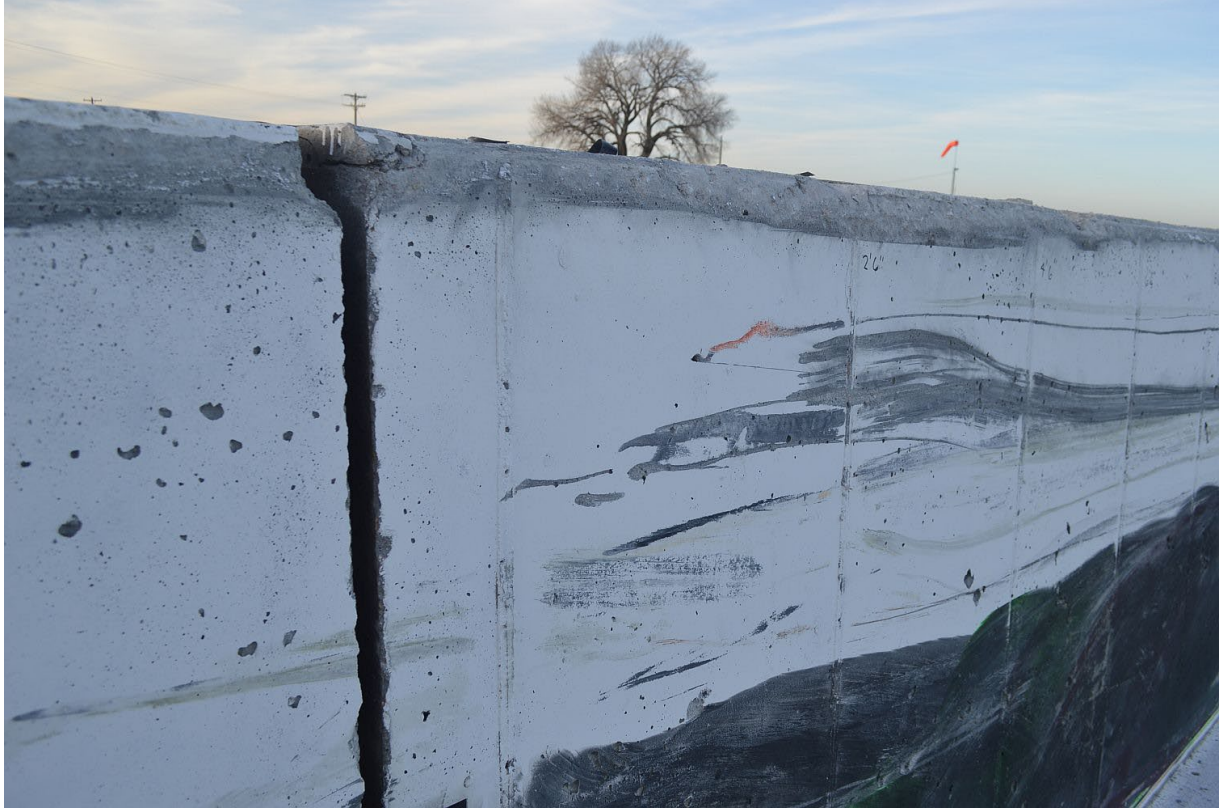
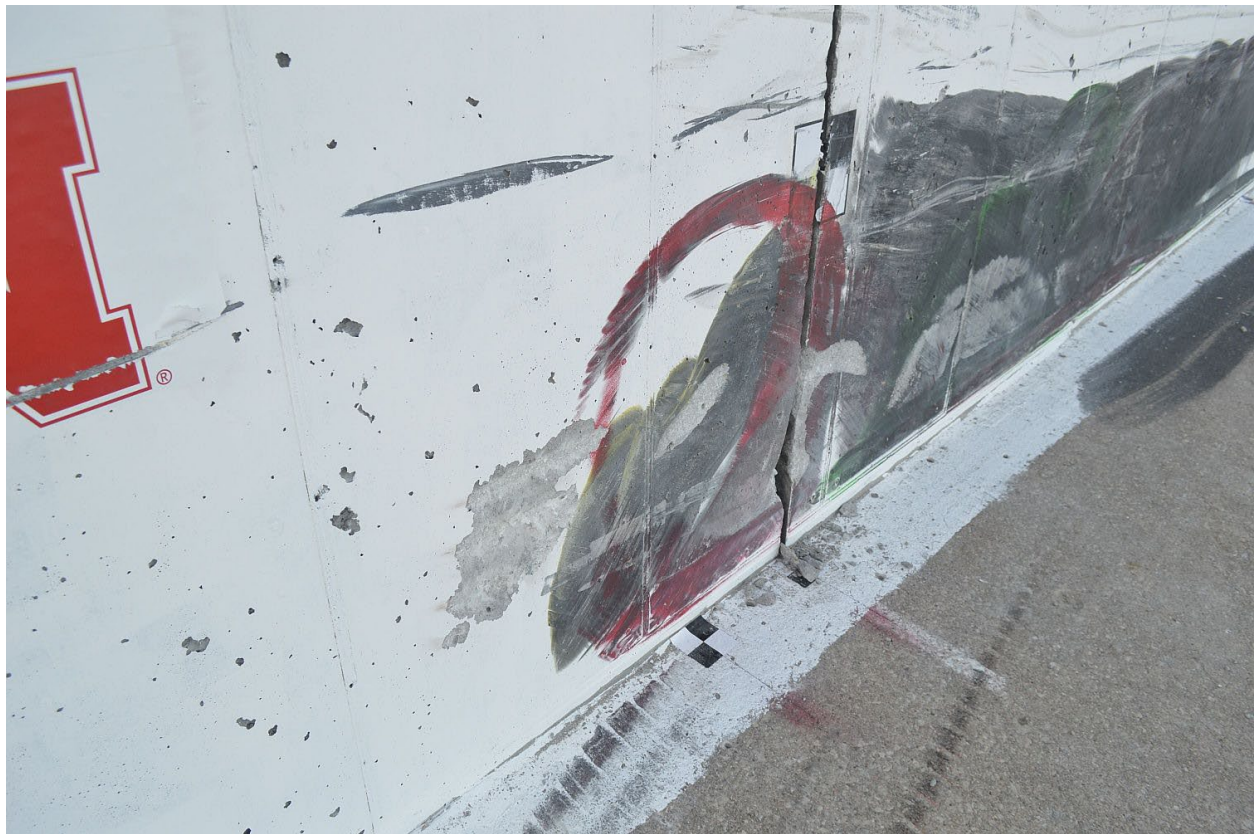
Figure 6.13 System Damage Near Expansion Joint, Test No. MTL6-1

Additional gouging and chipping were observed on the front face of the barrier, in the 3 ft to either side of the expansion joint. At the expansion joint location, the top-front corners of the barrier segments were broken off to a depth of approximately ½ in. as was 13 in. of the upstream front edge, beginning 5 in. above the tarmac. No reinforcing bars were exposed by this damage.

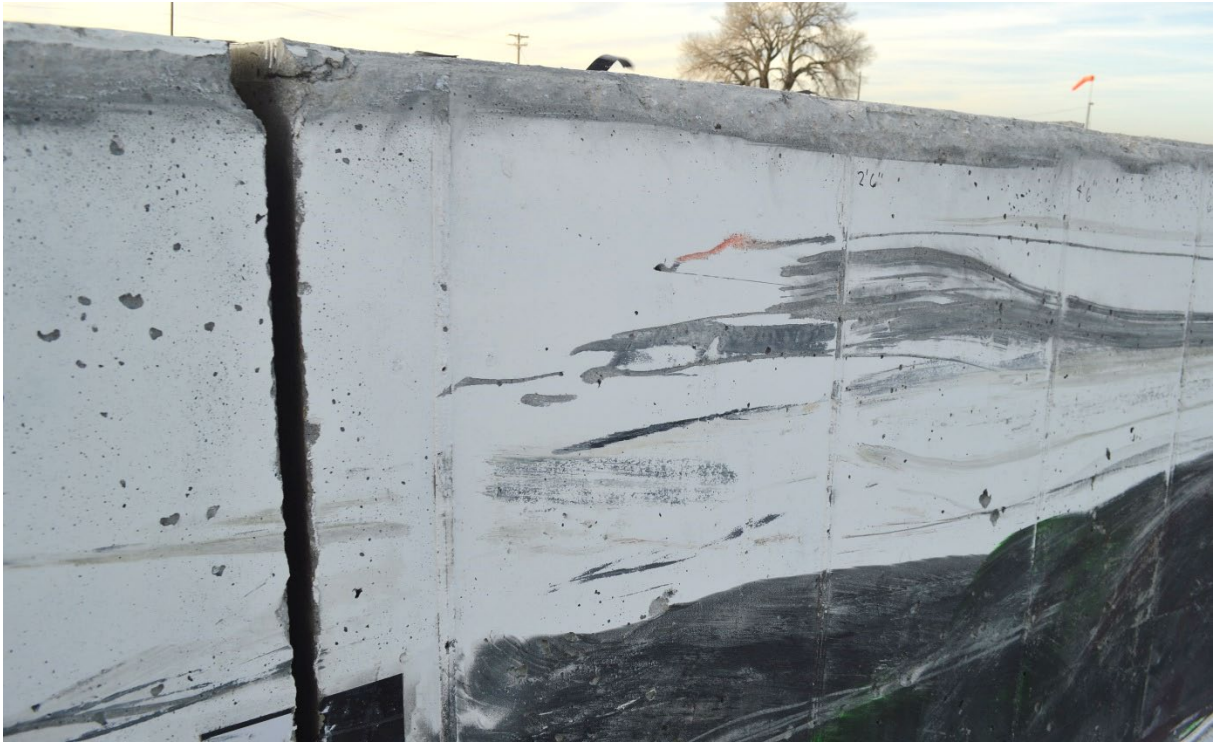
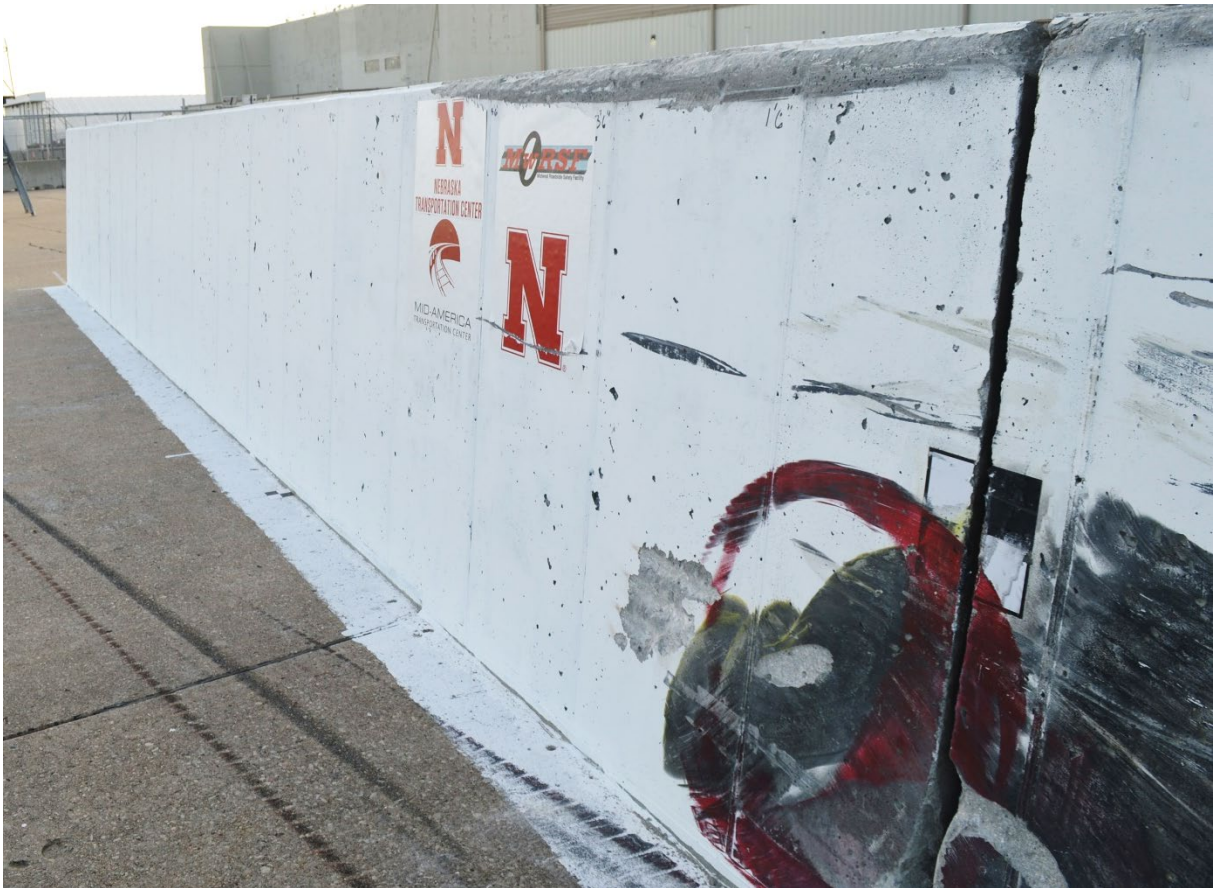
Figure 6.14 System Damage Near Expansion Joint, Test No. MTL6-1

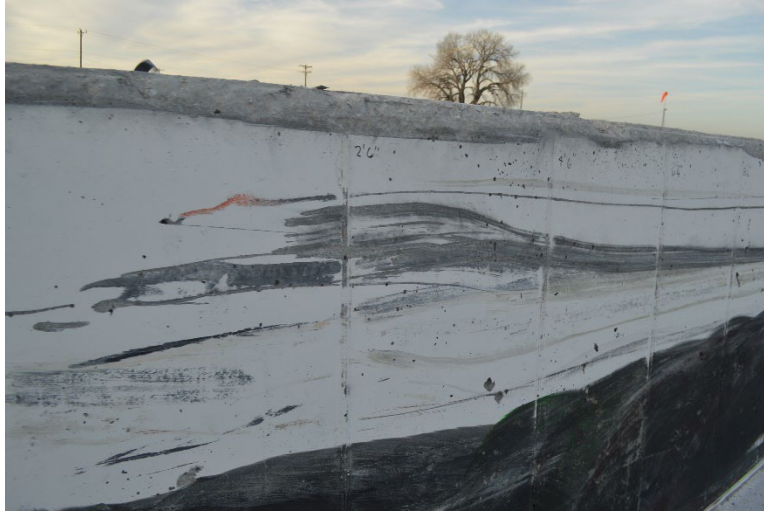
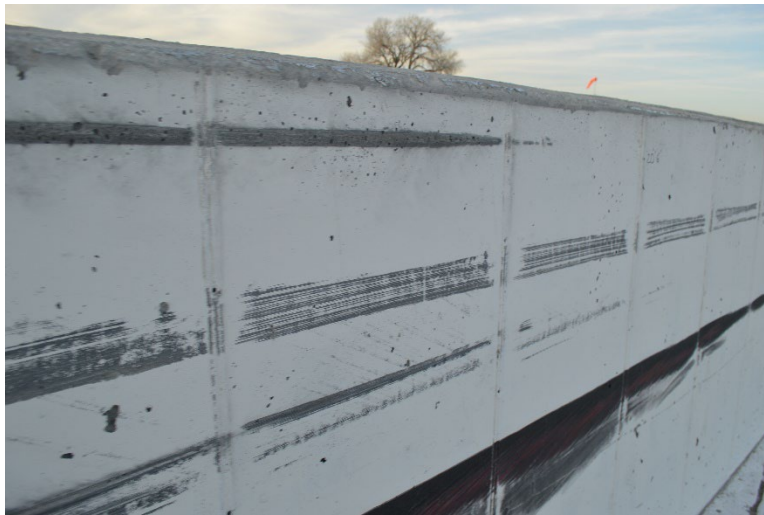
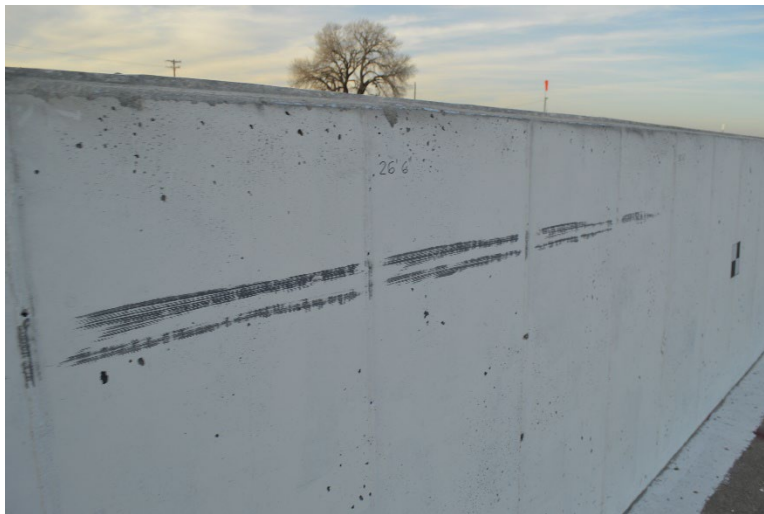
Figure 6.15 Scraping Damage along Top Impact-Side Edge of Barrier, Test No. MTL6-1

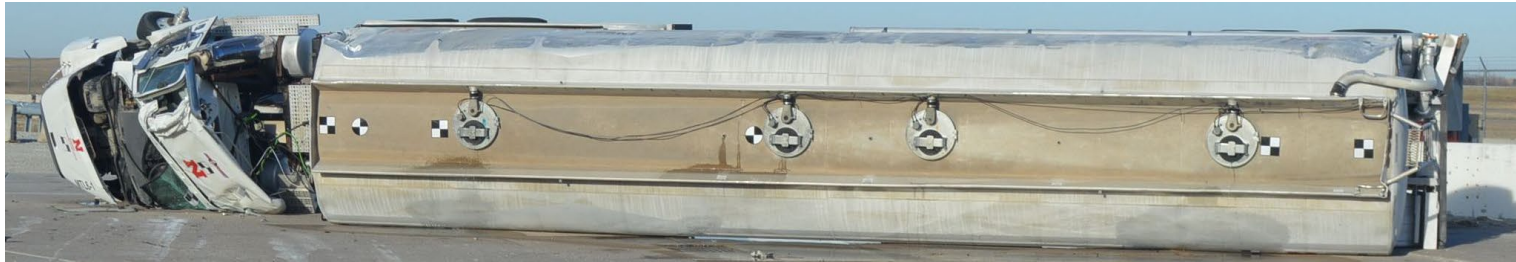
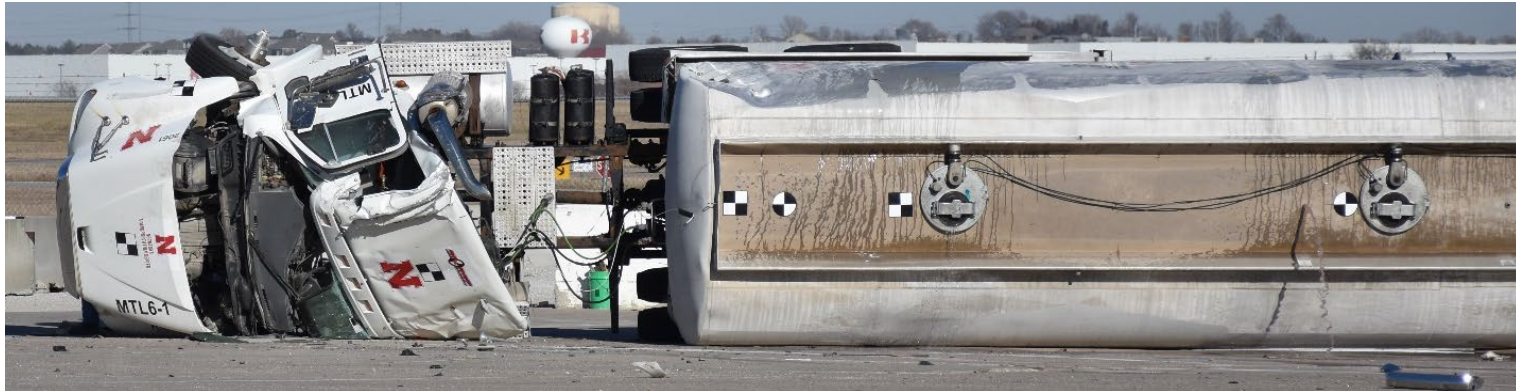
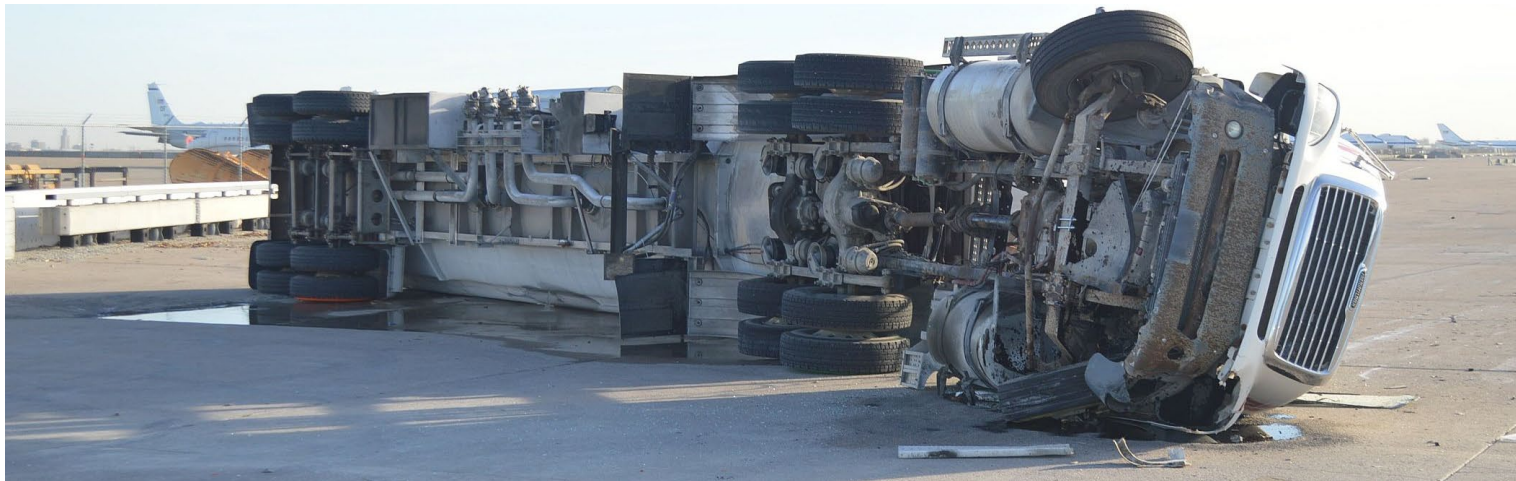
Figure 6.17 Vehicle Damage and Final Rest, Test No. MTL6-1

The damage to the vehicle was severe, as shown in Figures 6.17 through 6.30. The maximum occupant compartment intrusions were not collected after the test due to extensive occupant compartment deformations. MASH defines intrusion or deformation as the occupant compartment being deformed and reduced in size with no observed penetration. The secondary rollover event at the end of the crash sequence resulted in roof crush and damage to A-pillars which exceeded MASH occupant compartment deformation limits.

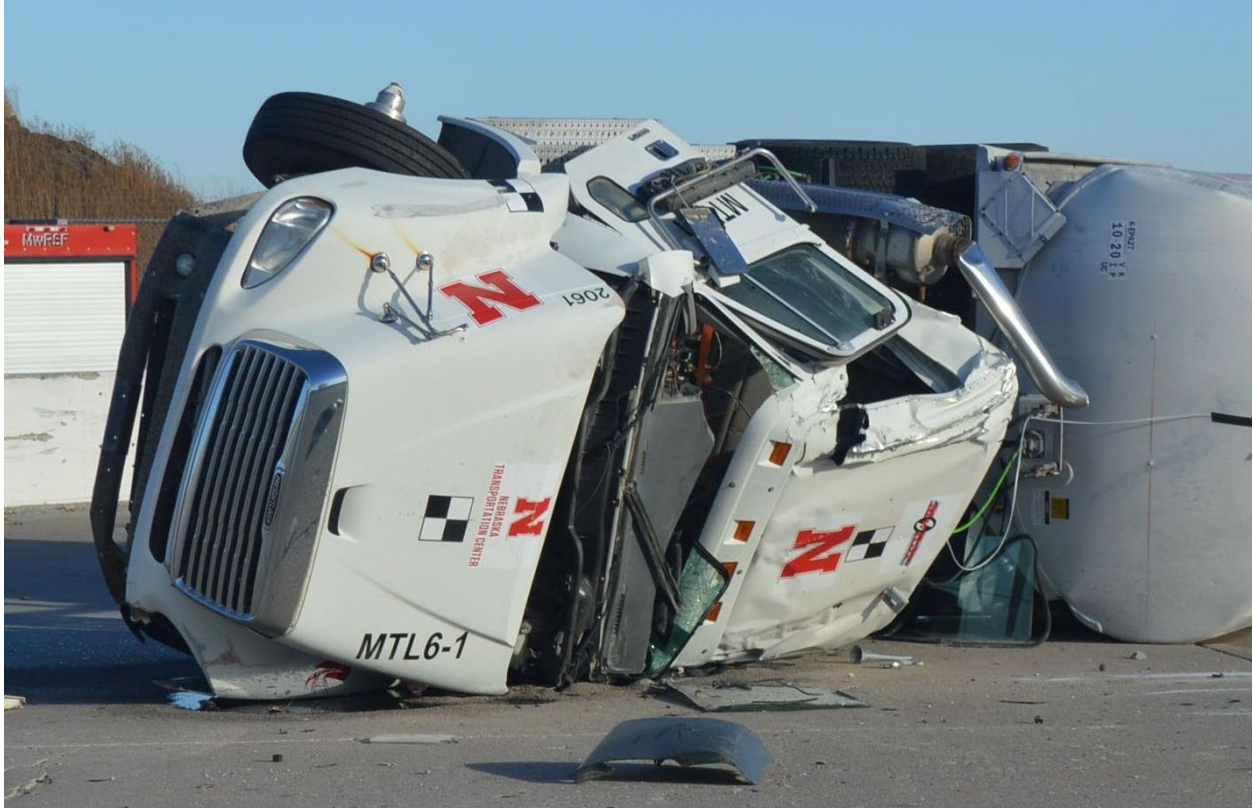
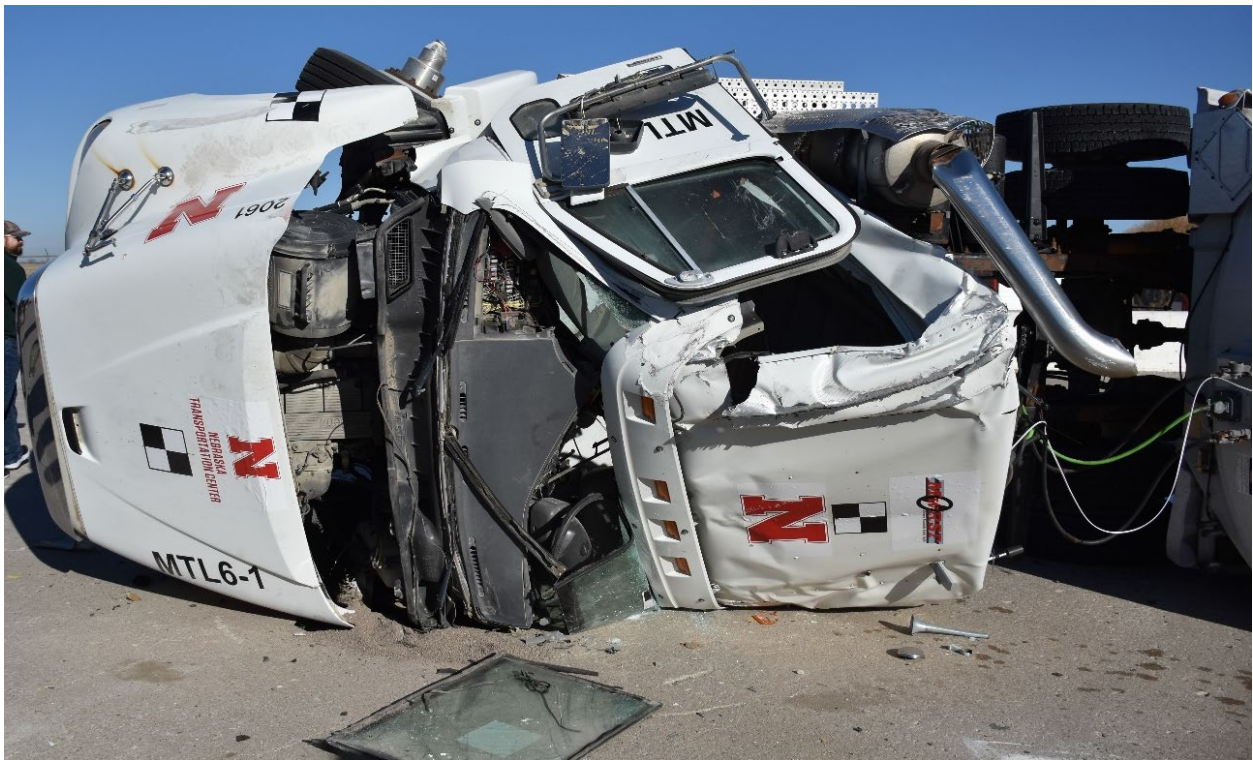
Figure 6.18 Tractor Damage, Test No. MTL6-1

The tractor experienced extensive damage from impact and the subsequent rollover. The cab, windshield, roof, and both side doors were crushed inward. The cab frame experienced tears which caused the roof and door structures to collapse inward when the vehicle was uprighted after the test. The left-front bumper corner, fender, and foot ramp were damaged from impact with the concrete barrier. A crease was observed at the approximate height of the concrete barrier across the left-side door and cab frame. The hood was disengaged from the left rear mount and displaced to the right side, and extensive engine frame and console frame damage occurred including buckling, twisting, and crushing.

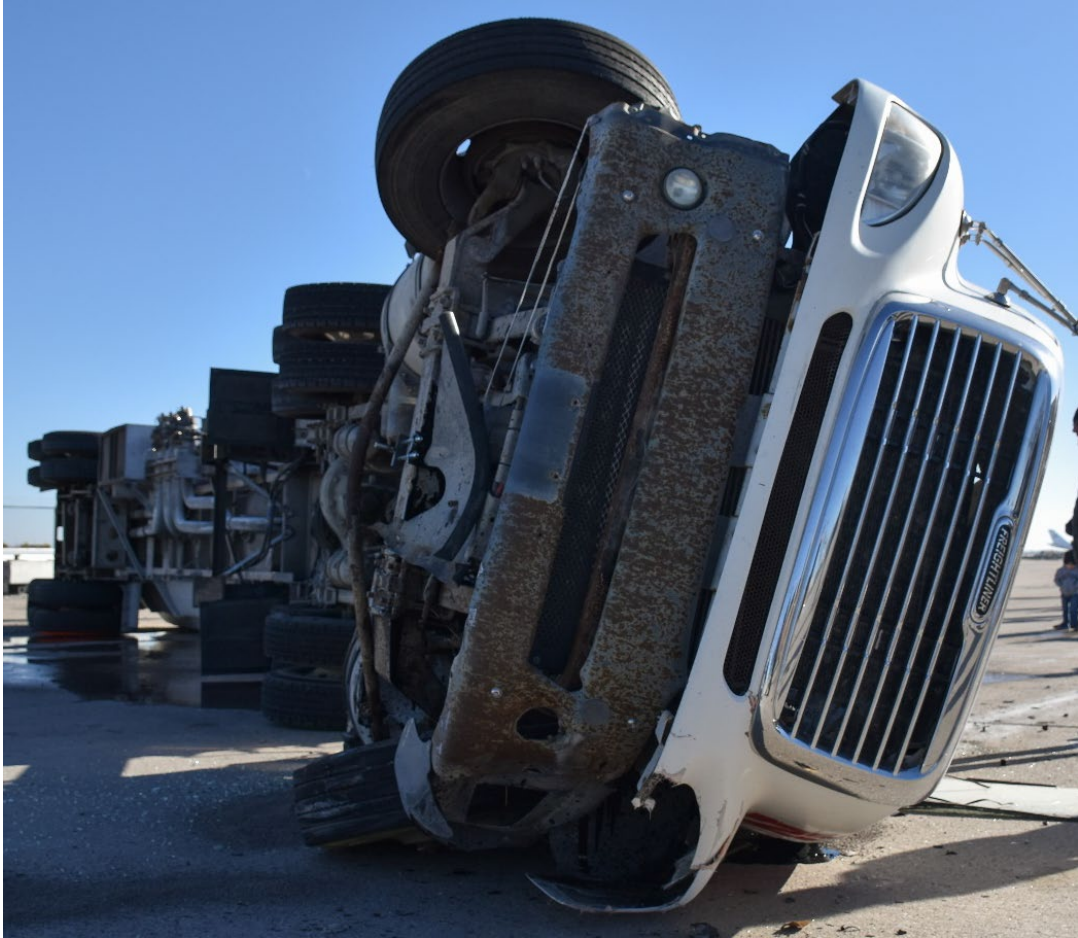
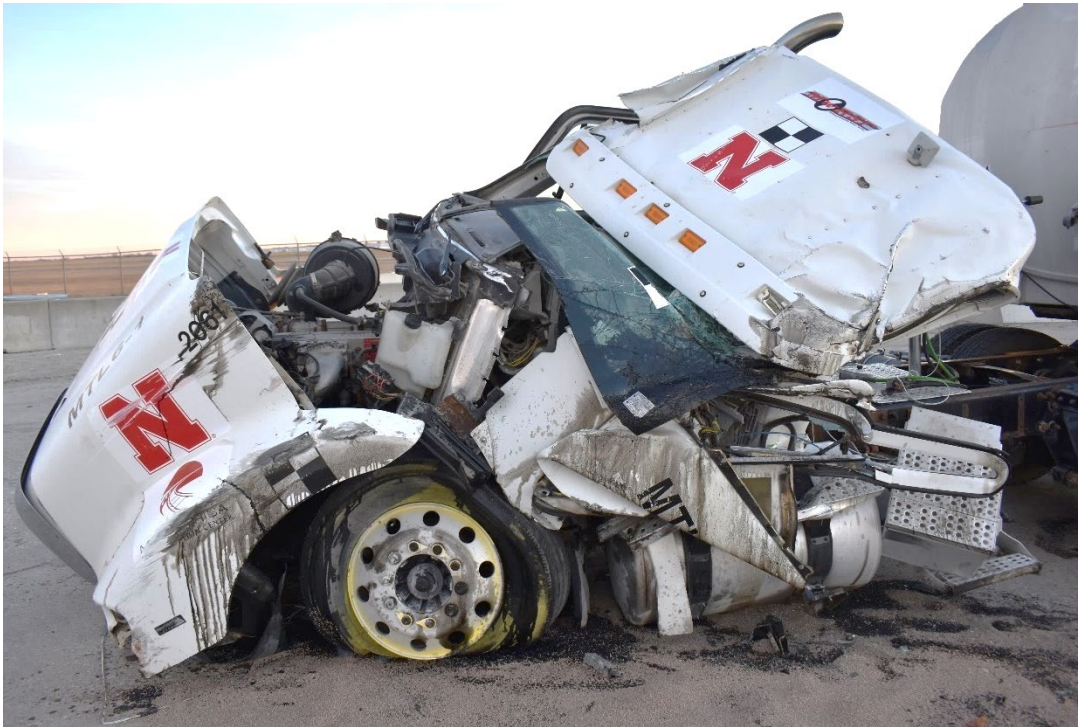
Figure 6.19 Tractor Damage, Test No. MTL6-1  
99

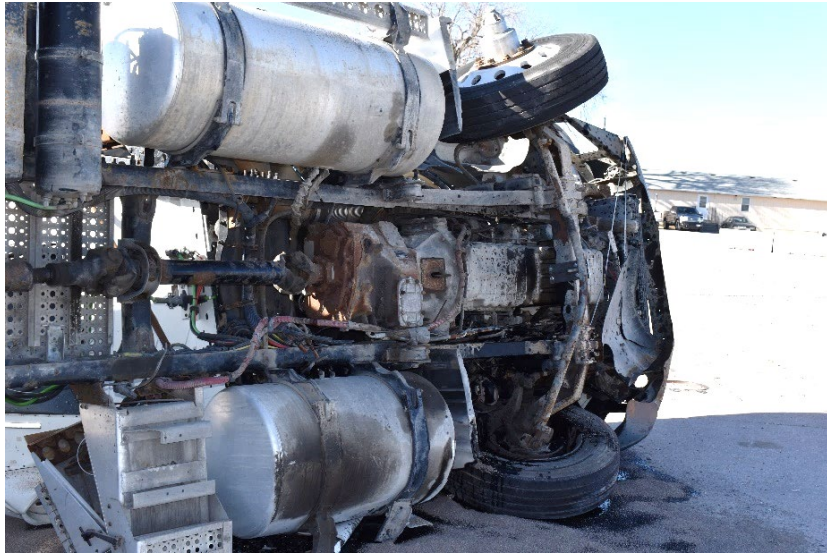
Figure 6.20 Tractor Undercarriage Chassis Damage, Test No. MTL6-1

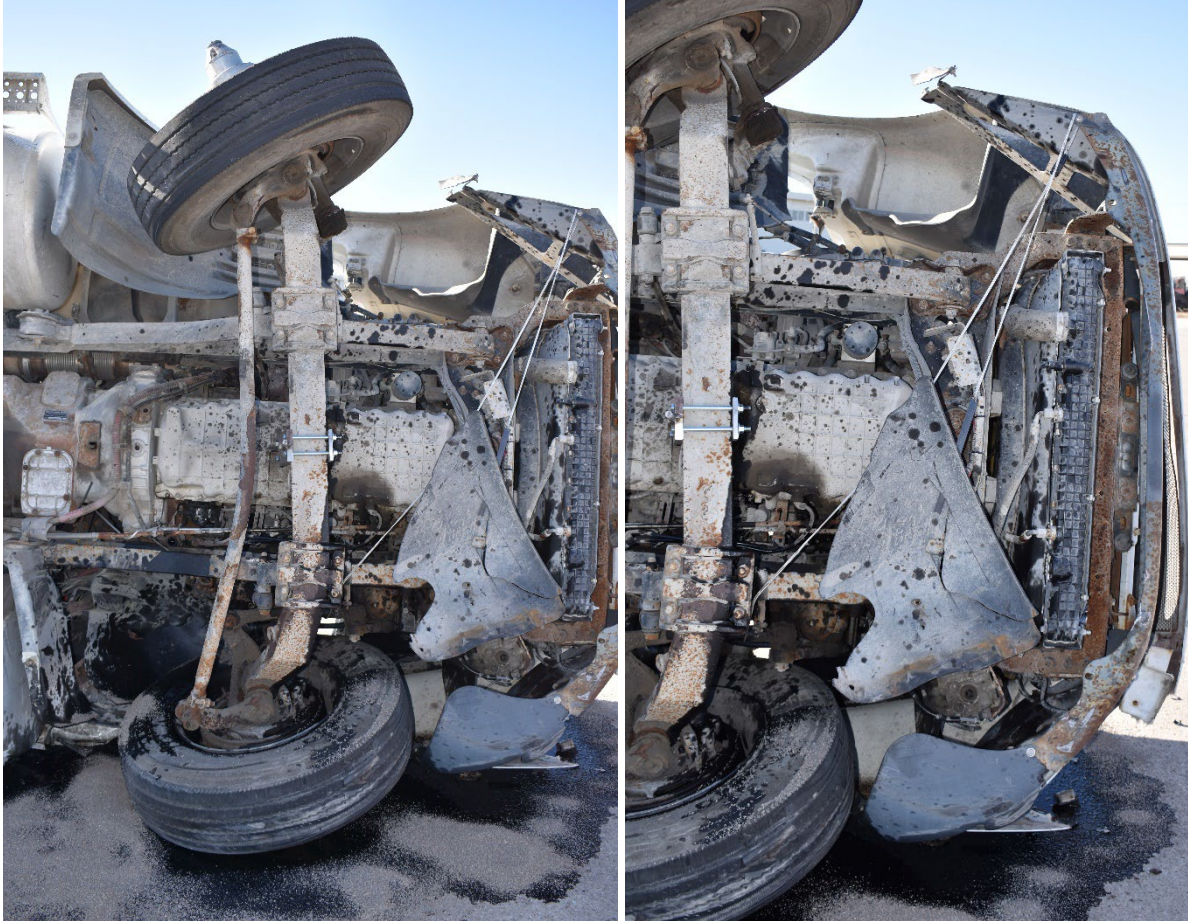
Figure 6.21 Tractor Suspension Damage, Test No. MTL6-1  
101

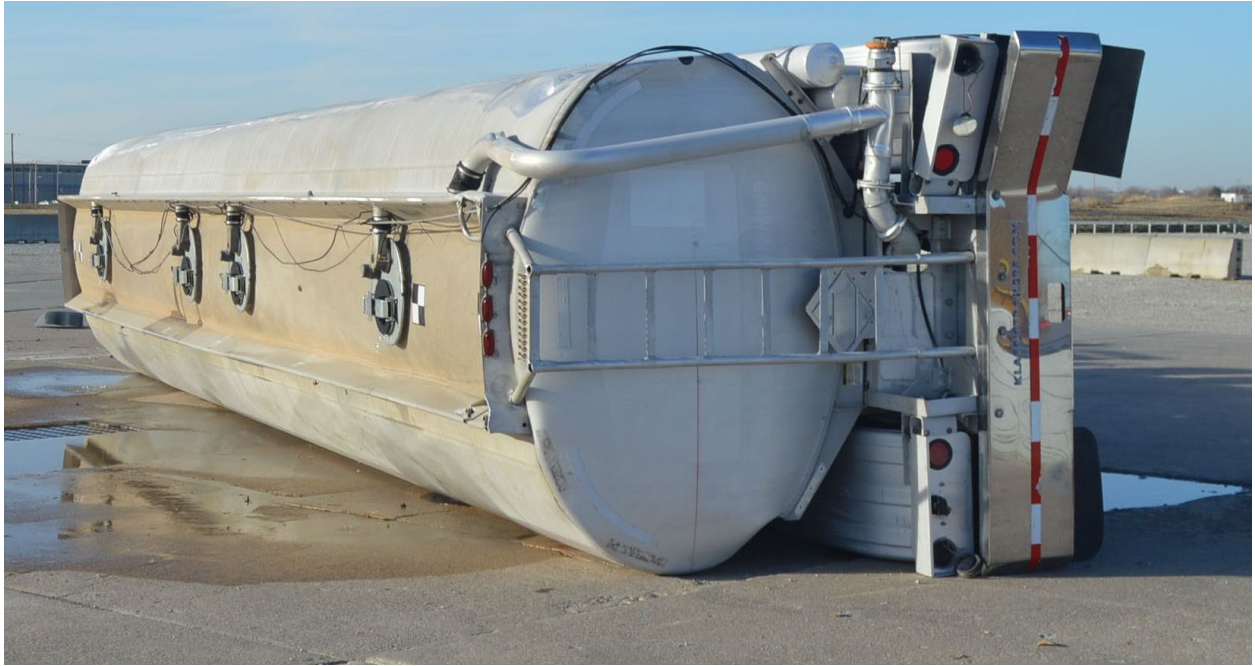
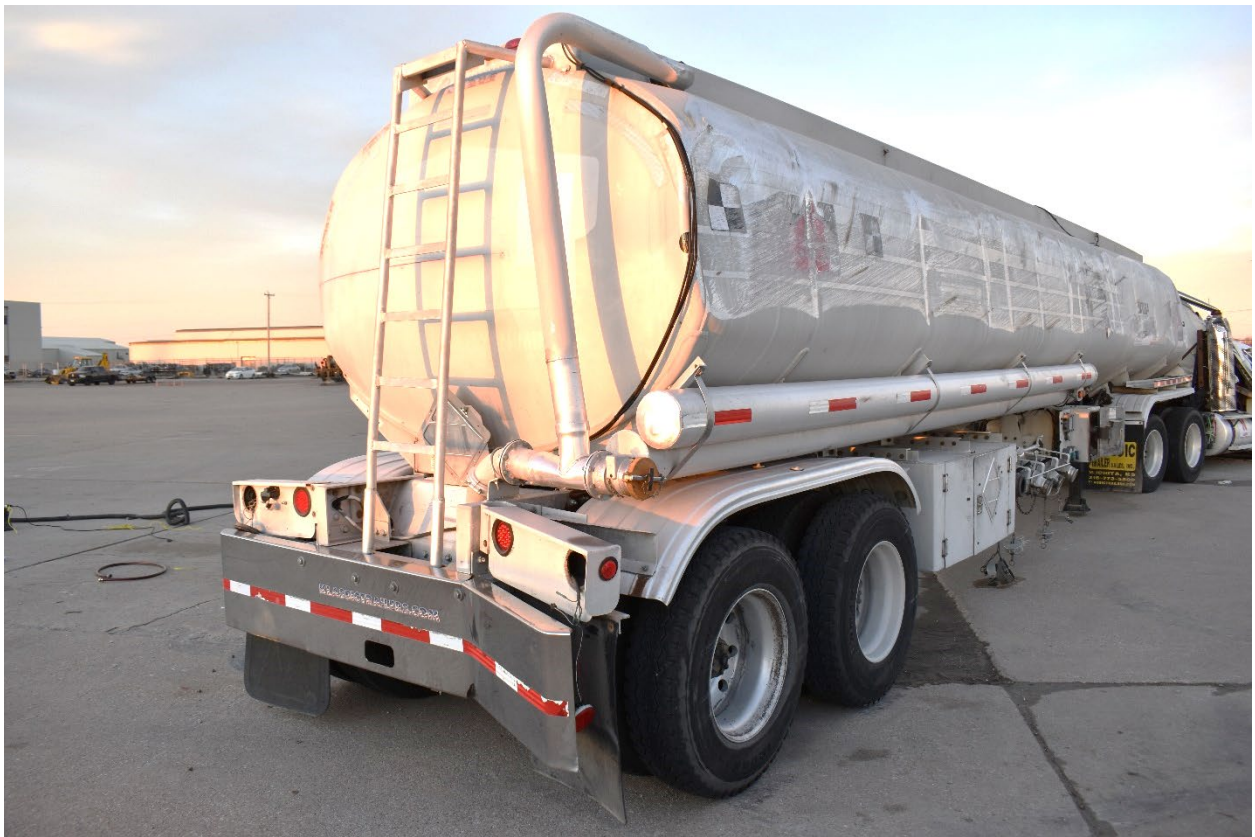
Figure 6.22 Trailer Damage, Test No. MTL6-1

The trailer experienced extensive damage to the left, top, and right sides. Scraping, minor gouging, and some peeling of the aluminum jacket were observed near interior baffle locations. Scrub marks were observed on the left side of the trailer at the impact height of the barrier, and two large dents were observed at the same height: one in the front, and one in the back. The left-side wheel hubs were scraped and gouged. The right side of the trailer experienced extensive scraping in the vertical direction corresponding to sliding on the concrete tarmac, with multiple small tears and holes observed in the aluminum jacket especially near the internal baffles. The right side was flattened and crushed inward along the entire middle section where the vehicle rolled and skidded, and several tears were observed in the jacket measuring between 2 and 3 in.

long. The top of the trailer was scraped, and the longitudinal safety rails were slightly deformed. One tear was observed in the undercarriage of the tank. The suspension, wheels, frame, and undercarriage of the trailer were not damaged.
