# MID-AMERICA TRANSPORTATION CENTER

Report # MATC-UNL: 004-24

## **MASH TL-6 Evaluation of a 62-in. Tall, Single-Slope, Concrete Median Barrier**

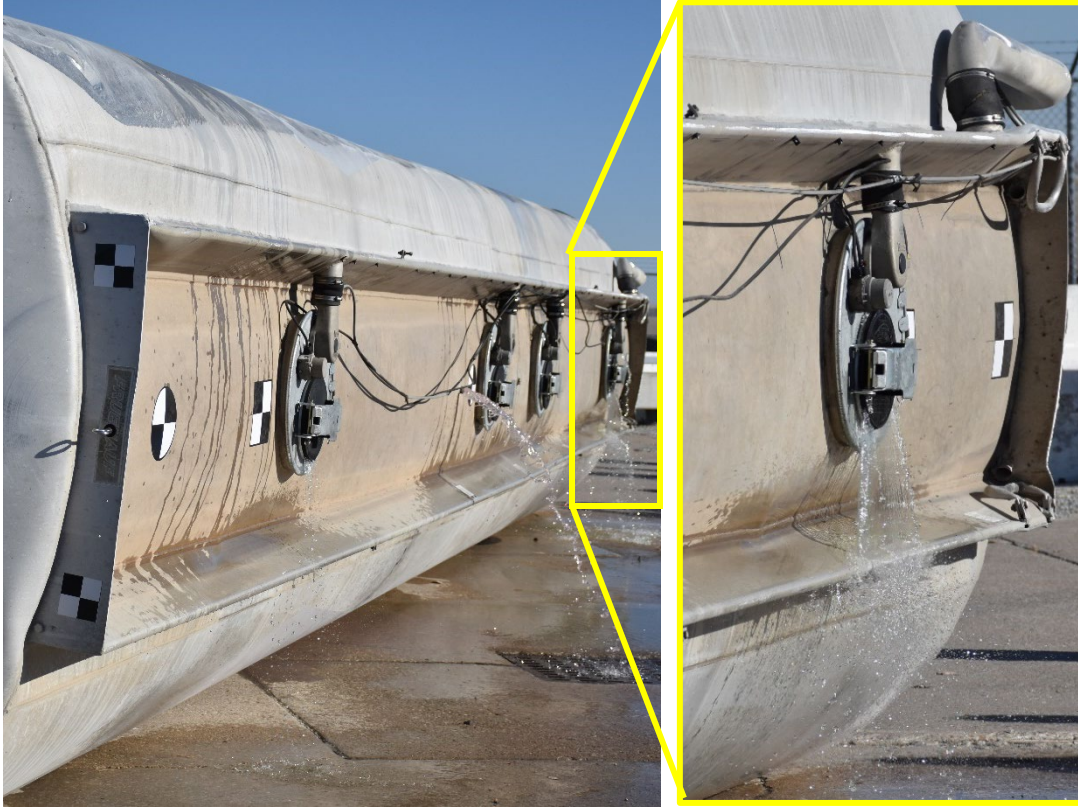
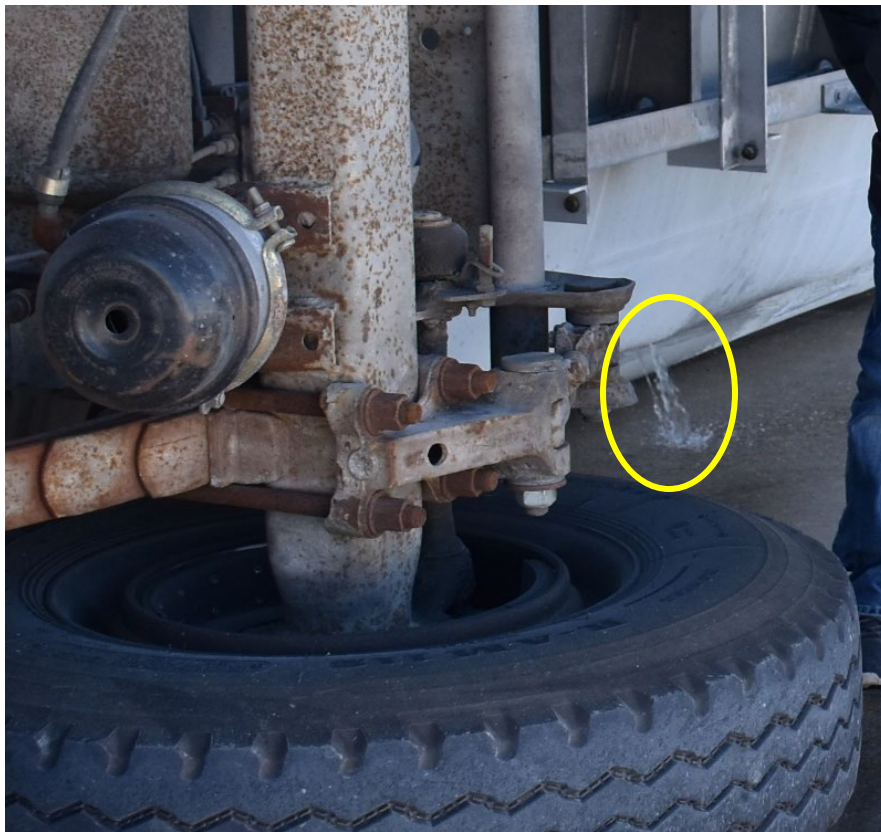
Figure 6.24 Locations of Trailer Leaks, Test No. MTL6-1

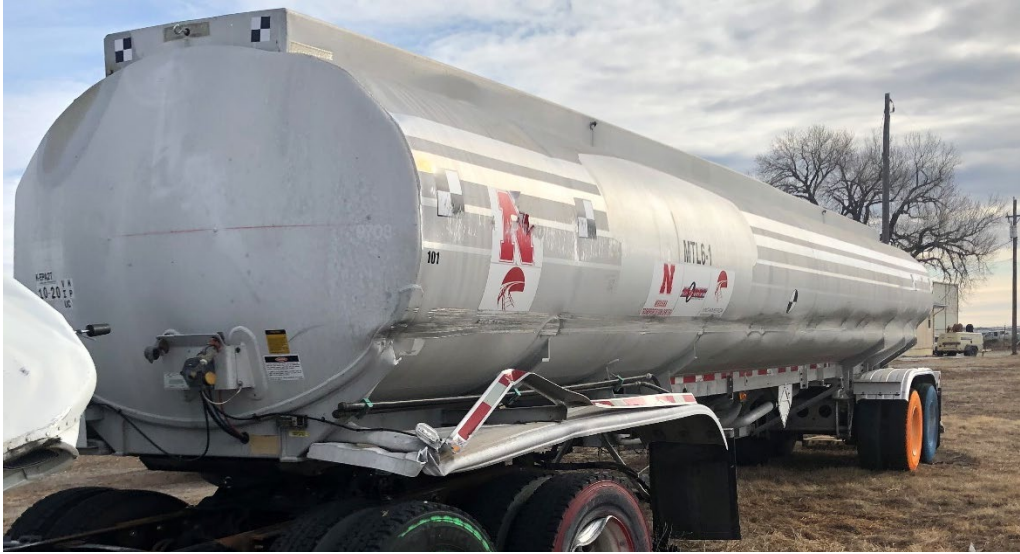
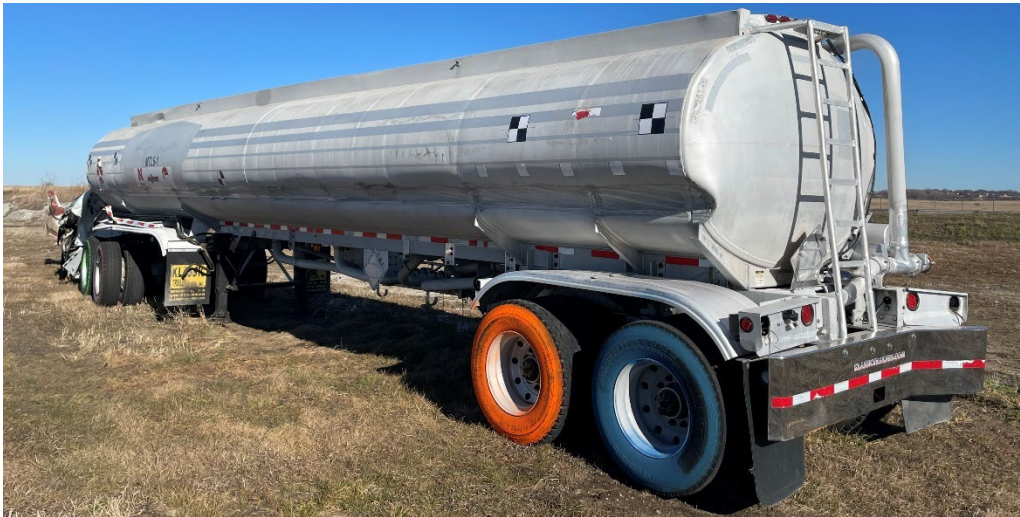
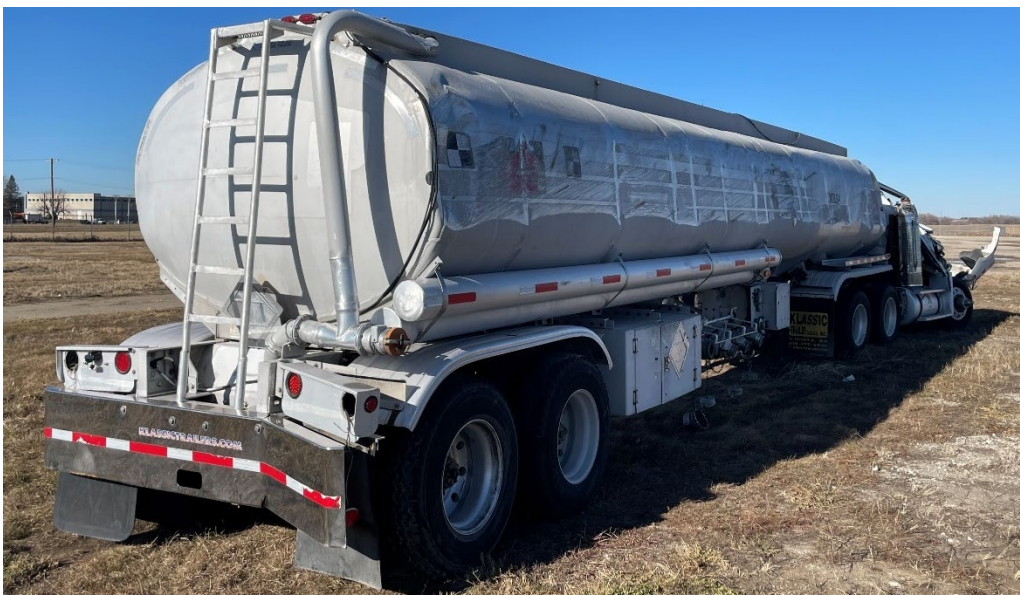
Figure 6.25 Trailer Damage After Uprighting, Test No. MTL6-1

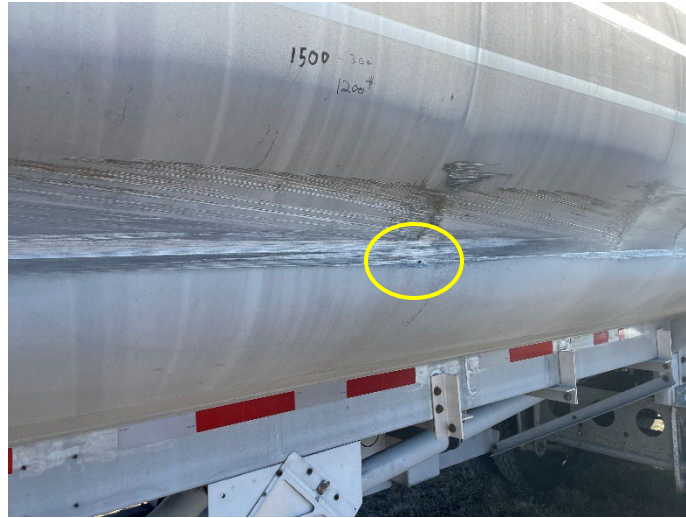
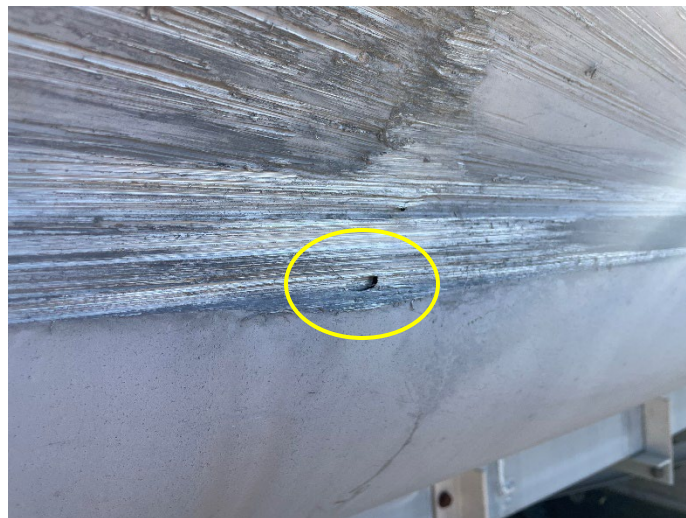
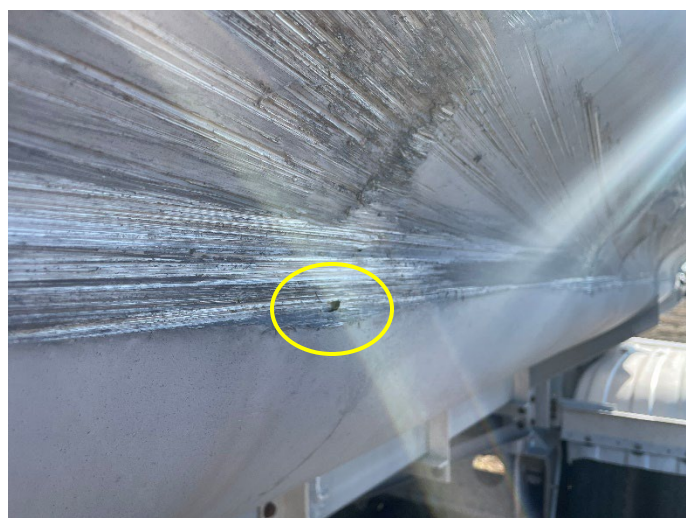
Figure 6.26 Pinhole Damage in Trailer After Being Uprighted, Test No. MTL6-1

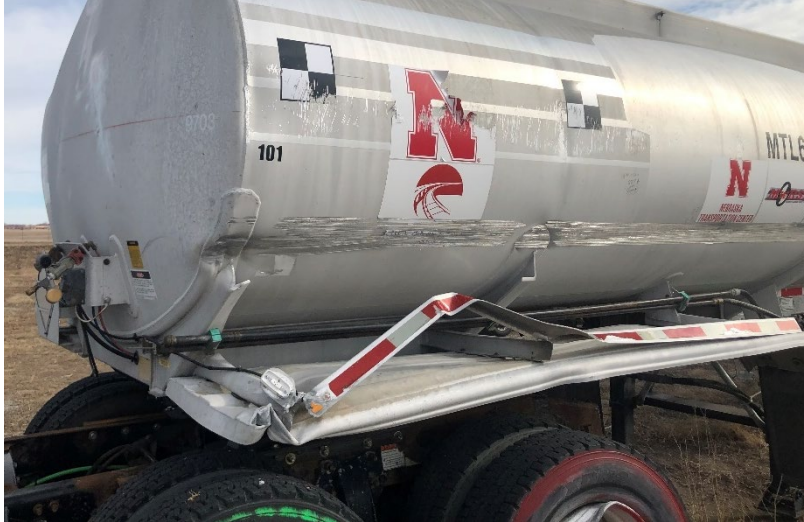
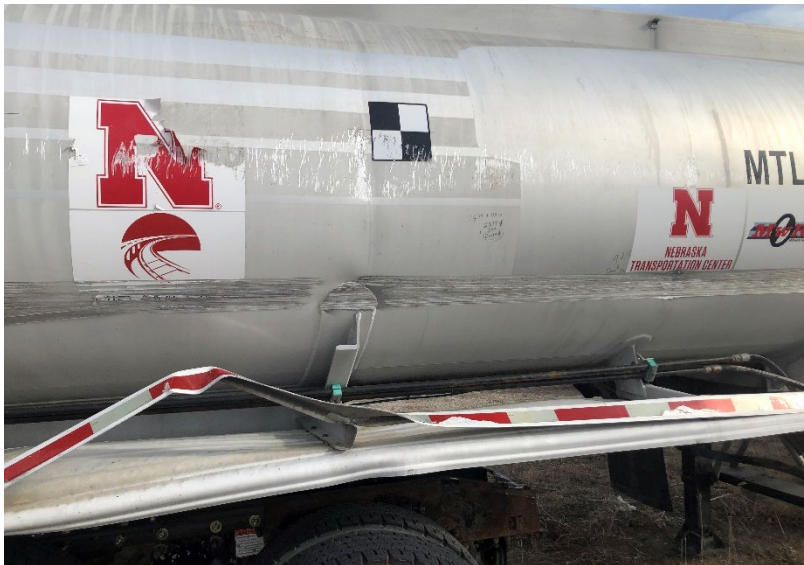
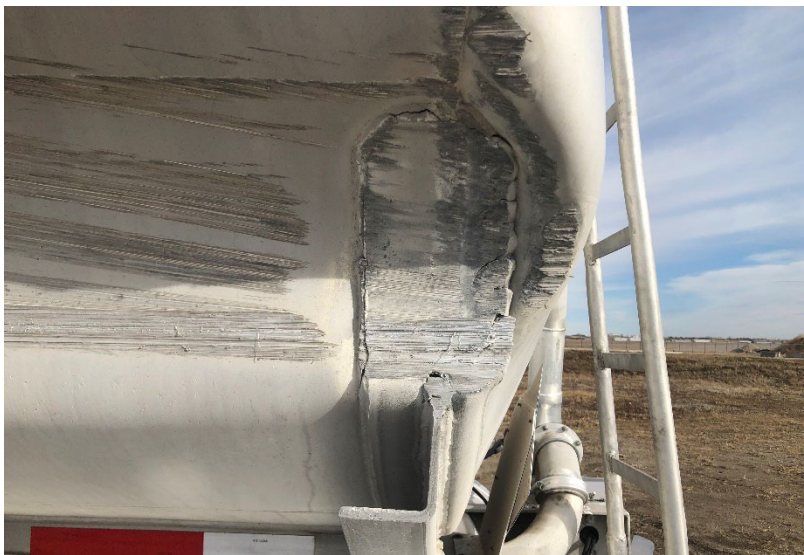
Figure 6.27 Trailer Damage on Impact Side After Being Uprighted, Test No. MTL6-1

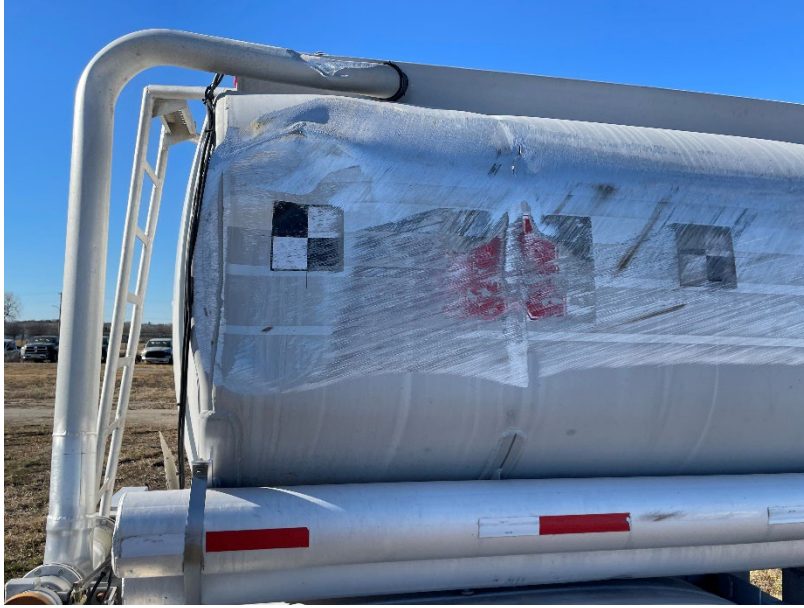
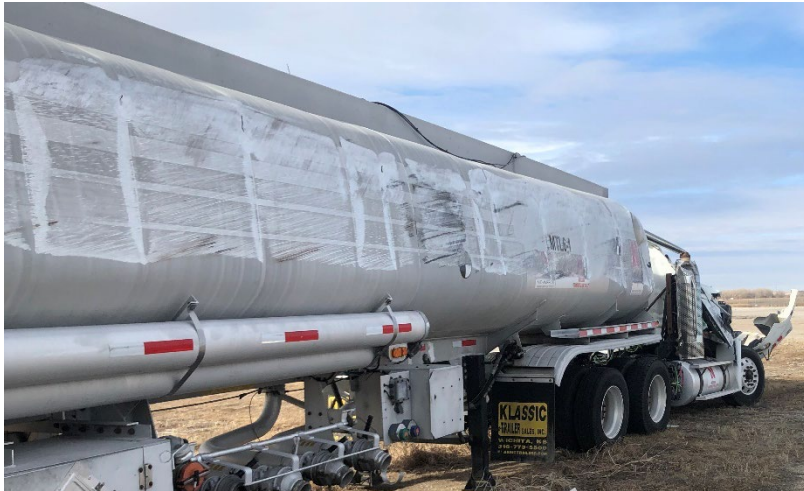
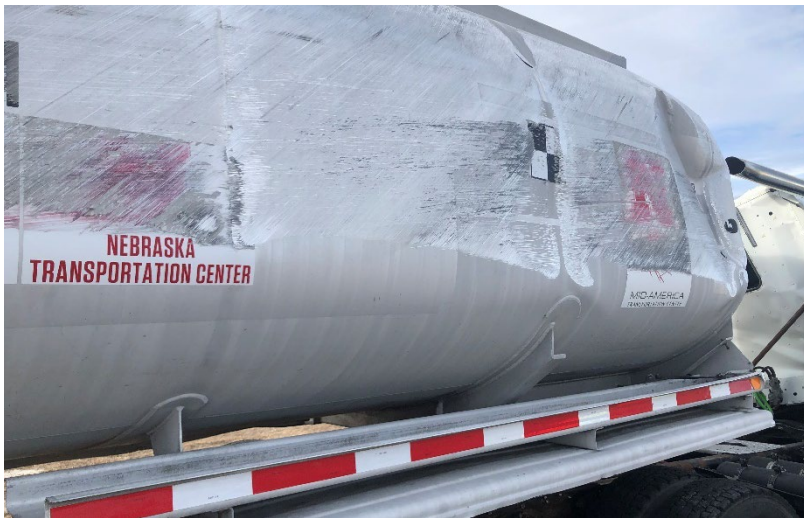
Figure 6.28 Trailer Damage on Non-Impact Side After Being Uprighted, Test No. MTL6-1

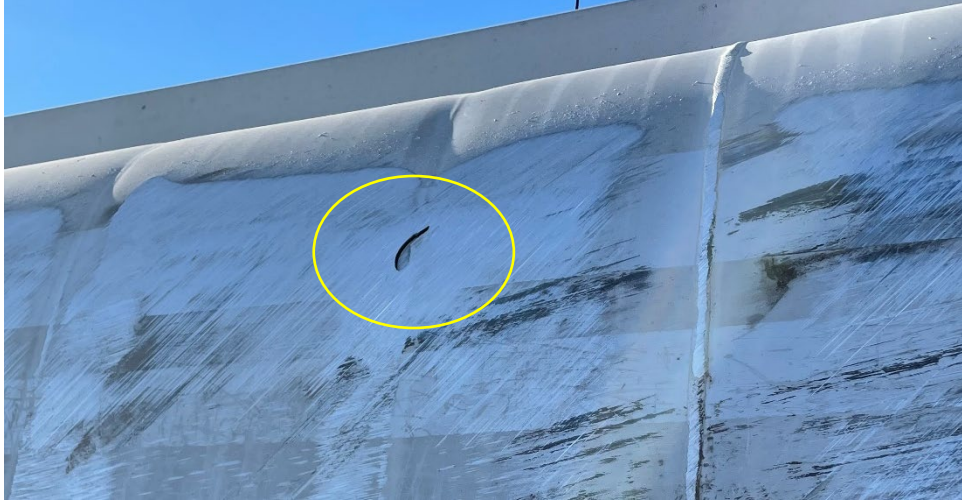
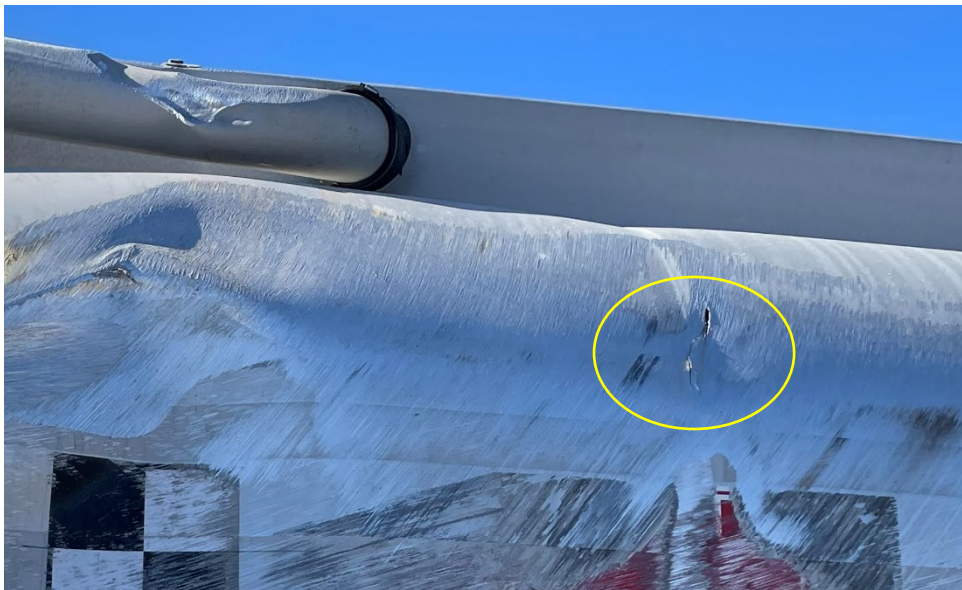
Figure 6.29 Tears in Trailer Jacket on Non-Impact Side, Test No. MTL6-1  
109

The trailer experienced extensive damage to the left, top, and right sides. Scraping, minor gouging, and some peeling of the aluminum jacket were observed near interior baffle locations. Scrub marks were observed on the left side of the trailer at the impact height of the barrier, and two large dents were observed at the same height: one in the front, and one in the back. The left-side wheel hubs were scraped and gouged. The right side of the trailer experienced extensive scraping in the vertical direction corresponding to sliding on the concrete tarmac, with multiple small tears and holes observed in the aluminum jacket especially near the internal baffles. The right side was flattened and crushed inward along the entire middle section where the vehicle rolled and skidded, and several tears were observed in the jacket measuring between 2 and 3 in.

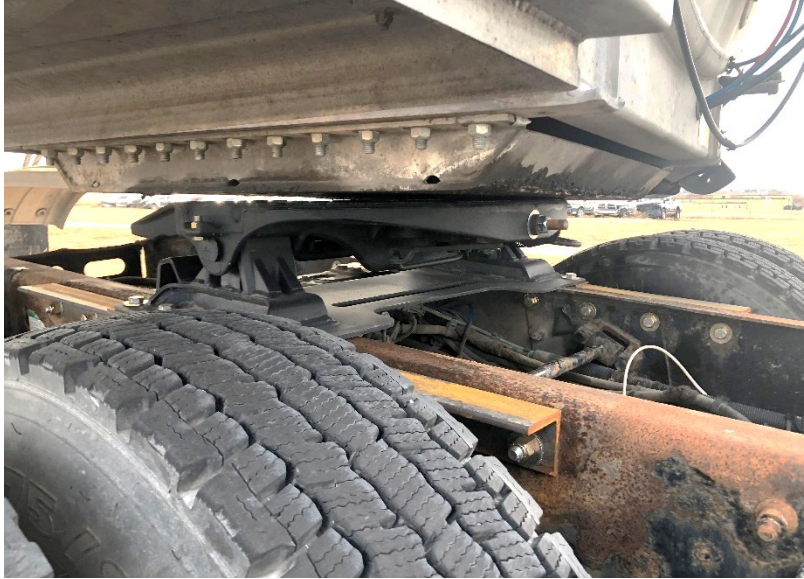
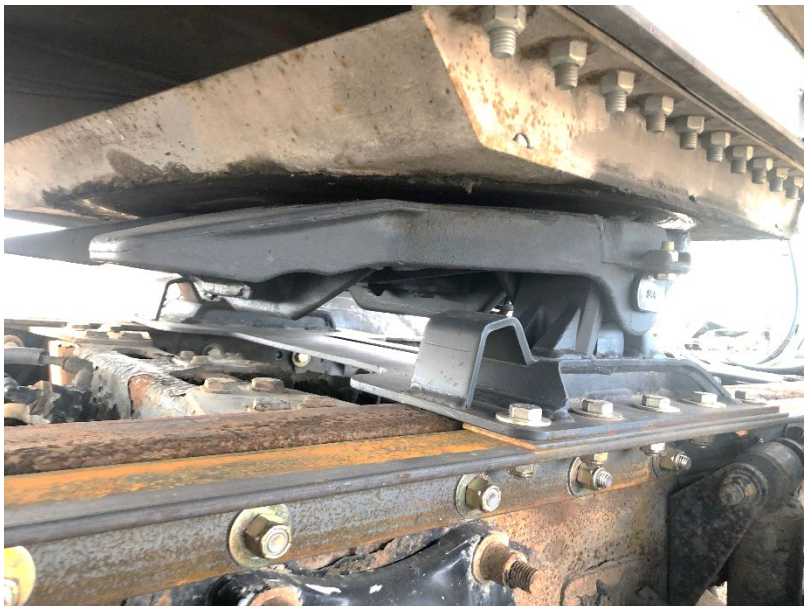
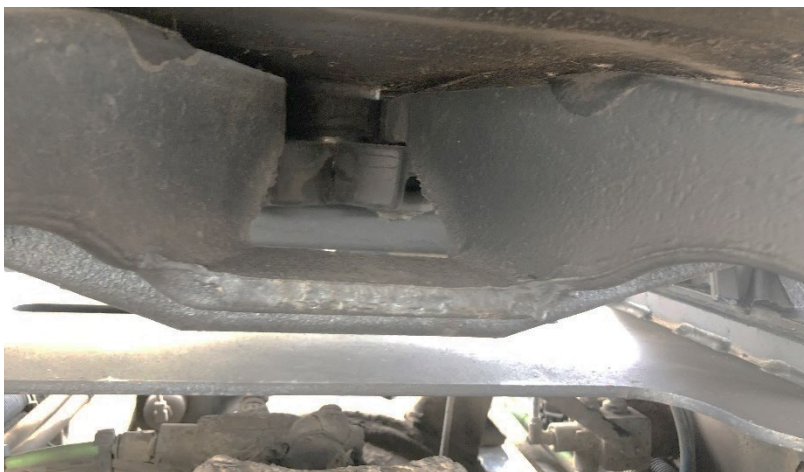
Figure 6.30 Fifth Wheel Damage, Test No. MTL6-1

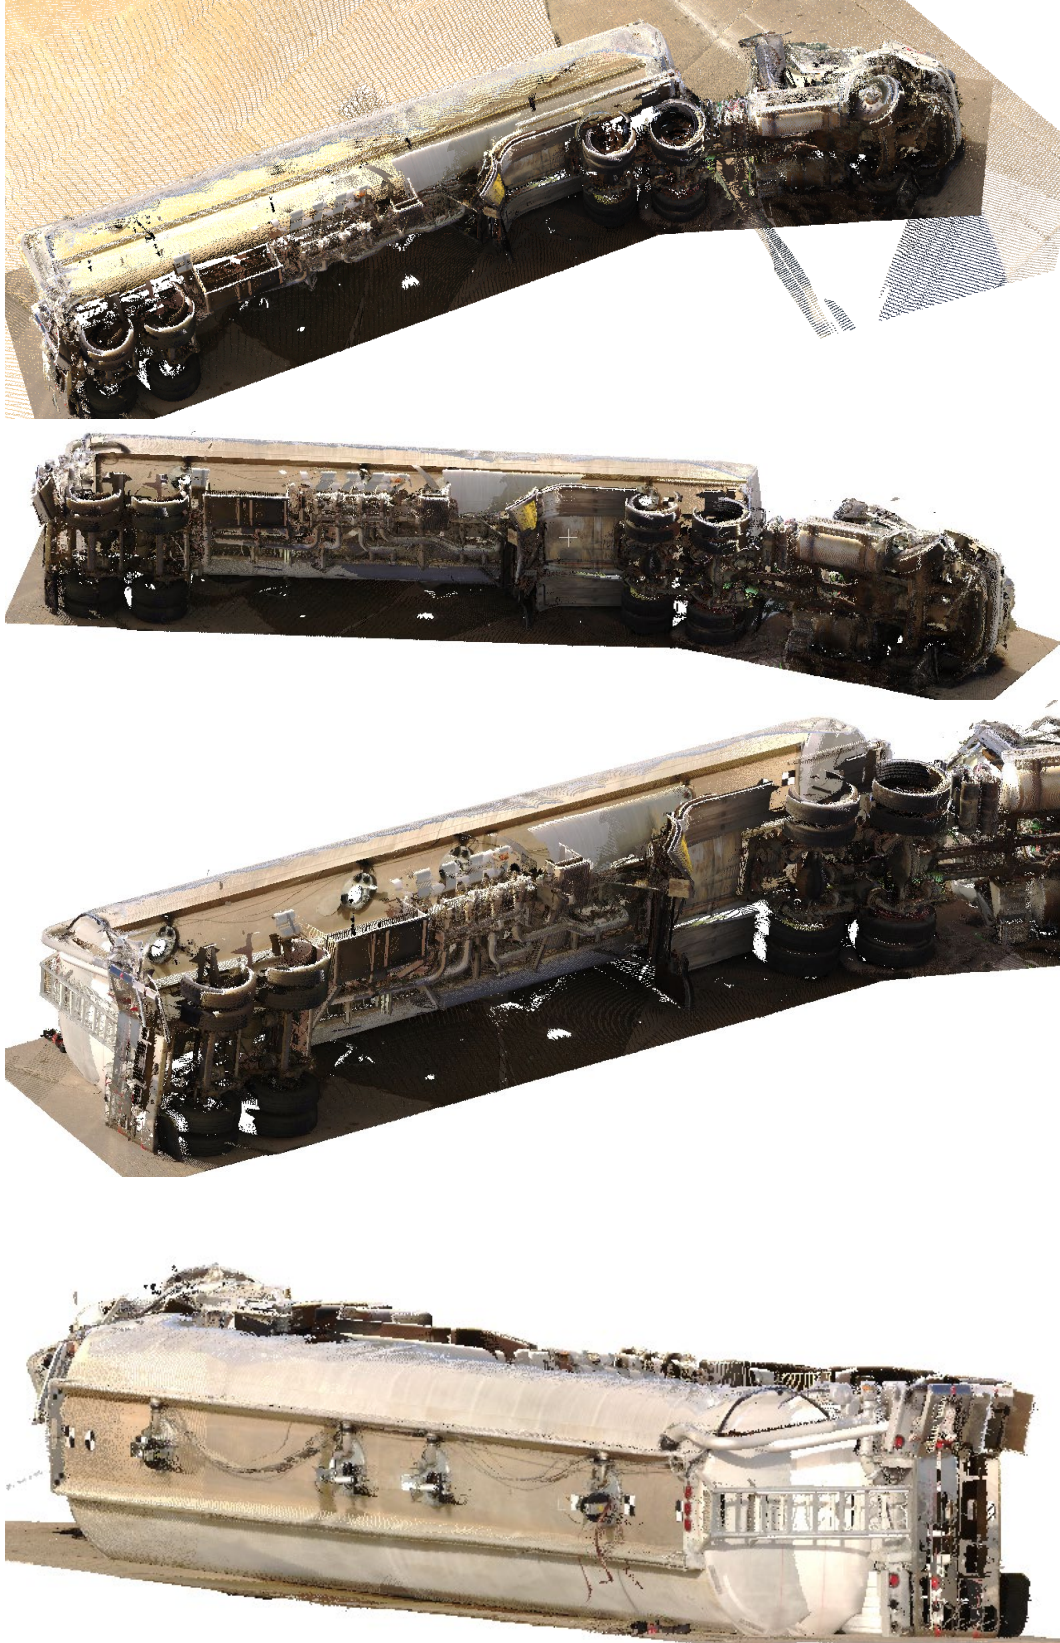
Figure 6.31 Vehicle Scan Results, Tanker Damage, Test No. MTL6-1

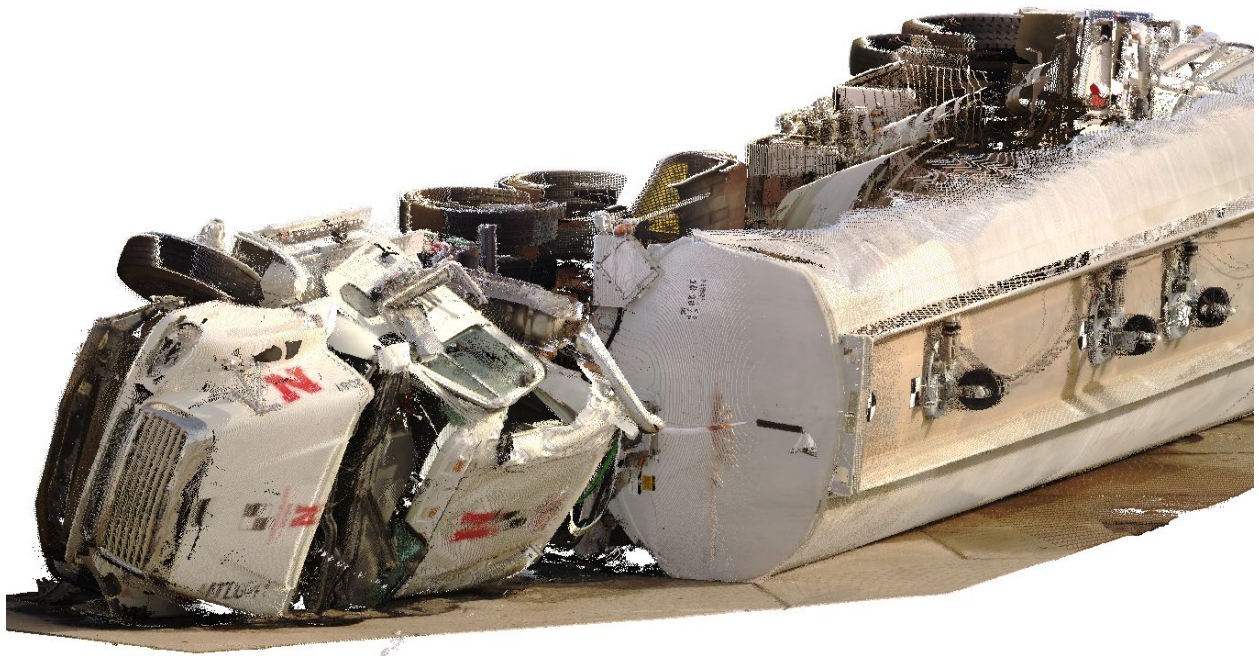
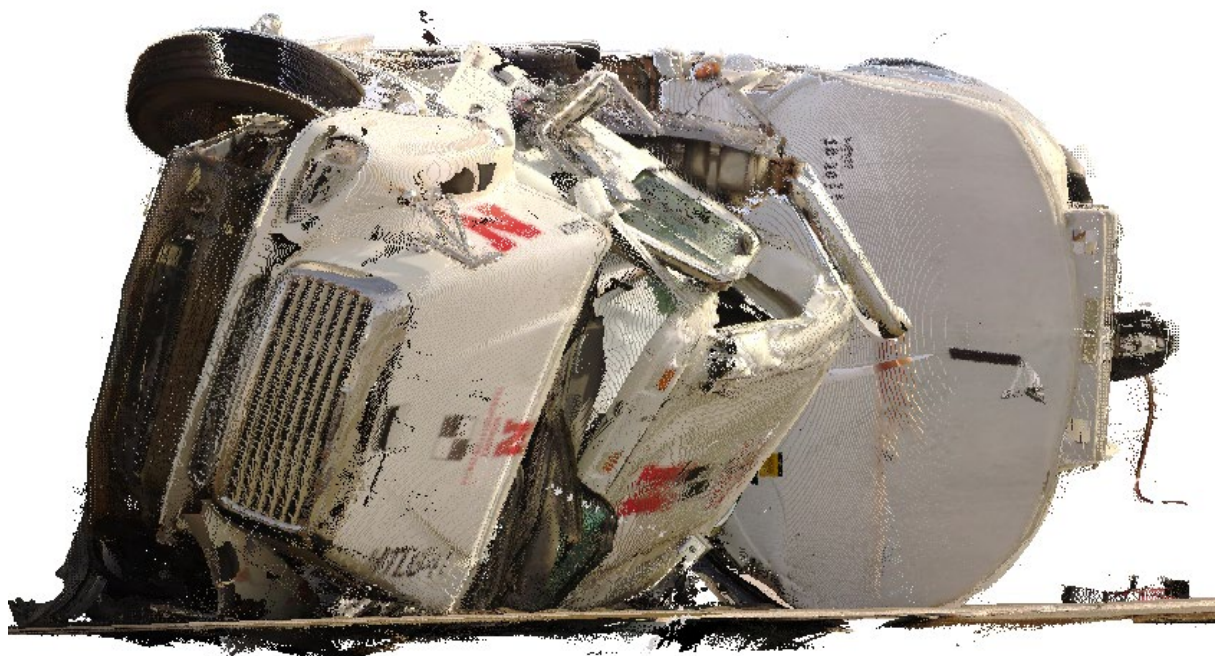
Figure 6.32 Vehicle Scan Results, Tractor Damage, Test No. MTL6-1
