MID-AMERICA TRANSPORTATION CENTER

Report # MATC-KU: 151-4

Final Report

Automated Bridge Inspection using Digital Image Correlation and Other Vision-based Methods - Phase IV

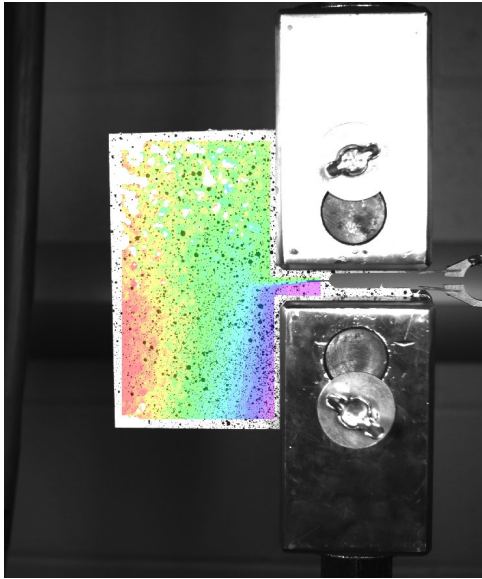
Figure 2.10 DIC results for a 25.4 mm (1.0 in.) crack with 648 mm (25.5 in.) camera distance under LC5 and Condition 1 in terms of (a) displacement and (b) strain

DIC data was collected for varying crack lengths and lighting and focus conditions. Typical outputs from the DIC software for LC5 with a crack length of 25.4 mm (1.0 in.) and a camera-to-specimen distance of 648 mm (25.5 in.) are shown in figures 2.10 and 2.11, showing conditions 1 and 5, respectively.

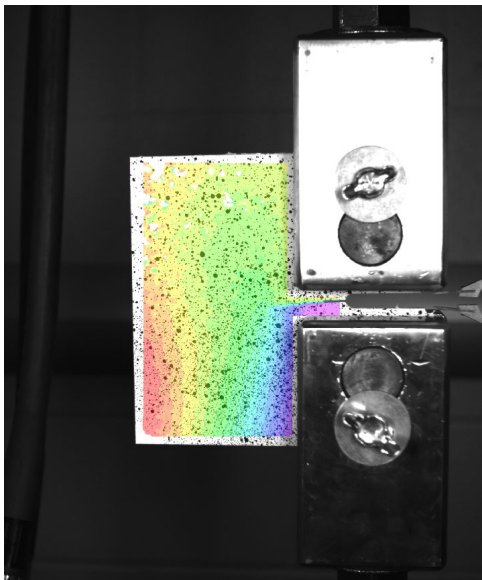
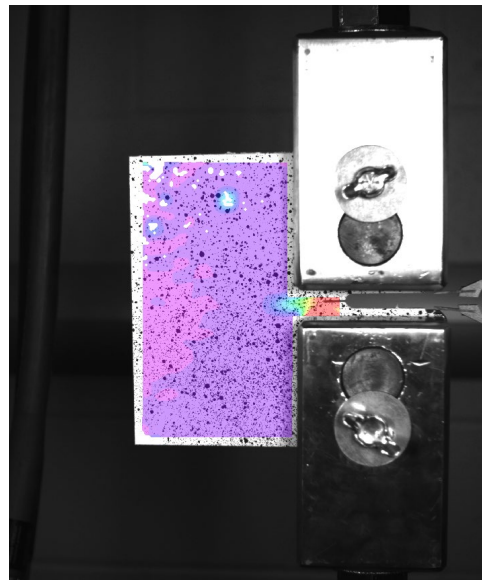
Figure 2.11 DIC results for a 25.4 mm (1.0 in.) crack with 648 mm (25.5 in.) camera distance under LC5 and Condition 1 in terms of (a) displacement and (b) strain

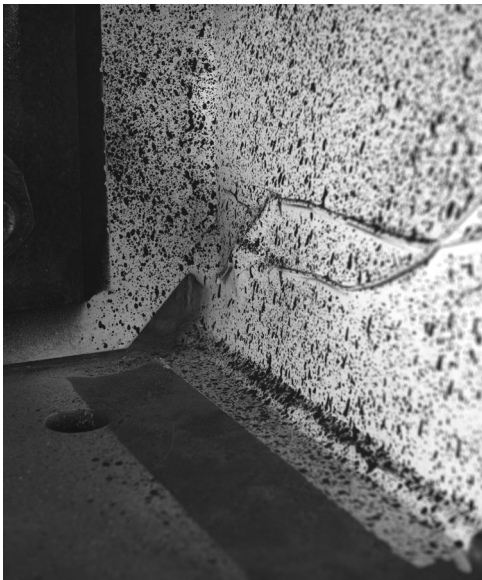
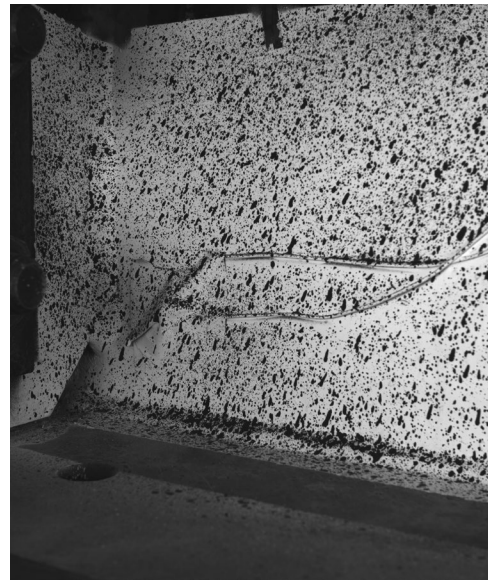
Post-processing of the images was performed in the VIC-2D software. While the original post-processing compared both images to determine an x -, y -, and z -axis relative displacement, the single camera testing found x - and y -axis relative displacement, U and V , respectively, for each camera angle, shown in figure 2.18. The data from a single camera was then used to find convergence of relative displacement along the crack length. This was compared to the original convergence values to determine if a single camera can capture the complex crack location.

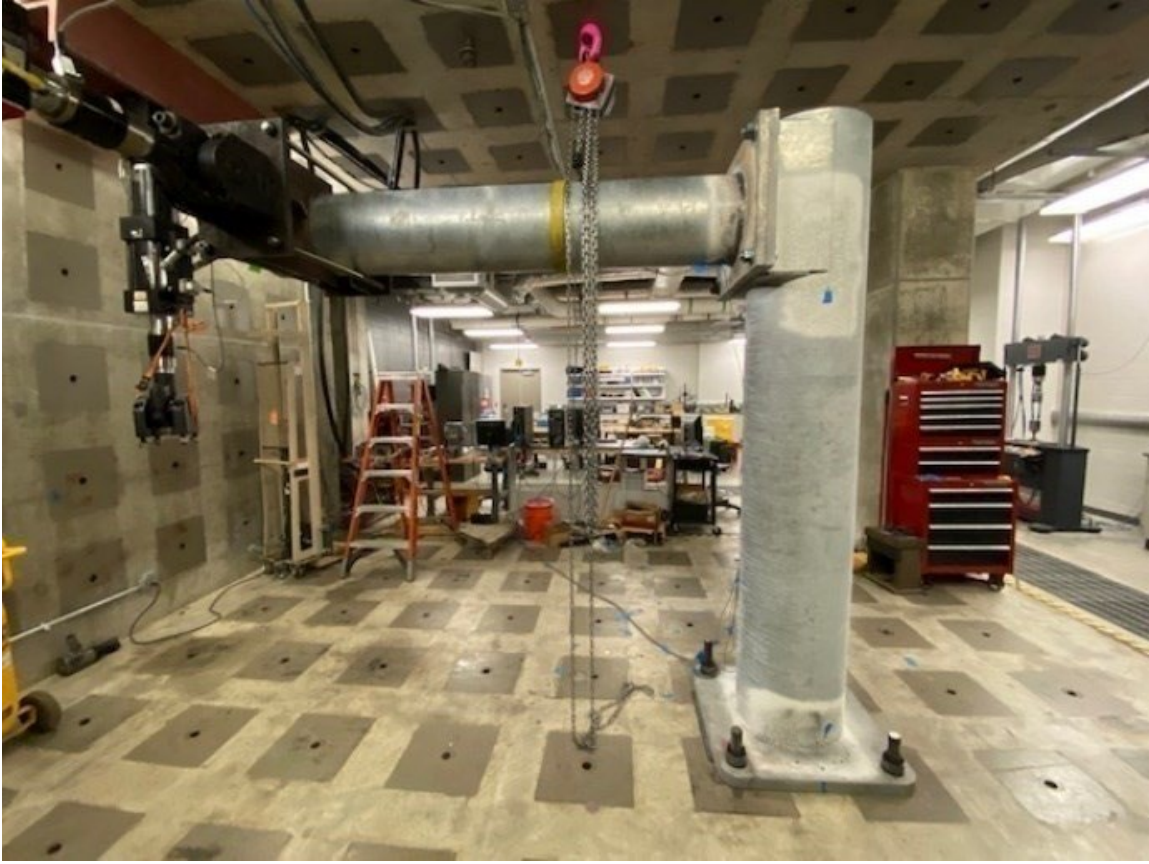
Figure 3.3 COSS test specimen

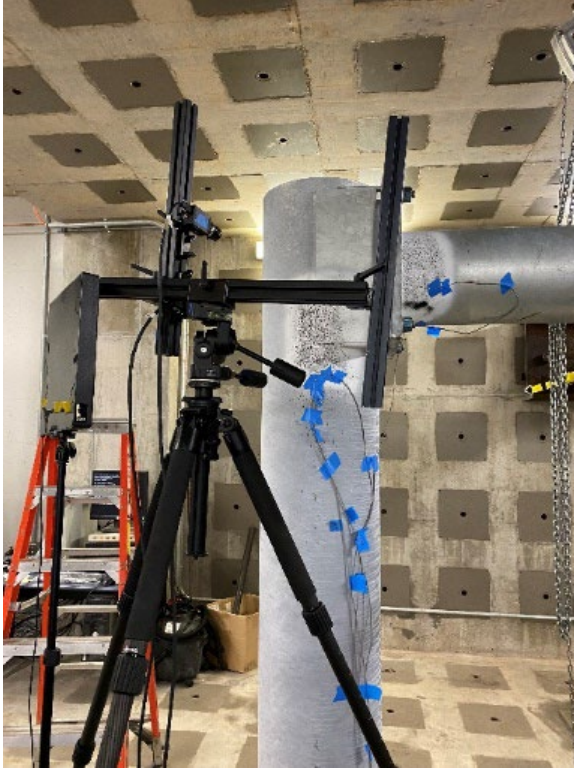
In addition to the box connection weld, the mast-arm-to-flange and baseplate welds were identified as potential hotspots for fatigue cracks. Prior to testing, a high contrast speckle pattern was applied to each region of interest by coating the surface with white paint and then using black spray paint and markers to create random patterns. The black speckle sizes ranged from 0.5 to 2.5 mm (0.02 to 0.10 in.). Two cameras were used to capture 3D images from each location. Figure 3.4 illustrates typical 3D DIC setup at the box, mast-arm and baseplate connections.

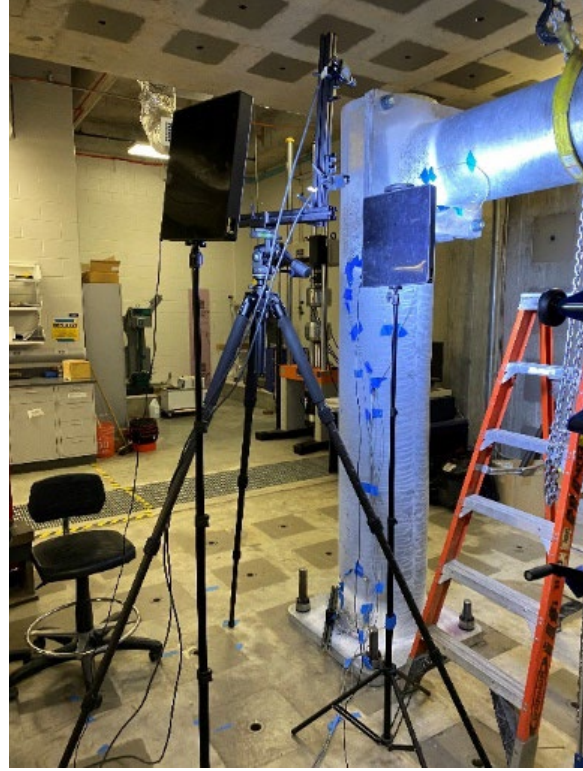
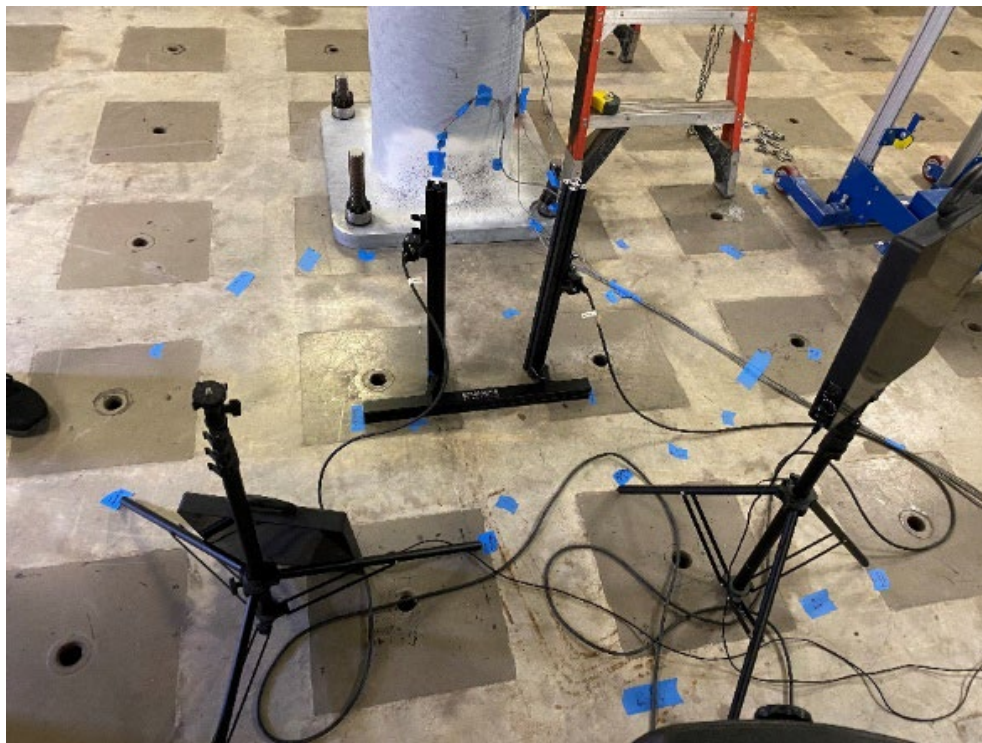
Figure 3.4 3D DIC setup for the (a) box connection, (b) mast-arm, and (c) baseplate

For the box connection monitoring, the two cameras were spaced 58 cm (23 in.) apart. The arm connection crack monitoring setup only used one vertical Unistrut bar with the cameras spaced 30 cm (12 in.) apart. Monitoring of the baseplate was done by placing the horizontal Unistrut bar on the ground with the cameras spaced 30 cm (12 in.) apart. In each case, the distance from the cameras to the region of interest was approximately 58 cm (23 in.).

The cameras used in this investigation were five megapixel (2448 x 2048 pixel) PGR Grasshopper3 cameras which used a Sony IMX250 complementary metal oxide semiconductor (CMOS) sensor and a frame rate of 50 frames/second. The cameras were equipped with a 17mm Schneider Xenoplan lens with aperture of f/1.4 resulting a field of view of 240 x 200 mm (9.45 x 7.87 in.). External adjustable LED lighting panels were used to reduce shadows caused by surrounding laboratory lighting and also provide good contrast for data analysis. The sigma value in VIC-3D was used to estimate the noise level during the test. Sigma values ranging from 0.002 to 0.009 were observed, and these ranges were considered conservative for the desired area of interest within the specimen.

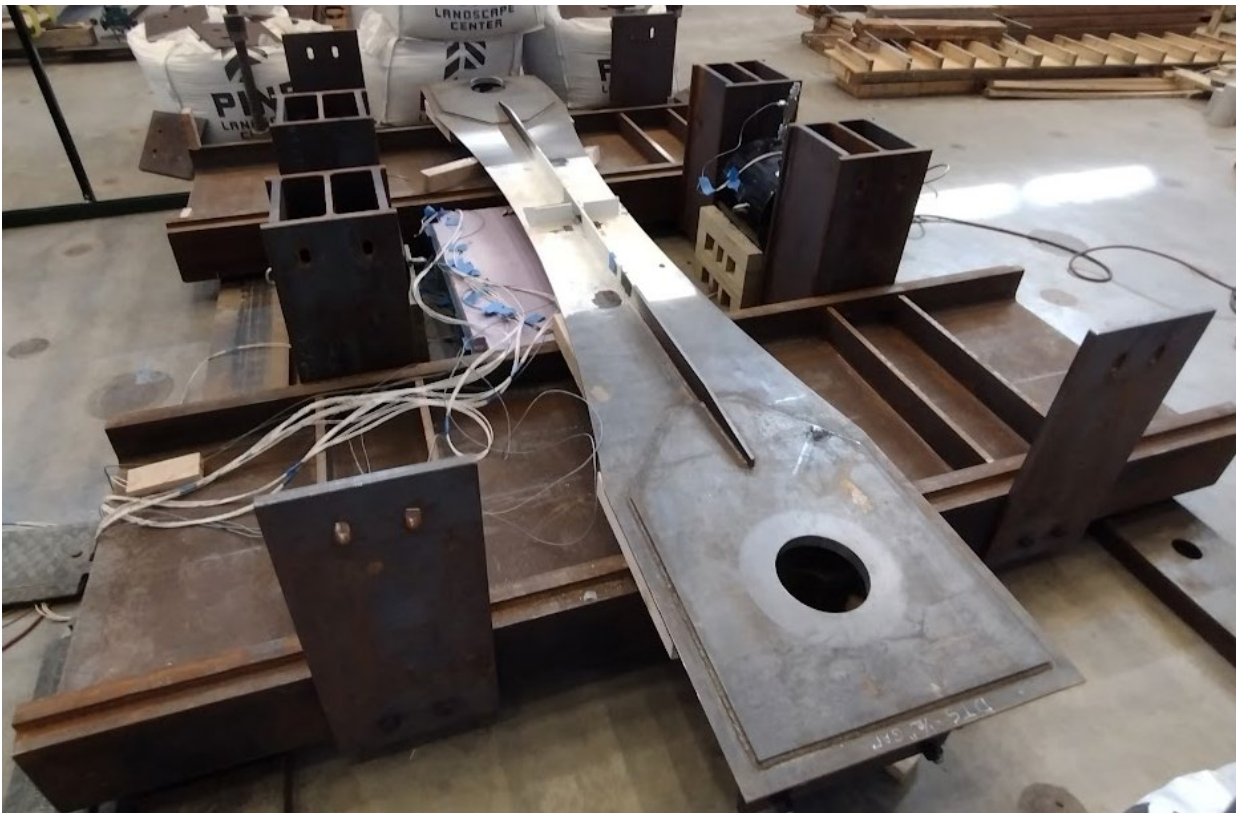
Figure 4.2 CIF specimen in place with partial self-reacting load frame

A large-scale specimen, approximately 4.4 m (14.5 ft) in length, was designed to be able to evaluate the details known to increase the likelihood of constraint-induced fracture occurrence. The specimen was intended to replicate conditions found on highway bridges where components intersect in three planes. The specimen evaluated as part of this study is comprised of a primary plate representing a girder web, a continuous longitudinal stiffener running the majority of the length of the specimen, and a discontinuous transverse stiffener. Tensile loading is applied to the specimen through large-diameter loading pins within a self-reacting frame. The specimen is schematically represented in figure 4.1, and can be seen in figure 4.2 with half of the self-reacting frame removed from view.

Loaded in tension, the primary plate has a reduced section at the point of interest measuring 457 mm x 9.5 mm (18 in. x 3/8 in.). Stiffeners in both directions are 8 mm (5/16 in.) thick and 89

mm (3.5 in.) tall. The specimen was detailed such that the distance between the longitudinal stiffener and the transverse stiffener was 20.6 mm (13/16 in.) with a gap of 12.5 mm (0.5 in.) between the longitudinal stiffener weld toe and the transverse stiffener. Details of the stiffener geometry is shown in figure 4.2.

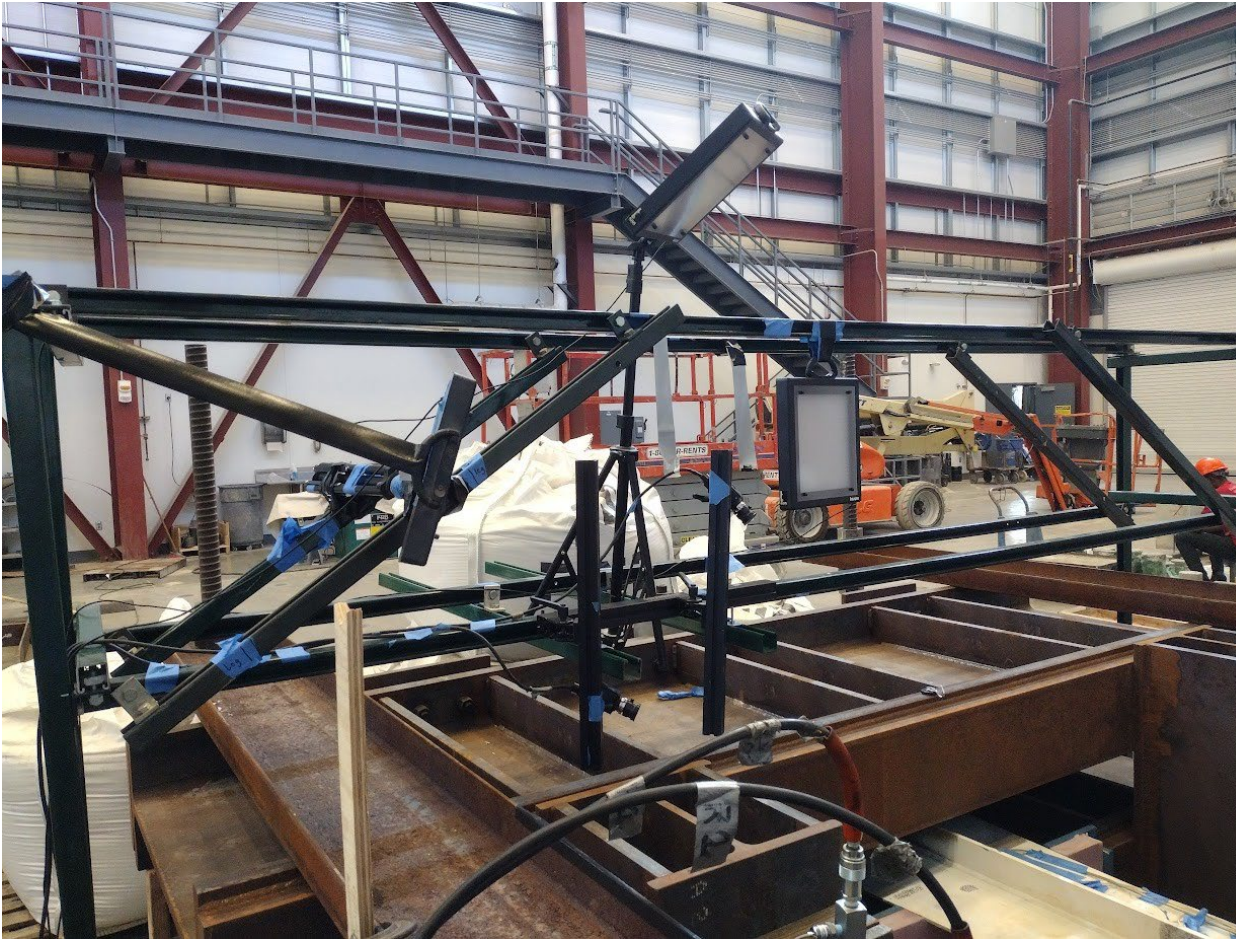
Figure 4.5 DIC cameras and lighting suspended above the CIF specimen

DIC was collected through a stereo camera setup, with the cameras and lighting positioned on a frame suspended above the specimen, allowing for appropriate spacing and angles to capture data in the area of interest. The cameras and lighting can be seen above the test specimen in figure 4.5.
