Repair of Corroded Steel H-Piles Using High Performance Material - Phase II

Department of Civil, Architectural & Environmental Engineering
Missouri University of Science and Technology

2021

1. Report No.: 25-1121-0005-133-2	2. Government Accession No.:	3. Recipient's Catalog No.:
4. Title and Subtitle: Repair of Corroded Steel H-Piles Using High Performance Material – Phase II (UHPC and FRP Repair Sections)		5. Report Date: Nov 2021

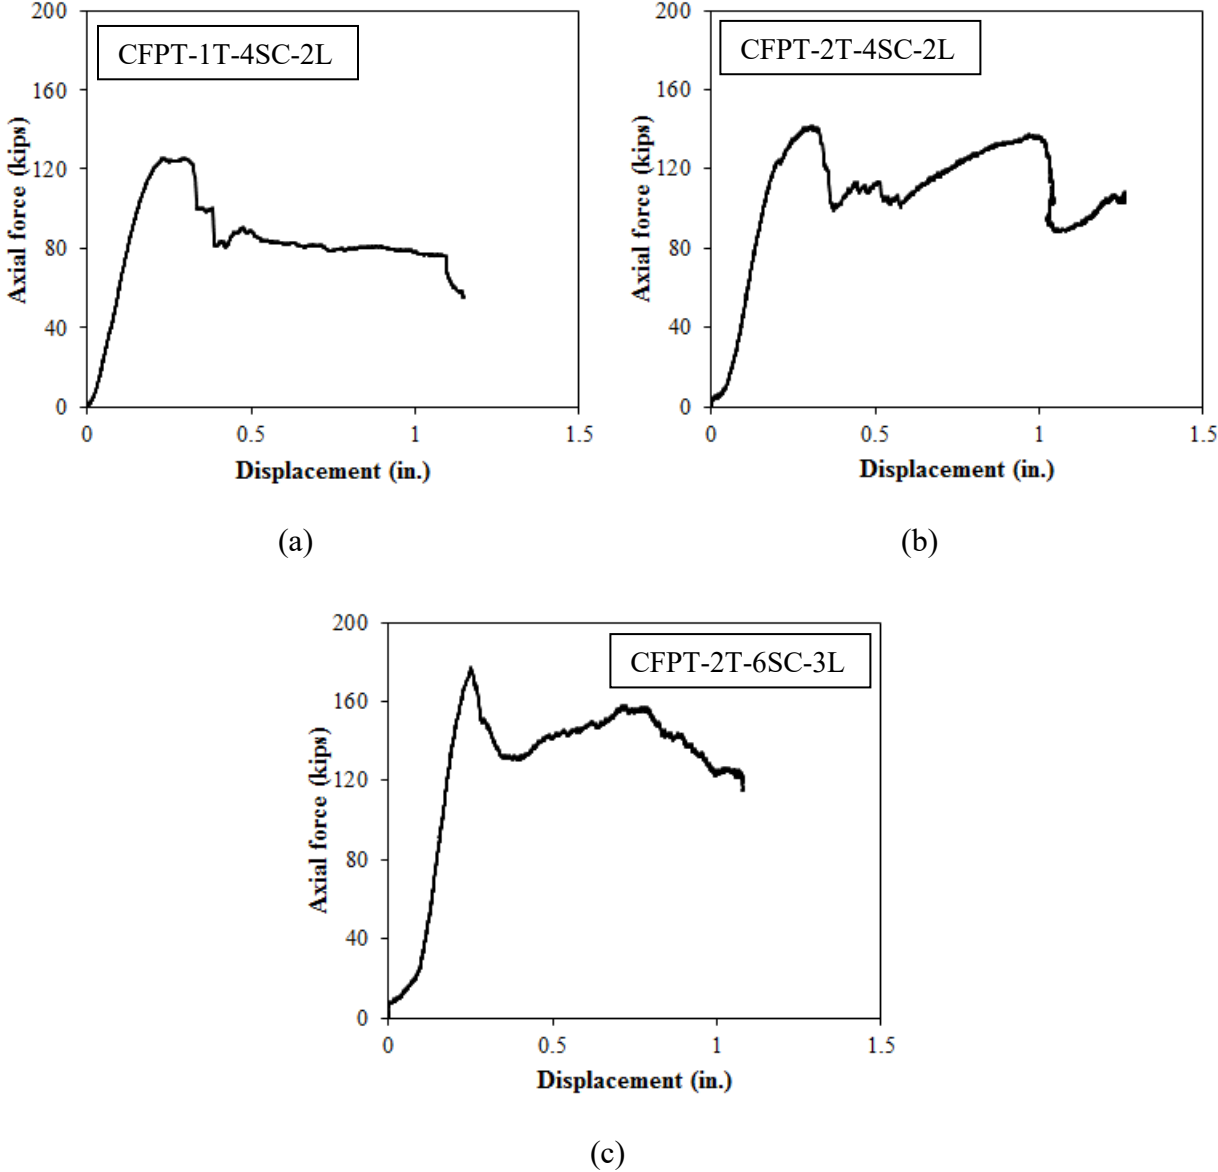
Figure 3.5 Axial force versus displacement curve (a) CFPT-1T-4SC-2L, (b) CFPT- 2T-4SC-2L, and (c) CFPT-2T-6SC-3L

Figure 3.4a shows the failure mode of specimen 1T-4SC-2L, dominated by the rupture of CFPTs at the corners right next to the web of the H-pile. The CFPT rupture proceeded by splitting initiating at the tube corners due to the stress concentration because of the concrete fill lateral expansion. Beyond that, debonding occurred between the filled concrete and the CFPTs until the specimen's failure. It reached an ultimate axial capacity of 141.8 kips and the highest axial shortening of 0.3 in. (fig. 3.5a), compared with the shortening of the other two specimens, 2T-4SC-2L and 2T-6SC-3L.

Figures 3.4b and 3.4c show the failure modes of the specimens 2T-4SC-2L and 2T-6SC-3L, respectively, which were mainly splitting failure initiating at both the concrete and CFRP and observed along the longitudinal direction passing through the center of the SCs. The peak load was 125.7 kips for 2T-4SC-2L (fig. 3.5b) and 177.2 kips for 2T-6SC-3L (fig. 3.5c).

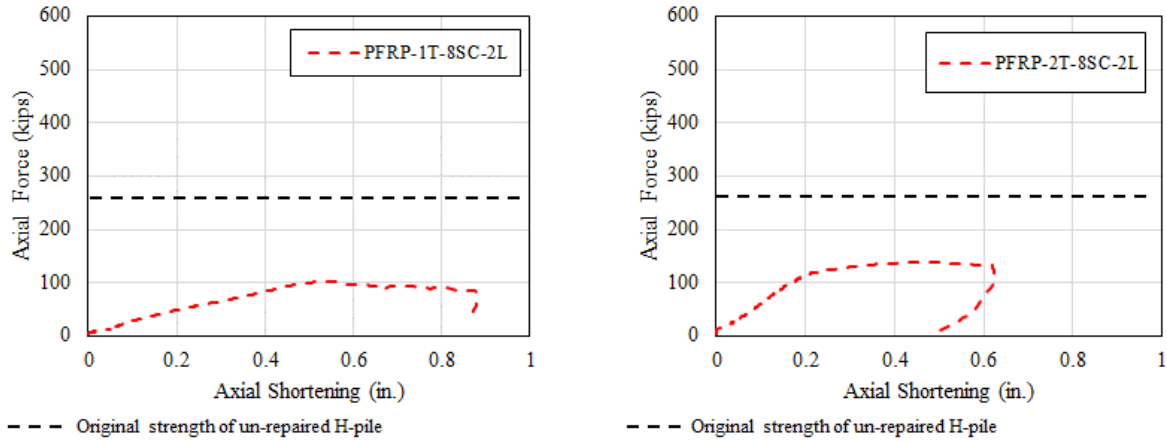
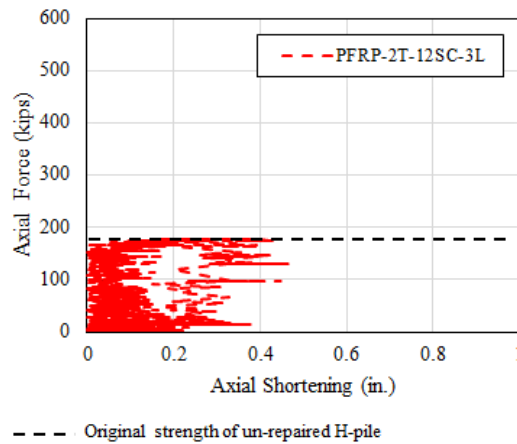
Figure 3.6 Axial force versus axial shortening of large-scale repaired H-pile (a) CFPT-1T-8SC-2L, (b) CFPT-2T-8SC-2L, and (c) CFPT -2T-12SC-3L

In specimen R1 (table 3.5), the corroded H-pile was repaired with one CFPT on each web and eight shear connectors(SC) that were distributed over two layers with two SCs per layer. The test results revealed the lowest failure axial load of 102 kips and the highest axial shortening of 0.90 in. compared to the other tested specimens (fig. 3.7a). Increasing the number of CFPTs to two and keeping the other parameters similar to those used in specimen R1 resulted in an increase in the axial failure load to 139 kips and a decrease in the axial shortening to 0.65 in (fig. 3.7b).

In specimen R2 (table 3.5), the corroded H-pile was repaired with two CFPTs on each web and eight shear connectors (SC) distributed over two layers with two SCs per layer. The axial capacity of the R2 specimen increased by 29%, and shortening decreased by 28% compared with the R1 specimen. This could be explained by the two extra pultruded tubes' webs, which increased the specimen's stiffness and delayed the debonding between the PFRP and concrete.

In the case of specimen R3, the corroded H-pile was repaired with two CFPTs on each web and twelve shear connectors (SC) distributed over three layers with two SCs per layer. Increasing the number of SC in the specimen R3 to twelve distributed over three layers while keeping other parameters (i.e., CFPTs configuration) similar to that of R2 resulted in the highest failure axial load at 190 kips and the lowest axial shortening of 0.40 in. compared to the other specimens (fig. 3.7c). The axial load increased by 41% while the shortening decreased by 38%

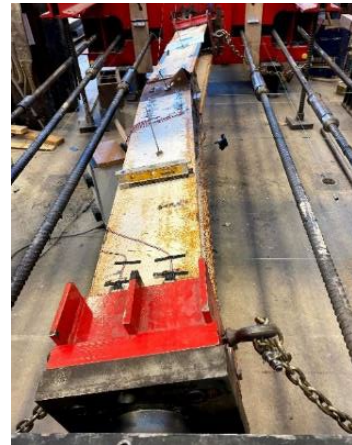
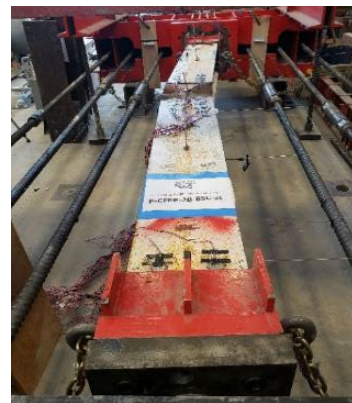
Figure 3.7 Large-scale repaired H-pile before and after the test: (a) CFPT-1T-8SC-2L, (b) CFPT-2T-8SC-2L, and (c) CFPT-2T-12SC-3L

Table 3.5 shows the results of large-scale testing of the steel H-pile repaired with CFPT under compression and it's failure modes. Figure 3.6 shows CFPT specimens before and after the testing. The failure mode was dominated by the global buckling at the corroded section location. Moreover, increasing the SC number used to attach the CFPTs improved the repaired-after-corrosion H-pile in terms of the axial capacity (table 3.5). In all three specimens, the failure mode was a global buckling, as anticipated by obtaining the same buckling shape during testing of the original corroded H-piles. However, the axial load and shortening at the failure were different.

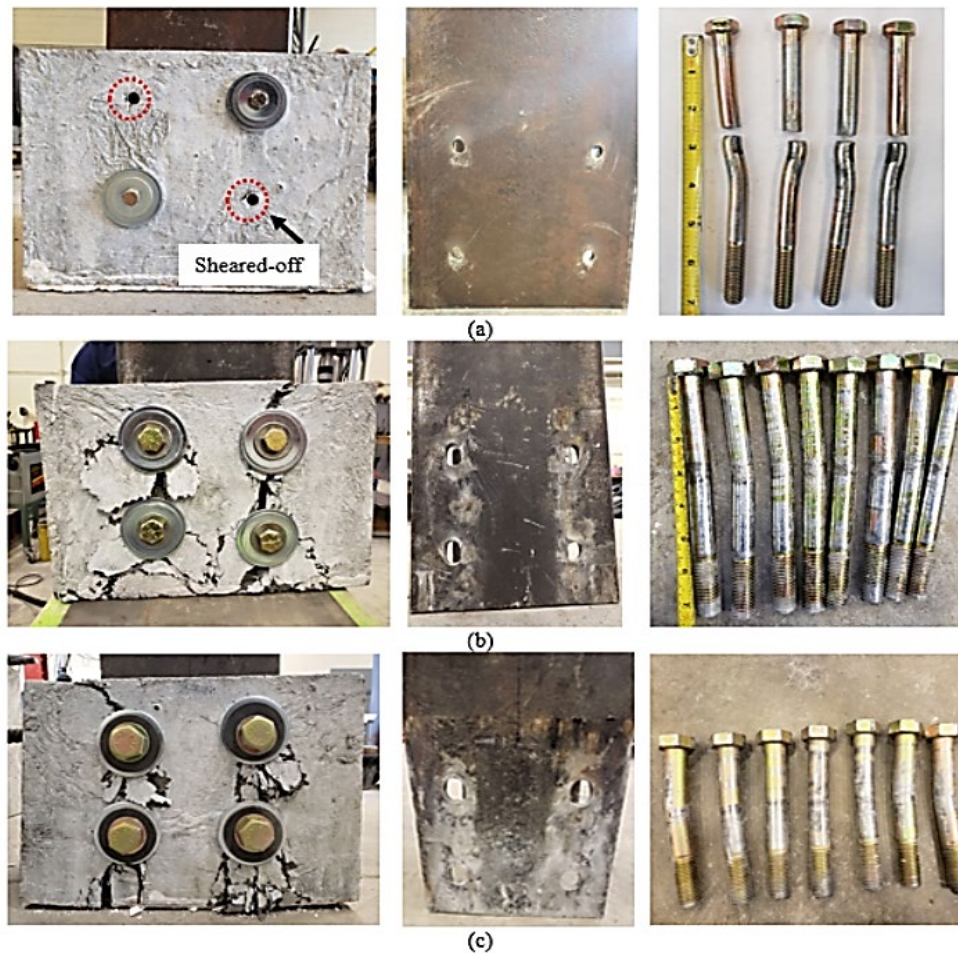
Figure 5.5 Typical failure modes for specimens with (a) ½ in., (b) ¾ in., and (c) 1 in. diameter SC

This was followed by the shearing-off of a top bolt from each flange (fig. 5.5a) and the

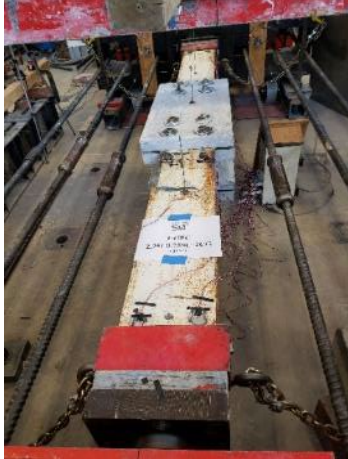
cracking and rupture of the top UHPC plate (fig. 5.8a). Similarly, for specimen UHPC-1SC-1CG, the capacity of the H-piles increased by 83% compared to the original corroded pile with the peak load reaching 430 kips (fig. 5.9b), and failure due to global buckling about the x-axis which triggered splitting cracking on the UHPC plates (fig. 5.8b).

Furthermore, specimen UHPC-1SC-2CG displayed the highest increment of 124% in the axial capacity compared to the reference corroded pile reaching a peak load of 445 kips (fig. 5.9c). The failure mode was similar, however, to that which occurred during testing specimen UHPC-1SC-1CG (fig. 5.8c).
